## REHABILITATION OF EARTHQUAKE-DAMAGED REINFORCED CONCRETE FLAT-PLATE SLAB-COLUMN CONNECTIONS FOR TWO-WAY SHEAR

Widianto<sup>1</sup>, Ying Tian<sup>1</sup>, Jaime Argudo<sup>1</sup>, Oguzhan Bayrak<sup>2</sup>, and James O. Jirsa<sup>2</sup>

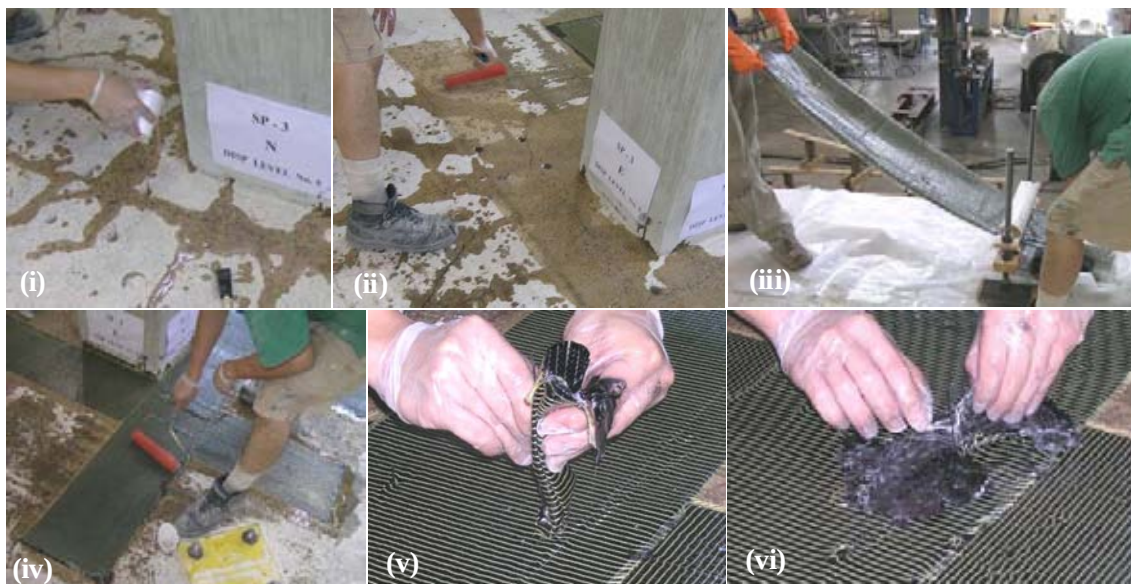
Figure 6. Installation of CFRP sheets and CFRP anchors in SP-3.

SP-3 was repaired by installing CFRP sheets around the column (Fig. 6). CFRP sheets were fastened to the slab tension face to increase the flexural capacity of the slab that had only 0.5% reinforcement ratio within  $(c+3h)$  region. With such a low reinforcement ratio, flexural failure is more likely to govern over the two-way shear failure (Marzouk and Hussein 1991). A 1.0% reinforcement ratio is considered to be typical in a slab-column connection designed using current codes. The amount of CFRP reinforcement was selected to produce the same flexural capacity within  $(c+3h)$  region as that of a connection with 1.0% steel.

The installation of CFRP sheets involved drilling four holes (3/4-inch diameter and 4½-inch deep) at each corner of the column so that CFRP anchors could be inserted. The edges of the holes were chamfered and the concrete surface was ground smooth and cleaned. The CFRP

installation is shown in Fig. 6. (i) Epoxy was poured into cracks and holes, (ii) concrete surface was coated with the epoxy, (iii) an impregnated CFRP sheet was inserted into a saturator to remove excessive epoxy, (iv) the sheet was placed on the concrete surface and a paint roller was used to remove air voids below the sheet, (v) CFRP anchors were inserted into the holes, and (vi) the protruding ends of the anchors were splayed over the CFRP sheet.

In order to develop a feasible technique to alleviate the adverse effects of low amounts of flexural steel within the  $(c+3h)$  region, SP-3 was tested. This test specimen contained 0.5% reinforcement ratio within the  $(c+3h)$  region. In order to add more flexural reinforcement, 12-inch wide CFRP sheets were installed on the top face of the slab and anchored by CFRP fan anchors (Fig. 6). As can be seen in Fig. 7, the installation of well-anchored CFRP sheets on the tension side of the slab improved the punching shear strength of the slab-column connection. Left unrepaired, the capacity of SP-3 would have resembled that of SP-Control 2. SP-3 can be considered as the repaired version of SP-Control 2 after the connection experiences earthquake damage. Table 1 shows that the CFRP installation improved the two-way shear strength of the connection by 38% (from  $2.47\sqrt{f_c'}$  to  $3.41\sqrt{f_c'}$ ). In addition, the capacity of SP-3 was about the same as that of SP-Control 3, implying that external CFRP sheets just as effective as the percentage of steel reinforcement.
