CENTER FOR INFRASTRUCTURE ENGINEERING STUDIES

STRENGTHENING OF RC STRUCTURES WITH NEAR SURFACE MOUNTED FRP RODS

University of Missouri-Rolla

**CIES
99-10**

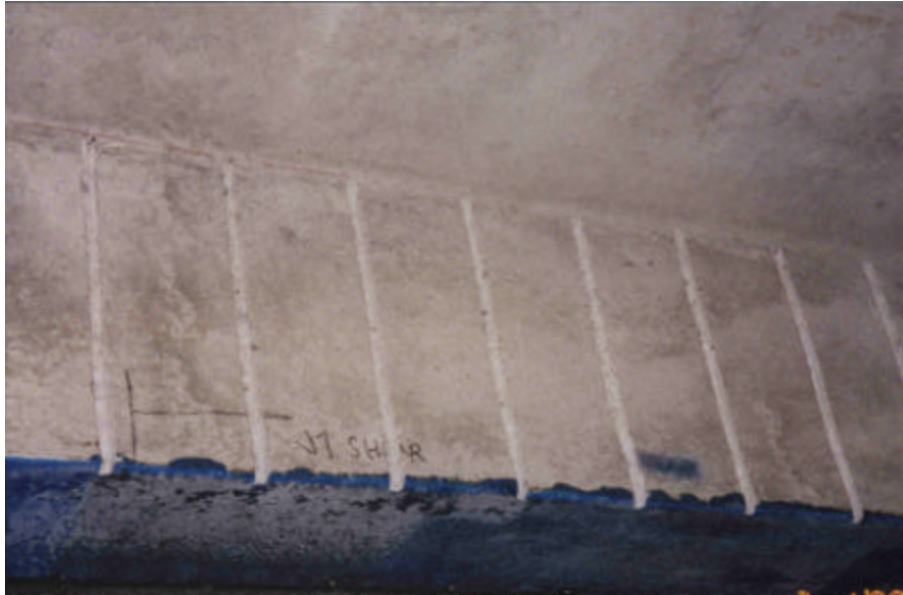
Figure 1.2. Vertical Grooves for Shear Strengthening with NSM FRP Rods (Hogue et al., 1999)

1.3.2. Field Projects. A strengthening project was carried out at the structural street level floor of Myriad Convention Center, Oklahoma City, OK (USA) in 1997-1998 (Hogue et al., 1999). The PC floor required strengthening in order to increase its live load bearing capacity. The strengthening system implemented included a combination of externally bonded steel plates, CFRP sheets and NSM CFRP rods. The strengthening system sought to address both flexural and shear deficiencies. NSM rods were used in this case for shear strengthening of one of the RC joists. Vertical grooves 1/2-in. wide and 3/4-in. deep with a total length of 20 in. were saw-cut along the side surfaces of the joist at such positions that existing stirrups were avoided (Figure 1.2). CFRP No. 3 rods were then inserted in the epoxy-filled grooves.

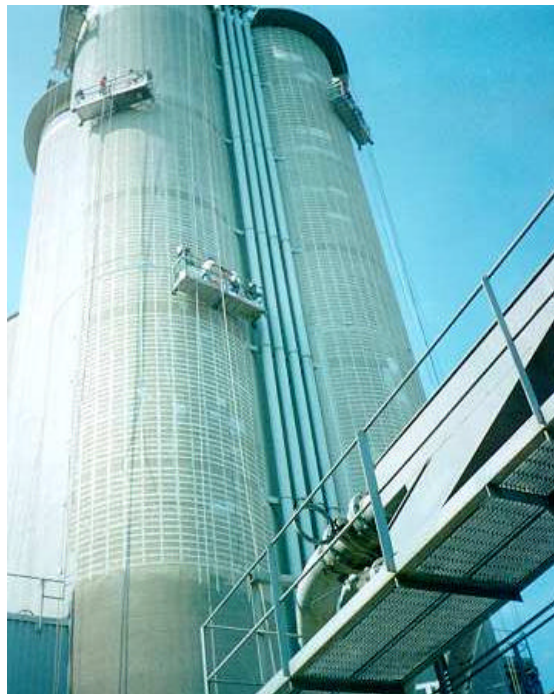
Figure 1.4. Filling of Grooves with Epoxy Paste (Nanni, 1998)

NSM CFRP rods were used for strengthening of two RC circular structures in the United States in 1998 (Nanni, 1998). Longitudinal and transverse grooves 1/2-in. wide and 1/2-in. deep were cut on the surface of the structures (Figure 1.3) and CFRP sandblasted rods with a nominal diameter of 5/16 in. were embedded in the epoxy-filled grooves (Figure 1.4).

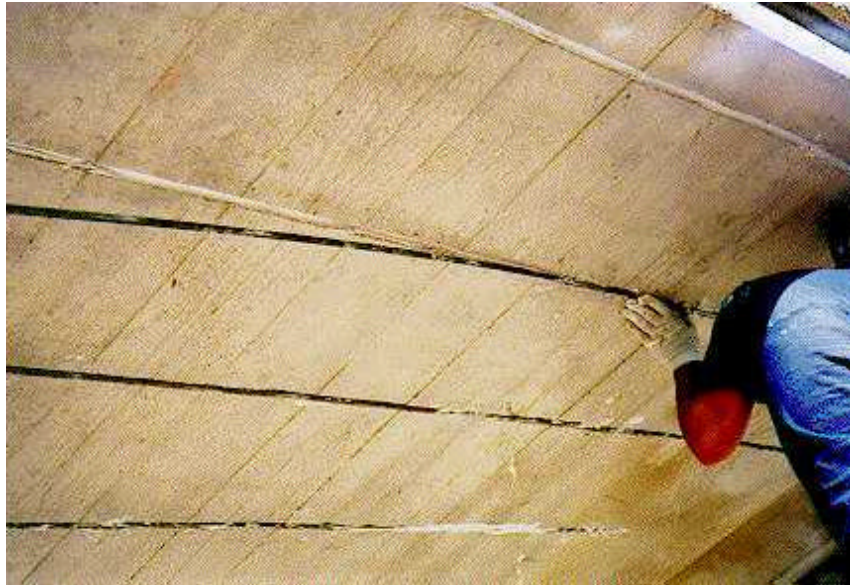
Figure 1.6. Installation of NSM CFRP Rods in the Bridge Deck (Alkhrdaji et al., 1999)

Bridge J-857 was located on Route 72 in Phelps County, MO (USA). It consisted of three solid RC decks simply supported by two bents. Each bent consisted of two piers connected at the top by an RC cap beam. Due to the realignment of Route 72, the bridge was decommissioned and scheduled for demolition. Therefore, it presented an excellent opportunity for in-situ testing to failure after strengthening with FRP composites (Alkhrdaji et al., 1999).

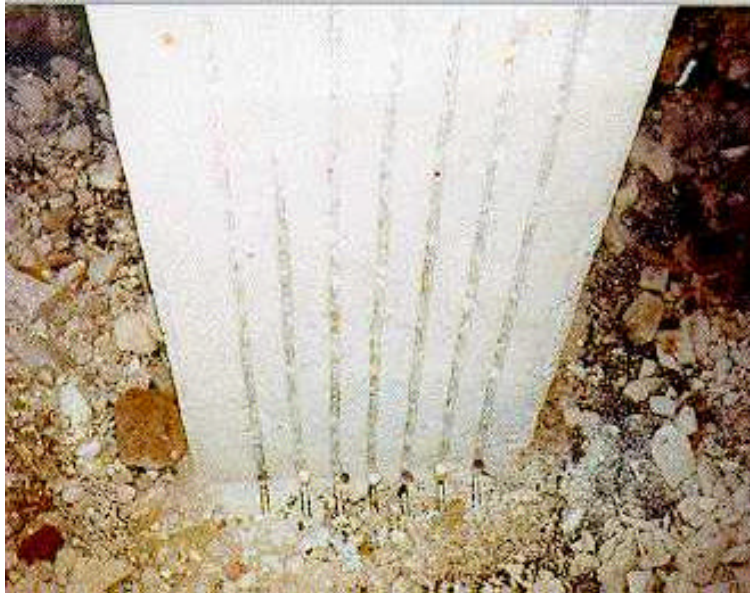
Figure 1.7. Columns Strengthened with NSM Rods (Alkhrdaji et al., 1999)

Two columns were also strengthened with NSM CFRP rods to increase their flexural capacity (Figure 1.7). The intended levels of flexural strengthening were such that two different failure modes would be achieved, one controlled by rupture of the CFRP reinforcement (6 rods, 3 on each face of the column) and one by crushing of concrete (14 rods, 7 on each face of the column). The rods were mounted on two opposite faces of the columns and fully anchored (minimum 15 in.) into the footings to ensure that the full capacity of the strengthened section would

be attained at the base of the column. The grooves and the drilled holes were filled with a viscous epoxy grout.

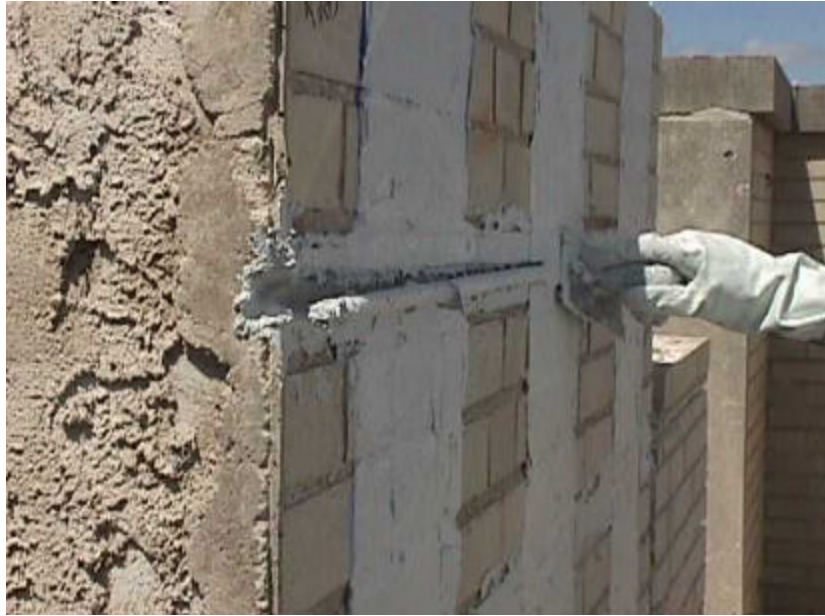
**Figure 1.8. Installation of NSM FRP Rods on Masonry Walls
(Tumialan et al., 1999)**

The program on masonry walls strengthened with FRP composites included testing of unreinforced masonry walls subjected to out-of-plane loading and reinforced masonry walls under in-plane loading. Parameters such as the type of composite system, strip width, and FRP installation methods were evaluated. Figure 1.8 shows the installation of NSM FRP rods on a masonry wall to be strengthened for out-of-plane loading.

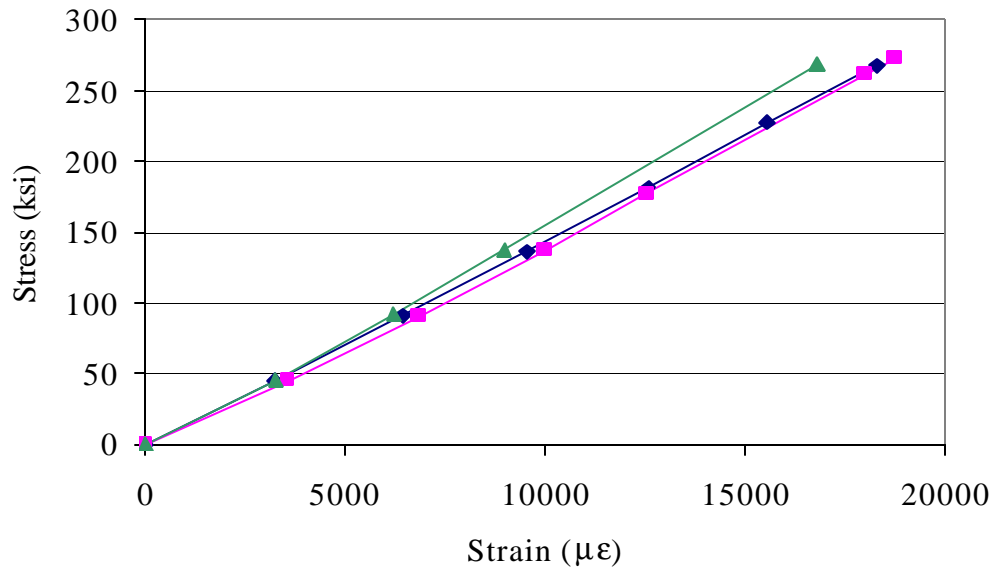
Figure 2.4. Stress – Strain Relationship of CFRP No. 3 Deformed Rods

2.4.1.3. Tensile Test Results. All specimens showed a linear elastic behavior up to failure and experienced tensile failure, which indicated that the bar had developed its full tensile capacity, and the anchor was efficient. Figure 2.4 shows the stress-strain relationship of the tested specimens. Figure 2.5 is a detail of a failed specimen.

Tensile strength, modulus of elasticity and ultimate strain were computed using load and strain data recorded during the test and the nominal cross-sectional area of the rod. Test results are summarized in Table 2.3. The modulus of elasticity was calculated from the difference between 20% and 60% of the tensile capacity according to the load-strain curve. The ultimate strain was computed dividing the ultimate stress by the calculated modulus of elasticity.

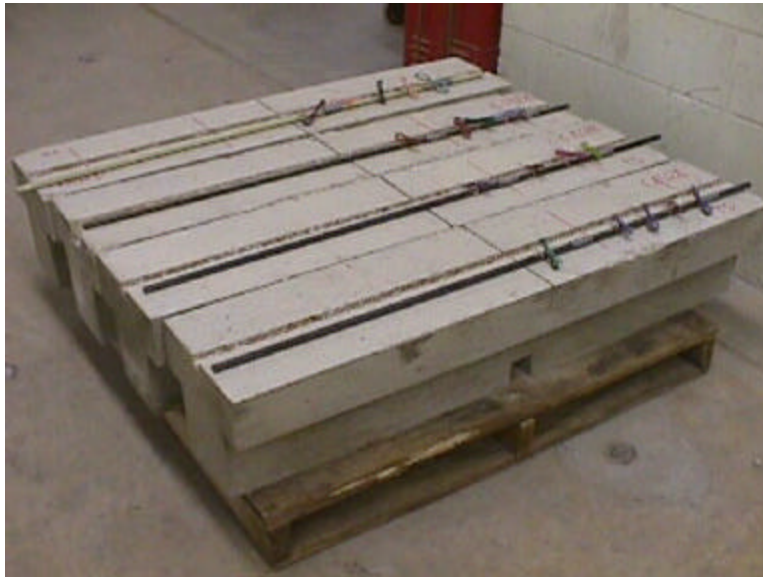
Figure 3.9. Specimens Before Preparation

3.3.4. Application of the NSM Rod. Figure 3.9 shows some specimens before application of the rods. The grooves were air blasted to remove the powdered concrete produced by the cutting process and all the possible loose material. Then the epoxy paste was prepared by mixing the two components (resin and hardener) in 2:1 proportion by volume with a power mixer. The groove was filled half-way with the paste (Figure 3.10-a), the rod was then placed in the groove and lightly pressed (Figure 3.10-b). This forced the paste to flow around the bar and fill completely between the bar and the sides of the groove. The groove was then filled with more paste and the surface was leveled (Figure 3.10-c). Figure 3.10-d shows the test side of the specimen after preparation.

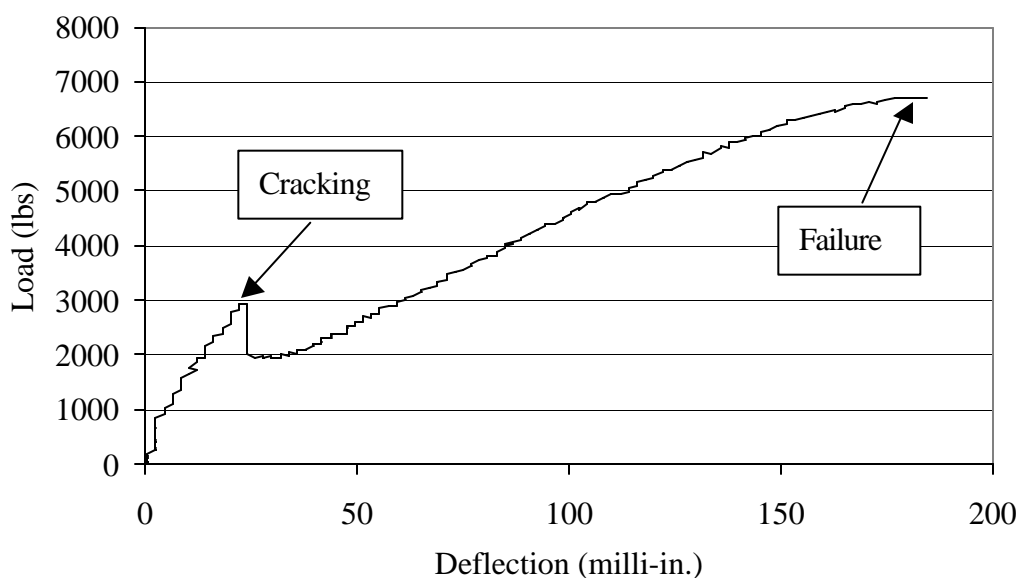
Figure 3.12. Load vs. Mid-Span Deflection for Specimen G4D12a (Failure by Epoxy Splitting)

Data recorded from the LVDTs and the strain gages was displayed graphically as shown in the following. First, the external load applied to the specimen was plotted versus the mid-span deflection recorded by means of an LVDT. This graph was used to check the overall behavior of the specimen during loading. The load vs. deflection diagram for specimen G4D12a is illustrated in Figure 3.12 as a representative example. The instant of cracking is clearly visible at a load level of 2930 lbs, after which the applied load starts increasing again until failure occurs in a sudden fashion.

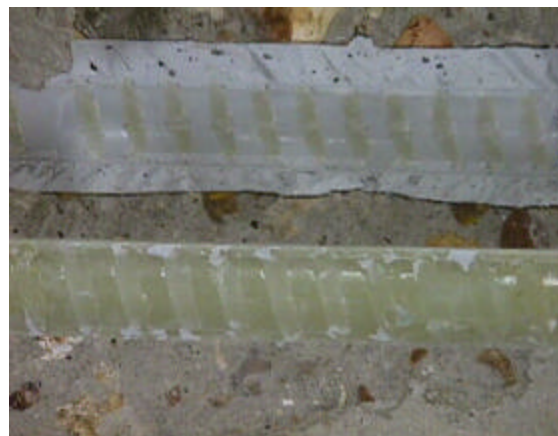
Finally, the test side of specimen G4D24c after failure is presented in Figure 3.16. In this specimen, inclined cracks formed in the epoxy paste and propagated in the concrete surrounding the groove (Figures 3.16-a and 3.16-b). At a closer visual inspection, longitudinal splitting cracks were also visible in the epoxy paste and the rod deformations were extensively sheared off (Figure 3.16-c).

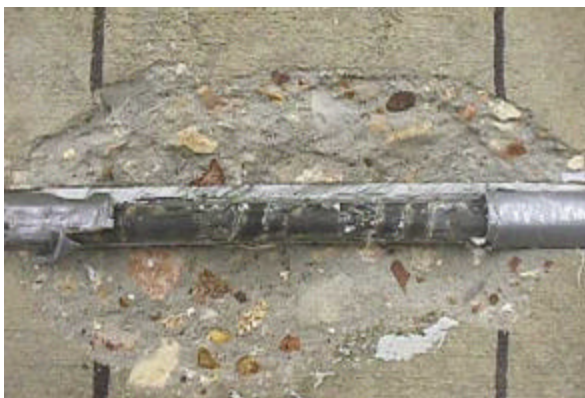
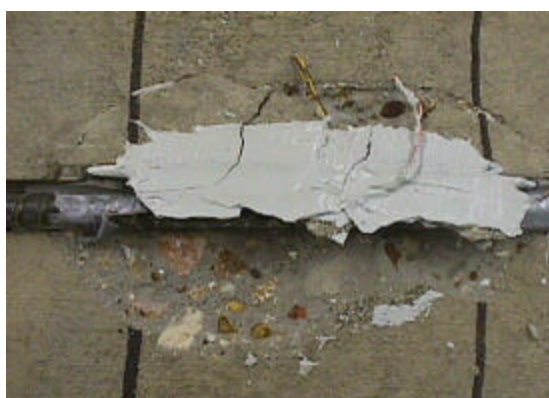
(a) (b)
Figure 3.25. Specimen C3D12b After Failure

In specimens C3D12b and C3D24b, due to the larger depth of the groove, a higher level of damage was observed in the concrete at the sides of the groove (Figure 3.25a) and the epoxy cover, rather than disintegrating in very small pieces, appeared as in Figures 3.25-b. In these specimens, inclined and longitudinal splitting cracks formed in the epoxy paste and the inclined cracks propagated in the surrounding concrete (Figure 3.26-a). Also, the rod deformations were sheared off in localized areas (Figure 3.26-b). The level of damage in the rod surface was more limited than in the case of GFRP rods.

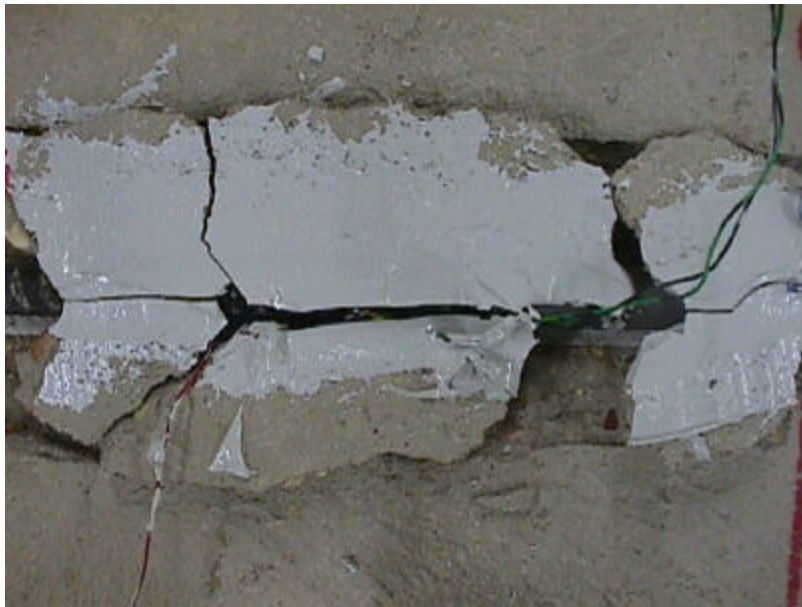
Figure 3.44. Crack Pattern in Specimen C3D24b After Failure

In the case of smooth rods, when load is first applied the inclination of the principal tensile stresses in the epoxy paste is 45 degrees. When the principal tensile stress reaches the tensile strength of the material, this angle changes and a radial stress between the rods and the surrounding material develops. In the case of deformed rods, radial stresses develop as soon as the deformations on the rod surface are brought into bearing. In both situations, the radial stress is balanced by circumferential tensile stresses which may lead to longitudinal splitting cracks, as shown in Figure 3.44 which is related to specimen C3D24b.

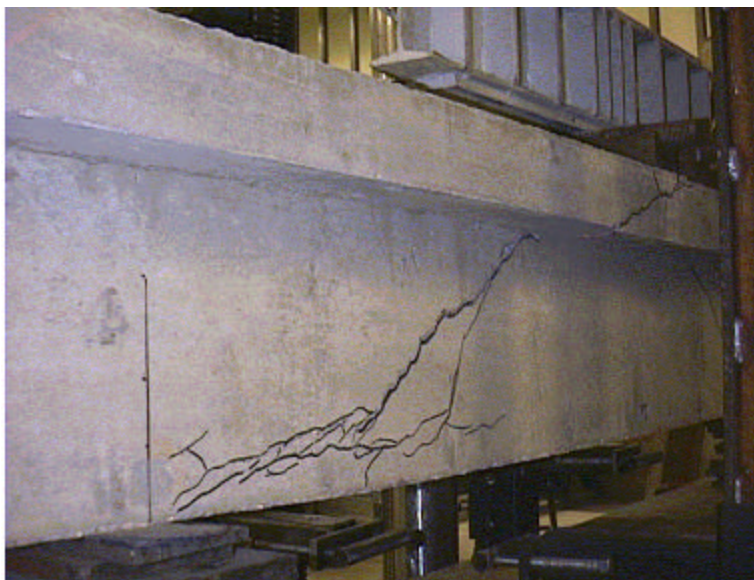
Figure 5.6. Failure of Beam BV

5.5.1. Beams Without Steel Stirrups. Beam BV was the control specimen, with no external strengthening. During loading of the beam, diagonal shear cracks formed at a load of 24.7 kips. The shear cracks initiated at the center of both shear spans almost simultaneously. The first shear crack was the critical crack in the specimen. As the load increased, this crack widened and propagated until failure resulted at a load of 40.6 kips. Figure 5.6 shows the specimen after failure.

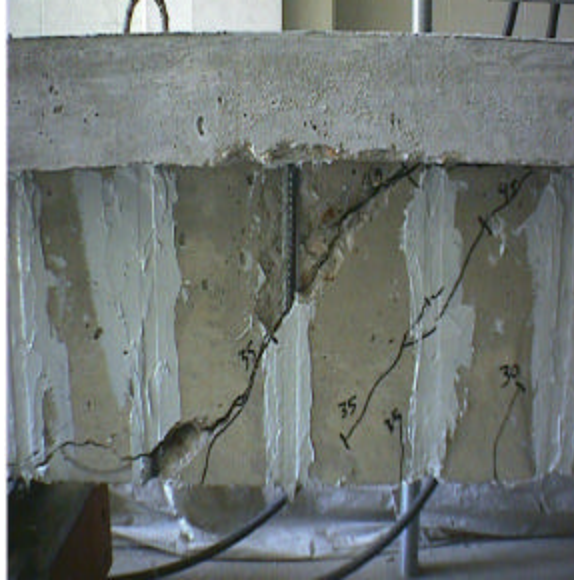
Figure 5.7. Failure of Beam B90-7

In specimen B90-7, with NSM vertical rods at a spacing of 7 in., failure occurred at a load of 51.8 kips. This corresponded to an increase in capacity of 27.6% with respect to beam BV. Diagonal shear cracks formed also in this beam, widened and propagated as the applied load increased. A crackling noise revealed throughout the test the progressive cracking of the epoxy paste in which the CFRP rods were embedded. Failure eventually occurred by splitting of the epoxy cover in one of the NSM FRP rods intersected by the major shear crack (Figure 5.7). The crack pattern of beam B90-7 is illustrated in Figure 5.8. The applied load versus the vertical strain in the CFRP rods is plotted in Figure 5.9. The highest vertical strain in the rods was recorded at 3 in. from a diagonal crack and was approximately equal to $850 \mu\epsilon$. It must be pointed out that this strain value and all those herein reported are not necessarily maximum values. They are strictly related to the location of the gages relatively to that of the shear cracks.

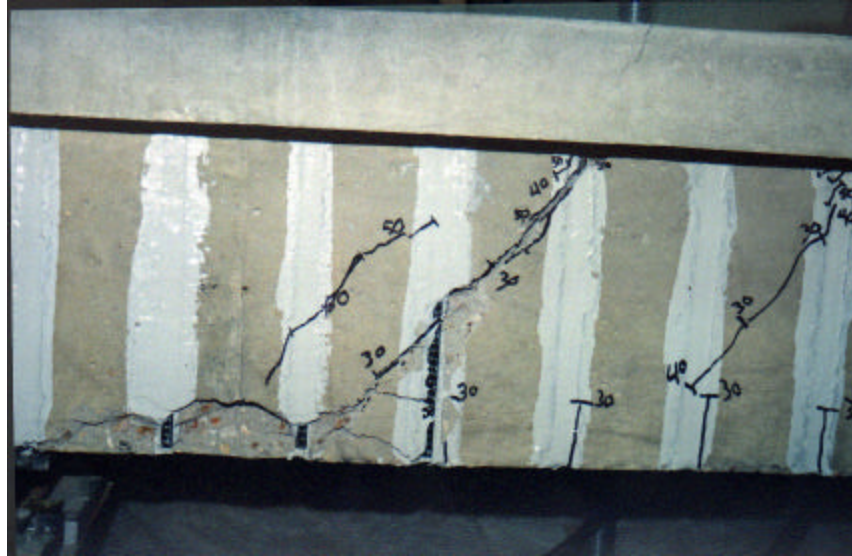
Figure 5.10. Failure of Beam B90-5

Same behavior and failure mode were registered from testing of beam B90-5, which differed from B90-7 only for the closer spacing of the CFRP rods (5 in.). The ultimate load was 57.4 kips, corresponding to an increase in capacity of 41.4% over the control beam and of 10.8% over specimen B90-7. Figure 5.10 is a picture of the failure mode. The crack pattern is illustrated in Figure 5.11. The load versus strain diagram is plotted in Figure 5.12. Strain gage 2, located at 0.5 in. from the major shear crack, recorded a maximum vertical strain approximately equal to 3000 $\mu\epsilon$. This value corresponds to 16.8% of the ultimate strain of the CFRP rods, as reported in Section 2.4 of this document.

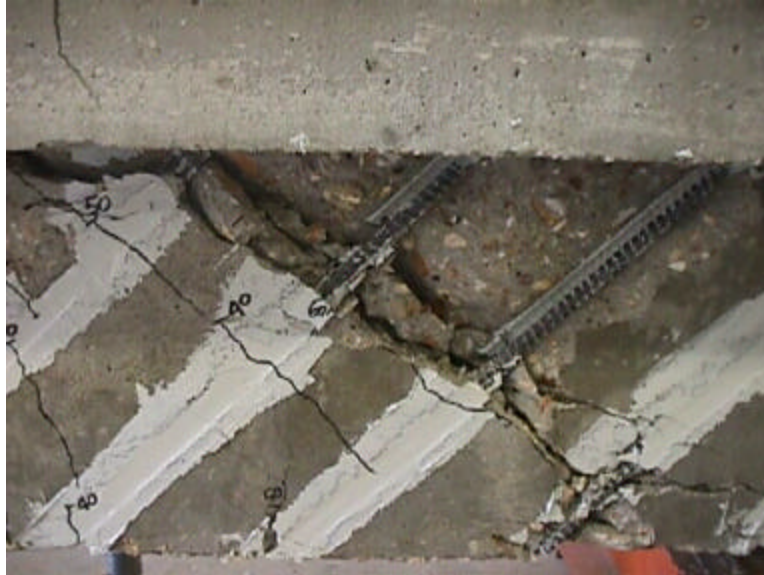
Figure 5.16. Failure of Beam B45-7

Specimen B45-7 had NSM rods at a spacing of 7 in. inclined at 45 degrees with respect to the longitudinal axis of the beam. Failure occurred at 74.4 kips, corresponding to an increase in capacity of 83.3% over the control beam. As expected, 45-degree inclined rods were more effective than vertical rods at the same spacing, as showed by the 43.6% increase in capacity of B45-7 with respect to B90-7. Failure, as in B90-7, was controlled by splitting of the epoxy cover that occurred simultaneously in two of the NSM FRP rods intersected by the major shear crack (Figure 5.16). The crack pattern is illustrated in Figure 5.17. The strain data recorded from the strain gages is reported in Figure 5.18. The maximum recorded strain was equal to approximately 4600 $\mu\epsilon$, corresponding to 25.7% of the ultimate strain.

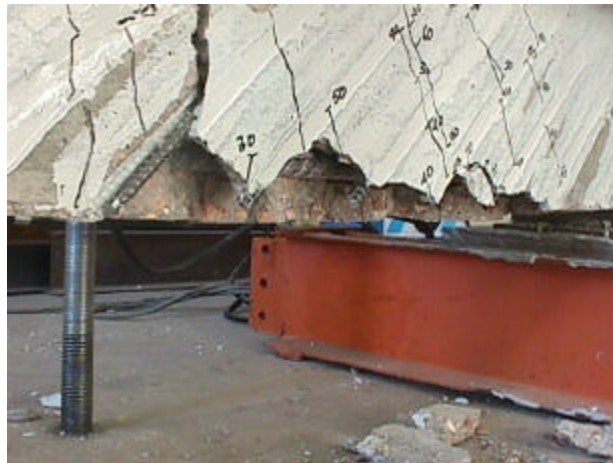
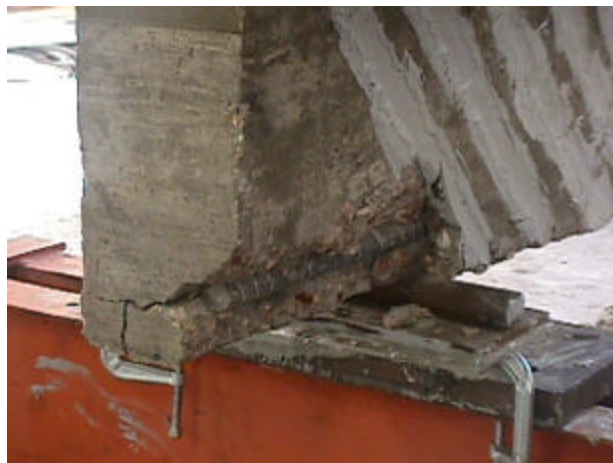
Specimen B45-5 differed from B45-7 for the spacing of the rods, equal to 5 in. Failure occurred at a load level of 80 kips, showing an increase in capacity of 97%, 7.5% and 39.4% over BV, B45-7 and B90-5, respectively. The failure mode was the same previously described for specimen B90-5A, that is, formation of splitting cracks along the longitudinal reinforcement and eventual loss of the concrete cover (Figure 5.19).
