STRENGTHENING OF RC STRUCTURES WITH NEAR SURFACE MOUNTED FRP RODS

Laura De Lorenzis

Antonio Nanni

**CIES
99-10**

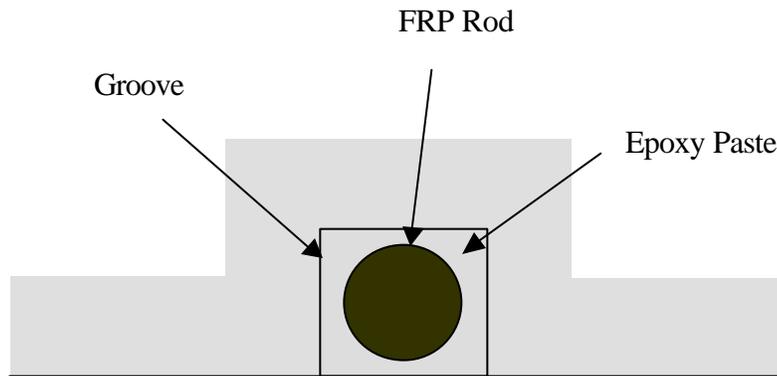
Figure 1.1. NSM Rods

The use of NSM FRP rods is an attractive method for increasing the flexural and the shear strength of deficient RC members and masonry walls and, in certain cases, can be more convenient than using FRP laminates. Application of NSM FRP rods does not require surface preparation work (other than grooving) and requires minimal installation time compared to FRP laminates. Another advantage is the feasibility of anchoring these rods into members adjacent to the one to be strengthened. Furthermore, this technique becomes particularly attractive for strengthening in the negative moment regions of slabs and decks, where external reinforcement would be subjected to mechanical and environmental damage and would require protective cover which could interfere with the presence of floor finishes.

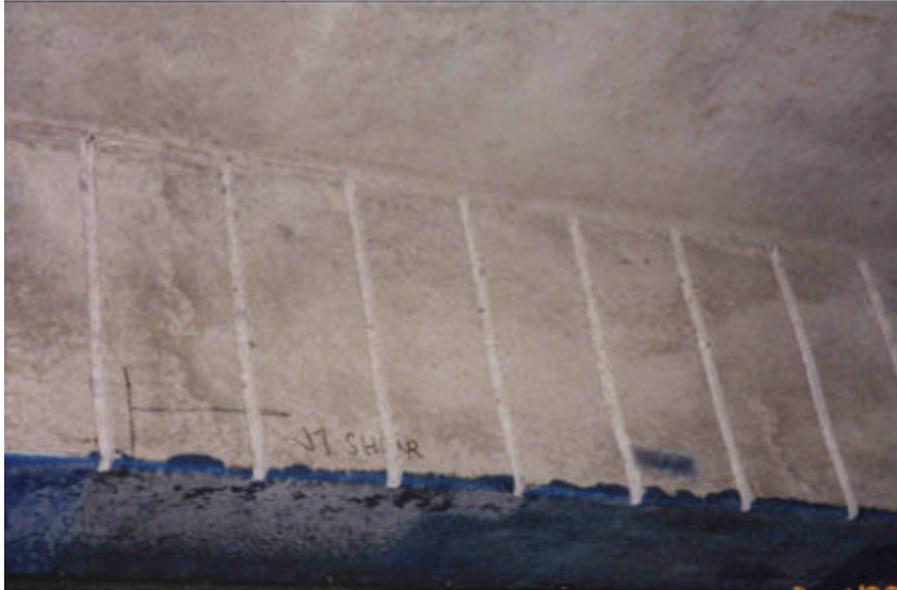
Figure 1.2. Vertical Grooves for Shear Strengthening with NSM FRP Rods (Hogue et al., 1999)

1.3.2. Field Projects. A strengthening project was carried out at the structural street level floor of Myriad Convention Center, Oklahoma City, OK (USA) in 1997-1998 (Hogue et al., 1999). The PC floor required strengthening in order to increase its live load bearing capacity. The strengthening system implemented included a combination of externally bonded steel plates, CFRP sheets and NSM CFRP rods. The strengthening system sought to address both flexural and shear deficiencies. NSM rods were used in this case for shear strengthening of one of the RC joists. Vertical grooves 1/2-in. wide and 3/4-in. deep with a total length of 20 in. were saw-cut along the side surfaces of the joist at such positions that existing stirrups were avoided (Figure 1.2). CFRP No. 3 rods were then inserted in the epoxy-filled grooves.

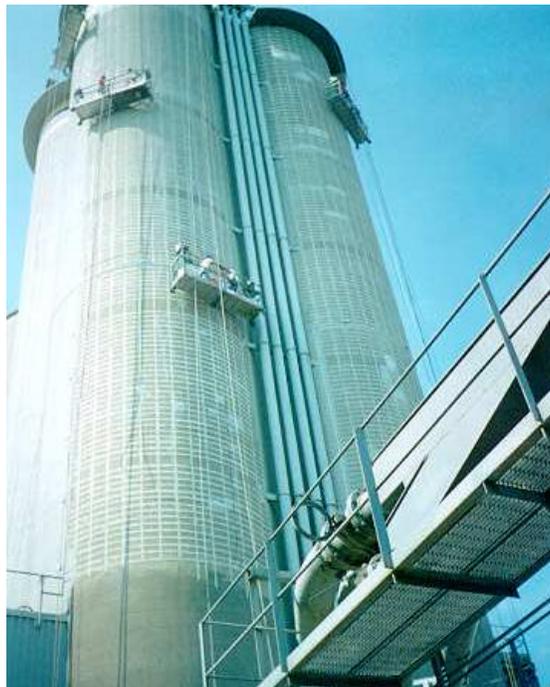
Figure 1.4. Filling of Grooves with Epoxy Paste (Nanni, 1998)

NSM CFRP rods were used for strengthening of two RC circular structures in the United States in 1998 (Nanni, 1998). Longitudinal and transverse grooves 1/2-in. wide and 1/2-in. deep were cut on the surface of the structures (Figure 1.3) and CFRP sandblasted rods with a nominal diameter of 5/16 in. were embedded in the epoxy-filled grooves (Figure 1.4).

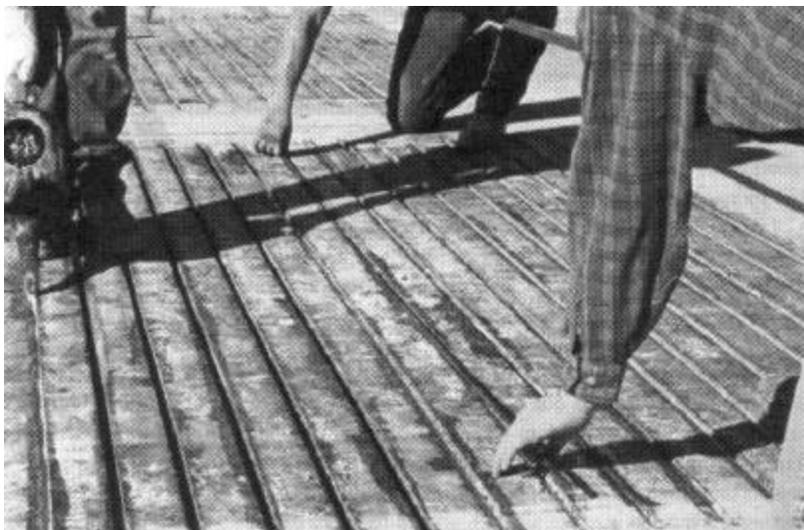
Figure 1.5. Embedding CFRP Rods in the Top Surface of the Deck (Warren, 1998)

abrasive blasted to roughen the surface, air blasted to clean the concrete and primed before filling with epoxy encapsulate. Carbon pultruded No. 3 rods were placed in sequence into the epoxy-filled slots and pressed to the bottom (Figure 1.5). The slots were then filled up to within $\frac{1}{4}$ in. of the original concrete surface. After the epoxy was cured, the surface was abrasive blasted and a UV protective layer was added to the top of the slot. The surface was ready for use 24 hours after the installation.

Pier 12 at the Naval Station San Diego, CA (USA) was strengthened in November 1998 to meet demand of operational changes accompanied by higher vertical loads (Warren, 1998). NSM CFRP rods were used to increase the capacity of the deck slab in the negative moment regions. The surface area was primed with penetrating epoxy sealer/primer and allowed to cure overnight. Slots were saw-cut in the deck in the range of 7/8-in. deep and 5/8-in. to 3/4-in. wide. The slots were

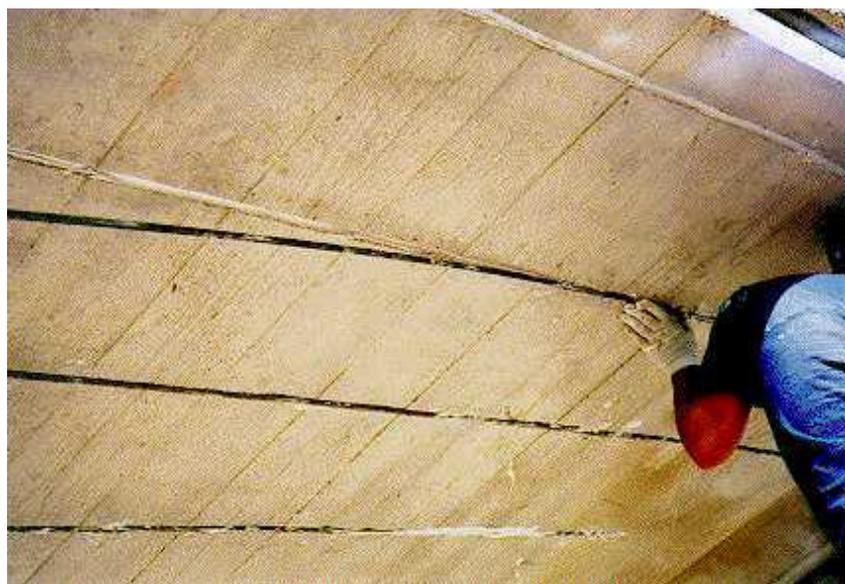
Figure 1.6. Installation of NSM CFRP Rods in the Bridge Deck (Alkhrdaji et al., 1999)

Each of the three decks was tested to failure by applying quasi-static load cycles. For the deck with NSM rods, failure was initiated by the rupture of some CFRP rods at the location of the widest crack. This deck exhibited the highest capacity with a failure load of 596 kips, corresponding to an increase in the moment capacity of 27% over the unstrengthened deck. At service levels (i.e., before yielding of the steel reinforcement), both decks strengthened with FRP composites exhibited higher stiffness than the unstrengthened control deck.

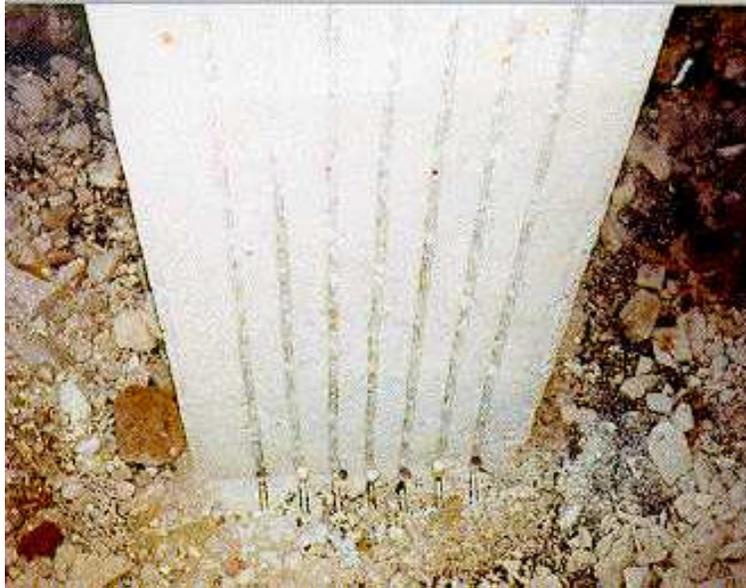
Figure 1.7. Columns Strengthened with NSM Rods (Alkhrdaji et al., 1999)

Two columns were also strengthened with NSM CFRP rods to increase their flexural capacity (Figure 1.7). The intended levels of flexural strengthening were such that two different failure modes would be achieved, one controlled by rupture of the CFRP reinforcement (6 rods, 3 on each face of the column) and one by crushing of concrete (14 rods, 7 on each face of the column). The rods were mounted on two opposite faces of the columns and fully anchored (minimum 15 in.) into the footings to ensure that the full capacity of the strengthened section would

be attained at the base of the column. The grooves and the drilled holes were filled with a viscous epoxy grout.

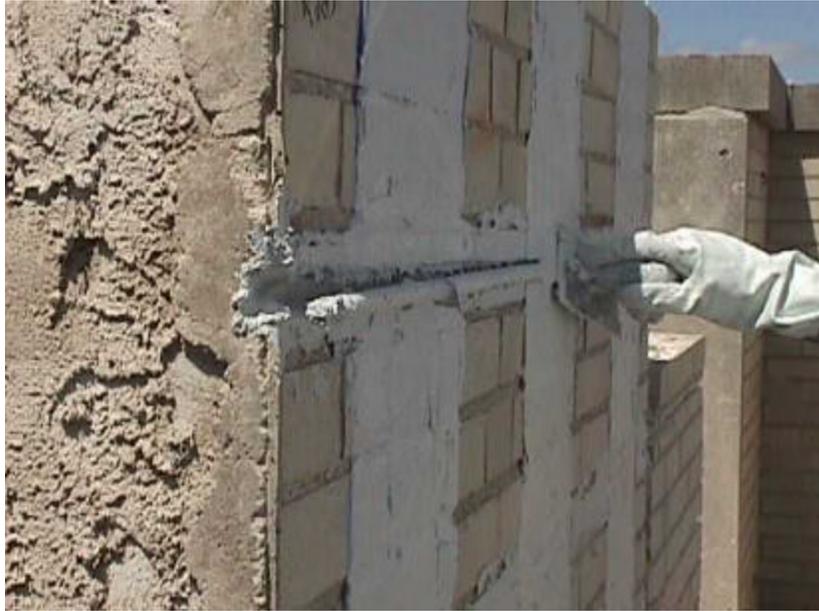
**Figure 1.8. Installation of NSM FRP Rods on Masonry Walls
(Tumialan et al., 1999)**

The program on masonry walls strengthened with FRP composites included testing of unreinforced masonry walls subjected to out-of-plane loading and reinforced masonry walls under in-plane loading. Parameters such as the type of composite system, strip width, and FRP installation methods were evaluated. Figure 1.8 shows the installation of NSM FRP rods on a masonry wall to be strengthened for out-of-plane loading.

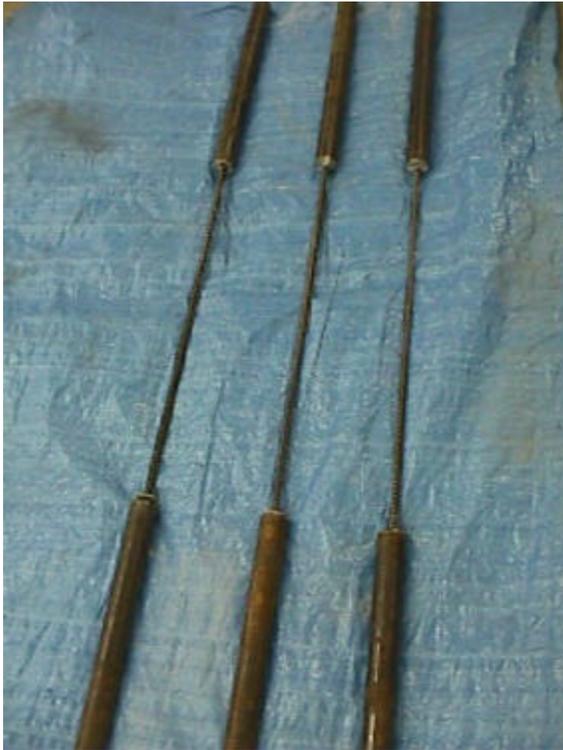
Figure 2.2. Specimens of CFRP Deformed Rods Ready for Testing

Three specimens were prepared. Figure 2.2 illustrates the specimens ready for testing.

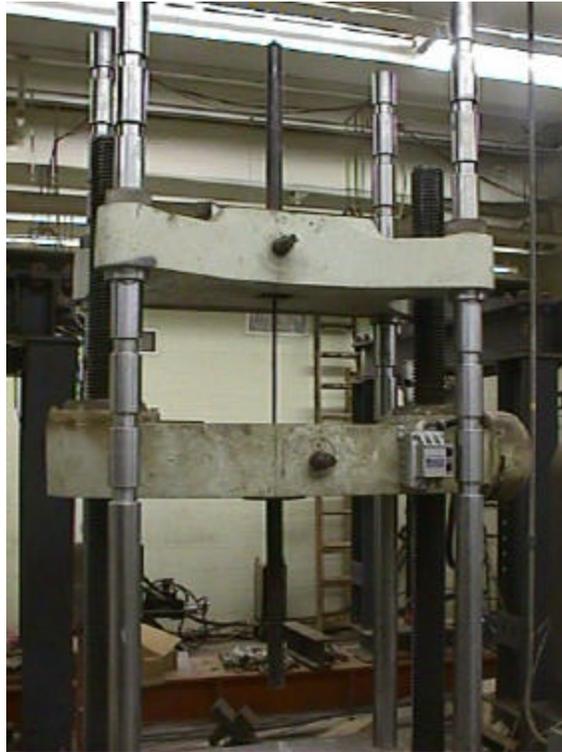
Figure 2.3. Tensile Test Setup

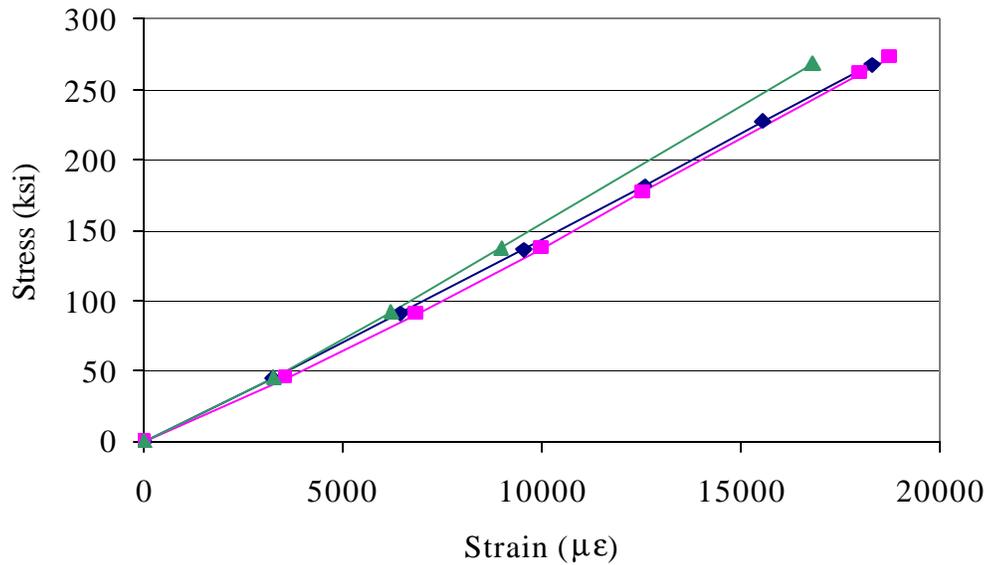
Figure 2.4. Stress – Strain Relationship of CFRP No. 3 Deformed Rods

Tensile strength, modulus of elasticity and ultimate strain were computed using load and strain data recorded during the test and the nominal cross-sectional area of the rod. Test results are summarized in Table 2.3. The modulus of elasticity was calculated from the difference between 20% and 60% of the tensile capacity according to the load-strain curve. The ultimate strain was computed dividing the ultimate stress by the calculated modulus of elasticity.

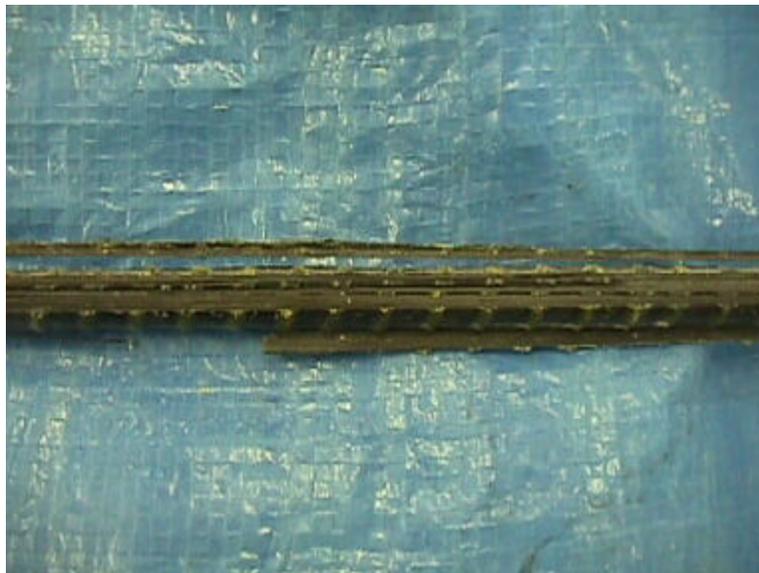
Figure 2.5. Tensile Failure of CFRP No. 3 Deformed Rods

2.4.1.3. Tensile Test Results. All specimens showed a linear elastic behavior up to failure and experienced tensile failure, which indicated that the bar had developed its full tensile capacity, and the anchor was efficient. Figure 2.4 shows the stress-strain relationship of the tested specimens. Figure 2.5 is a detail of a failed specimen.

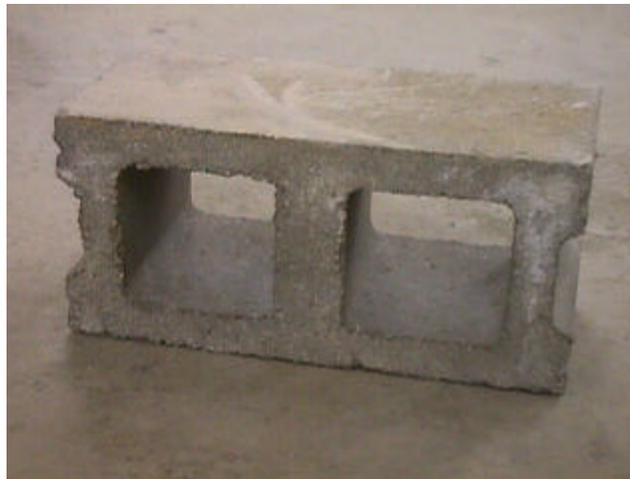
Figure 2.6. Standard Concrete Blocks

Standard concrete masonry blocks were involved in one phase of the experimental program. Hollow two-cell blocks with a percent solid of 50% were selected (Figure 2.6). The net compressive strength of the blocks was experimentally determined as part of another research project (Tinazzi et al., 2000) and resulted to be 3200 psi. The tensile strength was not obtained.

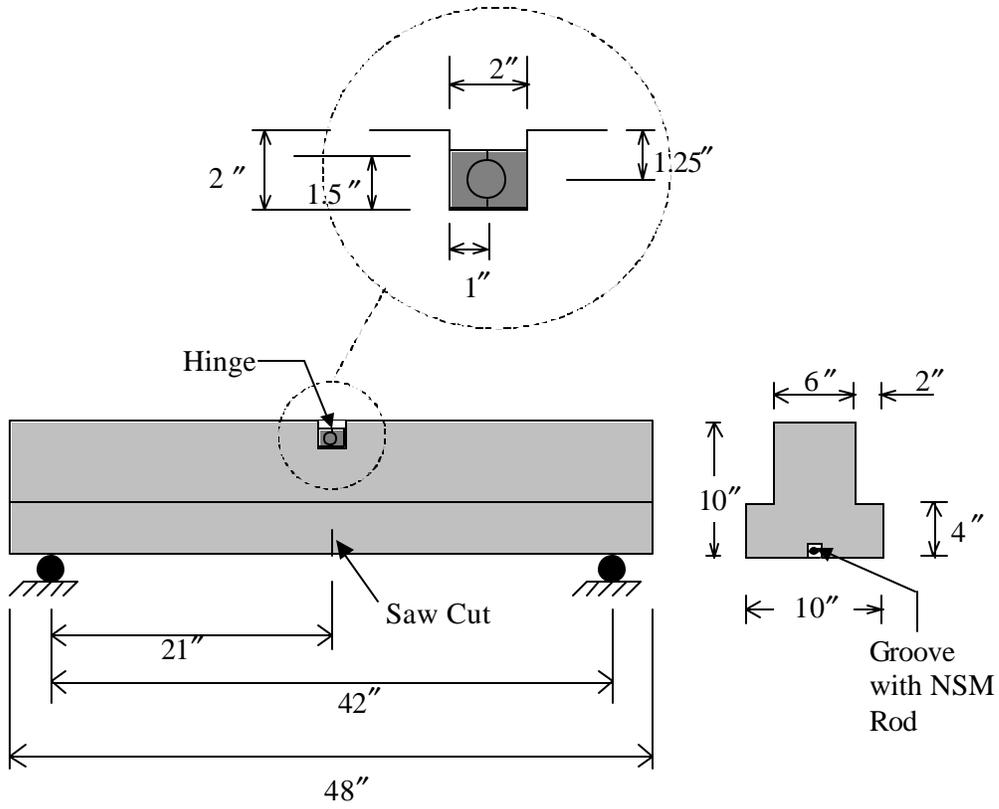
Figure 3.1. Test Specimen

Each beam had a NSM FRP rod applied to the tension face and oriented along the longitudinal axis of the beam. One side of the beam was the test region, with the NSM FRP rod having a limited bonded length and being unbonded in the remaining part. The rod was fully bonded on the other side of the beam, to cause bond failure to occur in the test region.

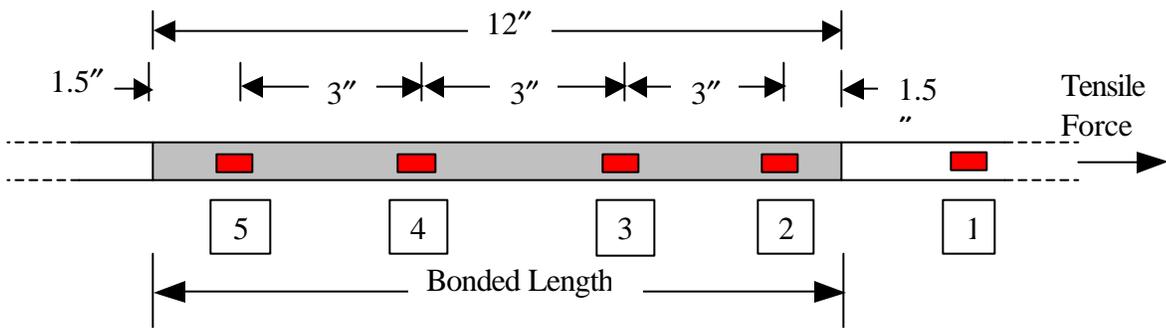
Figure 3.8. Position of the Strain Gages (Rods No. 4, Bonded Length $24 d_b$)

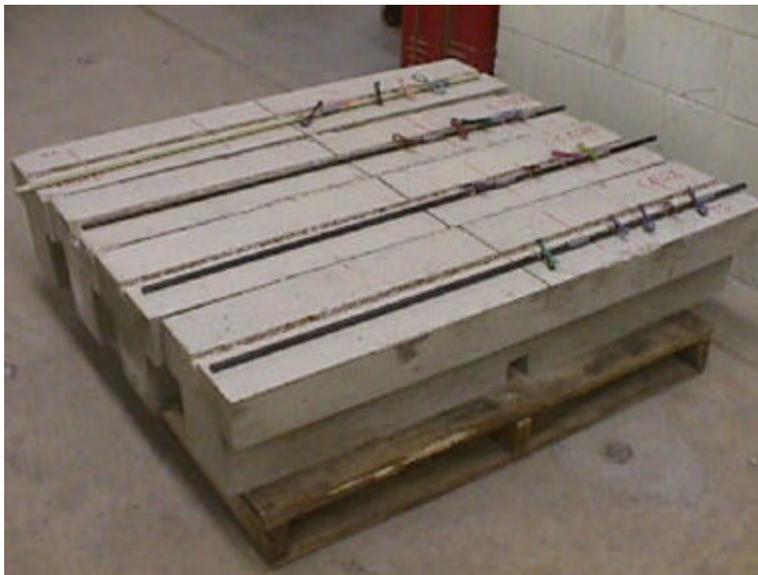
Figure 3.9. Specimens Before Preparation

3.3.4. Application of the NSM Rod. Figure 3.9 shows some specimens before application of the rods. The grooves were air blasted to remove the powdered concrete produced by the cutting process and all the possible loose material. Then the epoxy paste was prepared by mixing the two components (resin and hardener) in 2:1 proportion by volume with a power mixer. The groove was filled half-way with the paste (Figure 3.10-a), the rod was then placed in the groove and lightly pressed (Figure 3.10-b). This forced the paste to flow around the bar and fill completely between the bar and the sides of the groove. The groove was then filled with more paste and the surface was leveled (Figure 3.10-c). Figure 3.10-d shows the test side of the specimen after preparation.

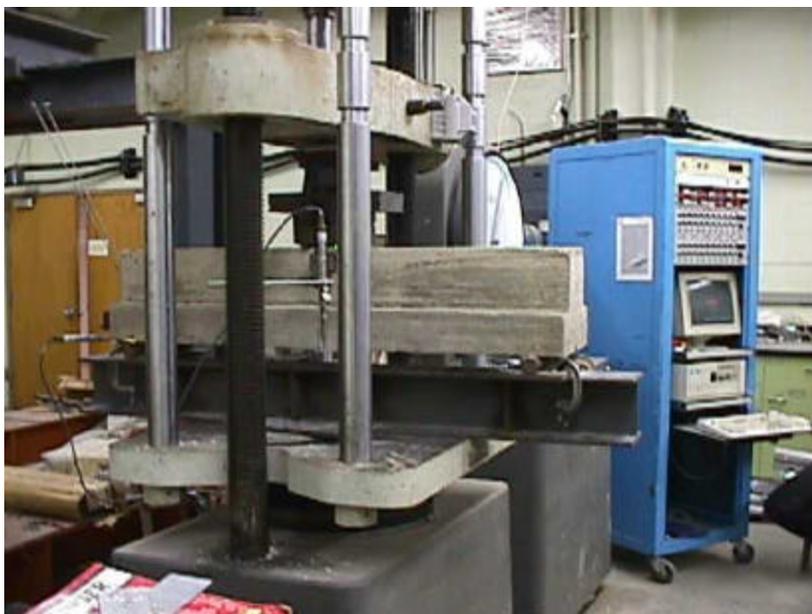
Figure 3.11. Test Setup

rate by a LABTECH (Laboratory Technologies Corp.) data acquisition system. Figure 3.11 is a picture of the test setup.

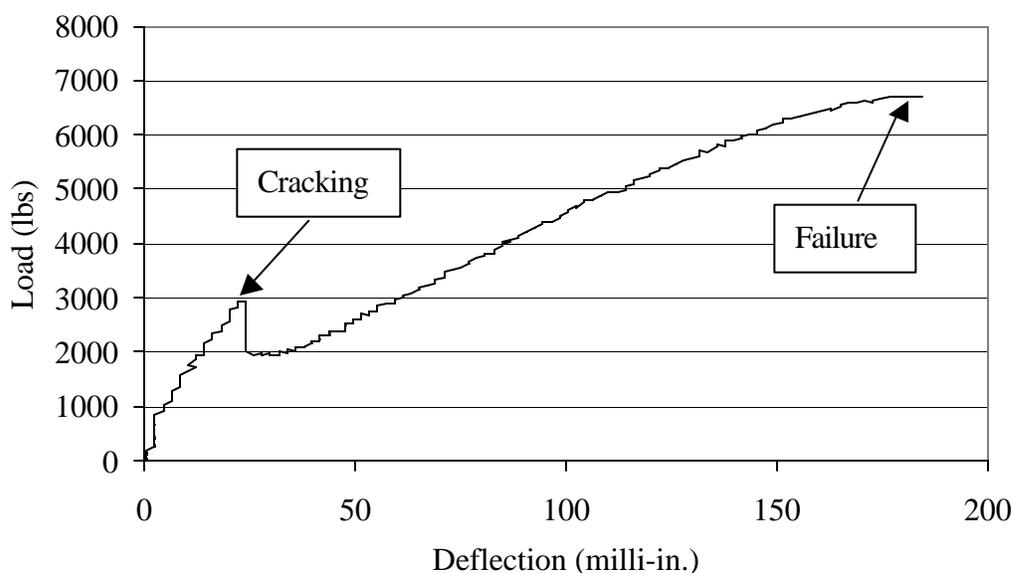
Figure 3.12. Load vs. Mid-Span Deflection for Specimen G4D12a (Failure by Epoxy Splitting)

Data recorded from the LVDTs and the strain gages was displayed graphically as shown in the following. First, the external load applied to the specimen was plotted versus the mid-span deflection recorded by means of an LVDT. This graph was used to check the overall behavior of the specimen during loading. The load vs. deflection diagram for specimen G4D12a is illustrated in Figure 3.12 as a representative example. The instant of cracking is clearly visible at a load level of 2930 lbs, after which the applied load starts increasing again until failure occurs in a sudden fashion.

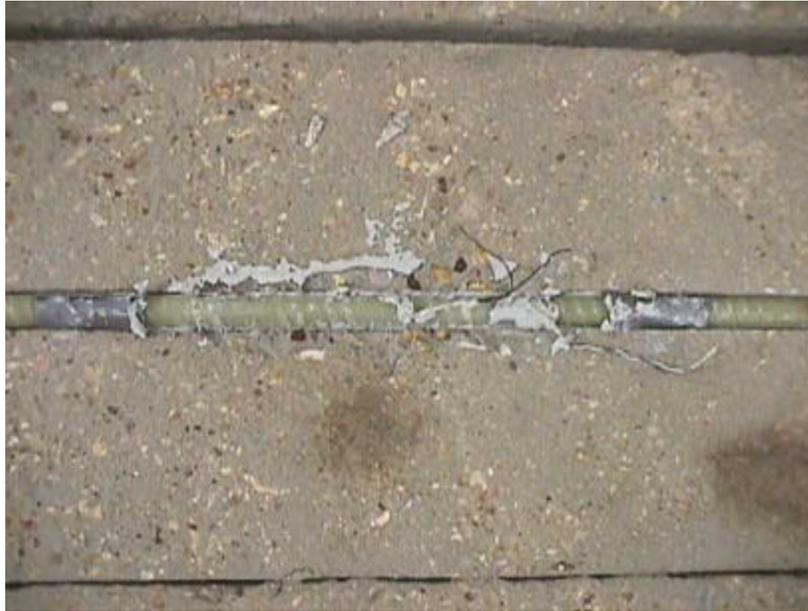
aspect of the test side of specimen G4D12a after failure is illustrated in Figure 3.13. The epoxy cover had been totally split off and no damage was visible in the surrounding concrete. The deformations on the bar surface were also intact.

Figure 3.13. Specimen G4D12a After Failure

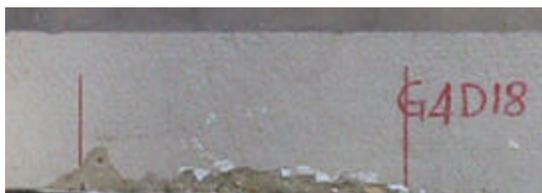
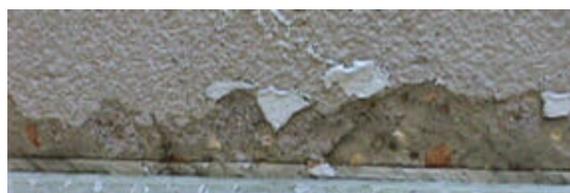
(a) (b)
Figure 3.14 . Specimen G4D18a After Failure

Very similar was the aspect of specimen G4D18a, having the minimum groove size and a bonded length of 18 bar diameters. In this case, some damage in the concrete surrounding the rod was visible (Figure 3.14-a) and the deformations on the rod surface in the region close to the loaded end had been partially sheared off (Figure 3.14-b).

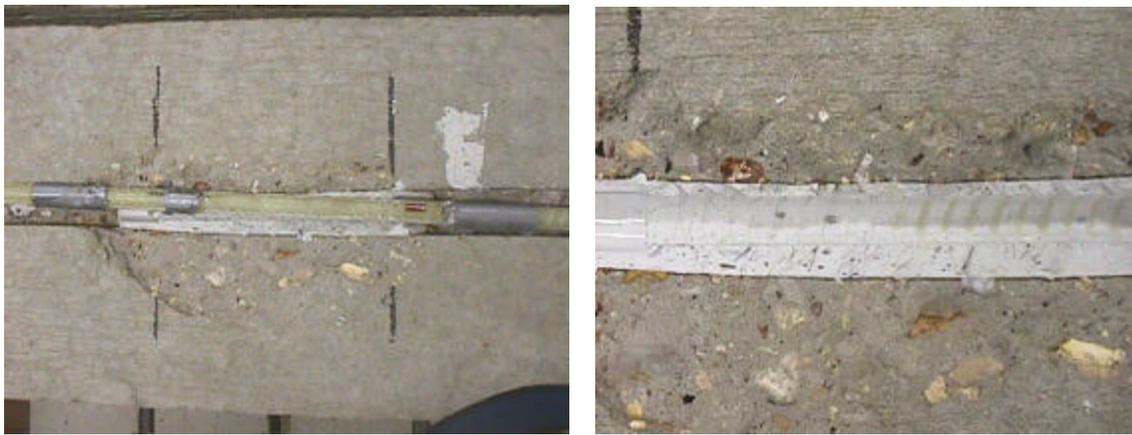
(a) (b)
Figure 3.15. Specimen G4D12c After Failure

In specimens G4D12b and G4D12c, due to the larger depth of the groove, a higher level of damage was observed in the concrete at the sides of the groove. This can be clearly noticed by comparing Figures 3.13 and 3.15-a, which refer to specimens having the same value of bonded length but the minimum and the maximum groove size, respectively. Also, since specimen G4D12c was able to sustain a load slightly higher than G4D18a, shearing-off of the rod lugs occurred also in specimen G4D12c (Figure 3.15-b).

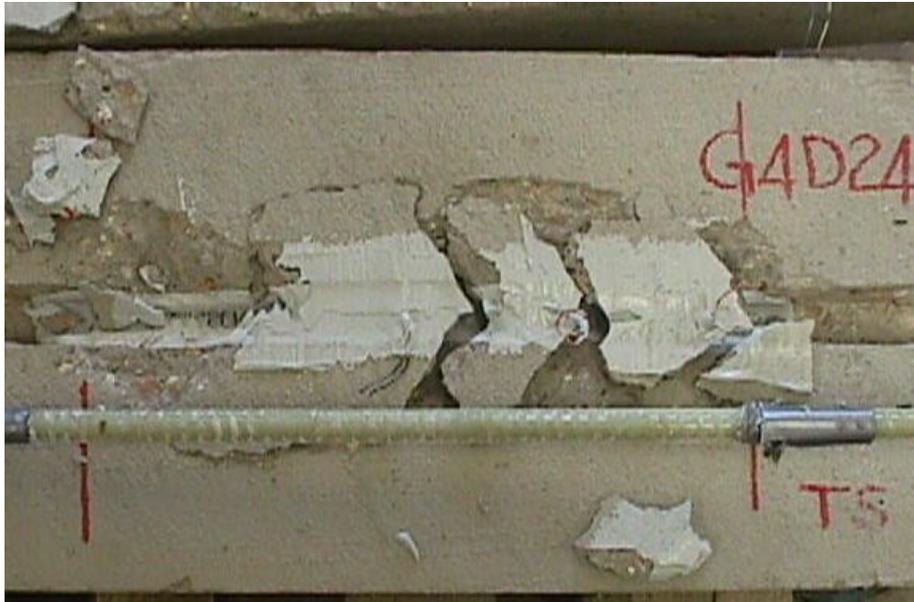
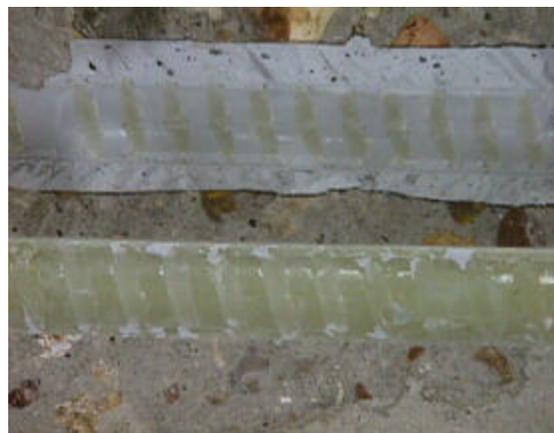
Finally, the test side of specimen G4D24c after failure is presented in Figure 3.16. In this specimen, inclined cracks formed in the epoxy paste and propagated in the concrete surrounding the groove (Figures 3.16-a and 3.16-b). At a closer visual inspection, longitudinal splitting cracks were also visible in the epoxy paste and the rod deformations were extensively sheared off (Figure 3.16-c).

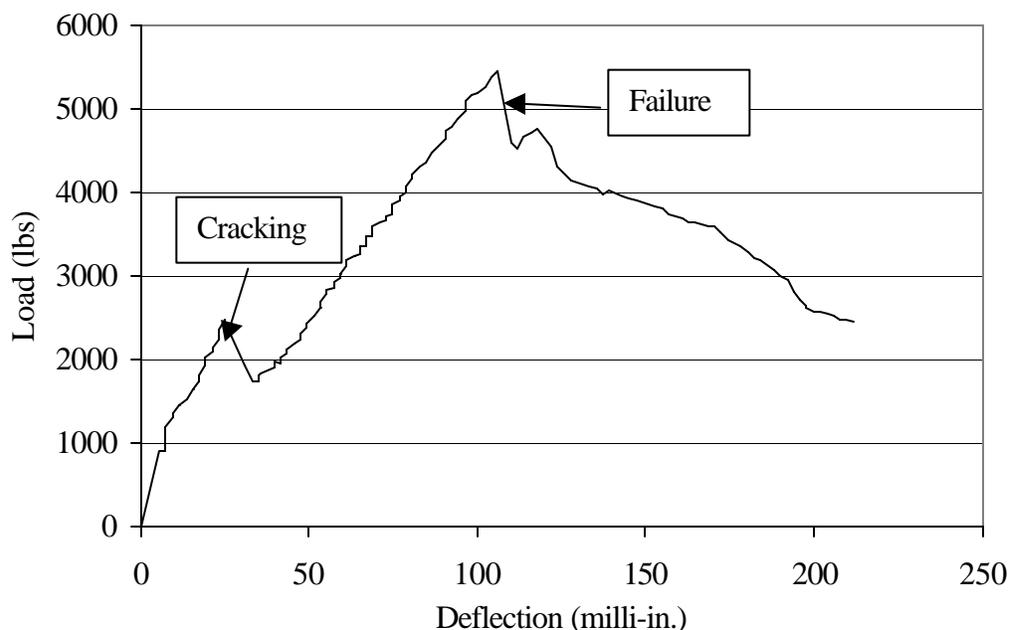
Figure 3.22. Load vs. Mid-Span Deflection for Specimen C3D12c (Failure by Concrete Cracking)

3.6.3. Failure Modes. With the only exception of C3D12c, failure occurred for all the specimens by splitting of the epoxy paste in which the NSM rods were embedded, accompanied or not by cracking of the concrete surrounding the groove. During testing, a crackling noise revealed the progressive cracking of the epoxy paste. Eventually, the epoxy cover was completely split and the load suddenly dropped. As in the case of GFRP rods, some differences could be observed as bonded length and groove size were changed.

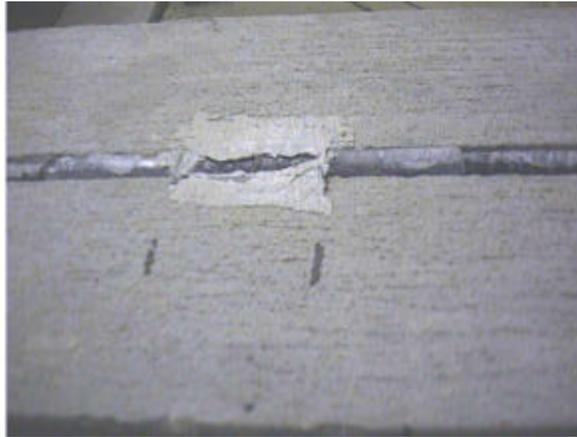
**Figure 3.23. Specimen C3D6a
After Failure**

In specimens C3D6a and C3D12a, having the minimum groove size, failure occurred by splitting of the epoxy paste which disintegrated in very small pieces. The aspect of the test side of specimen C3D6a after failure is shown in Figure 3.23. The epoxy cover had been totally split off and no damage was visible in the surrounding concrete. The deformations on the bar surface were also intact.

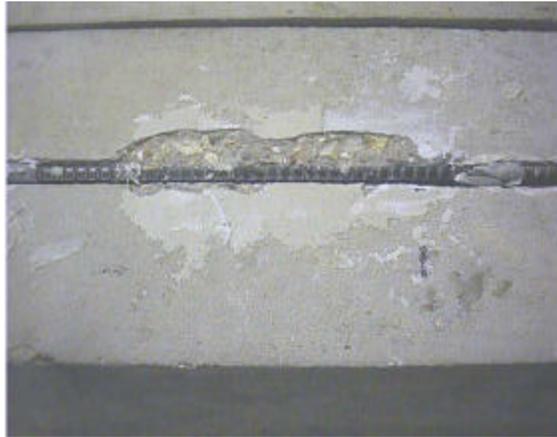
**Figure 3.24. Specimen C3D18a
After Failure**

Very similar was the aspect of specimen C3D18a, having the minimum groove size and a bonded length of 18 bar diameters. In this case, some damage in the concrete surrounding the rod was visible (Figure 3.24).

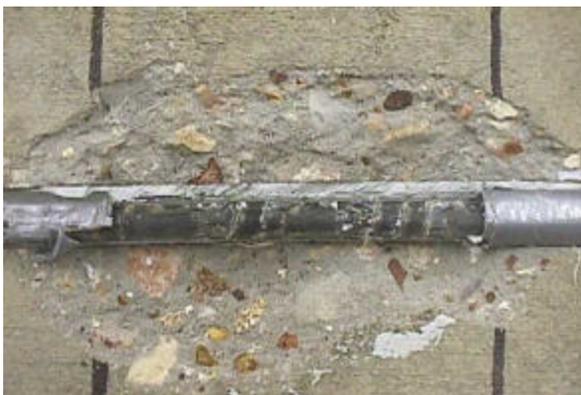
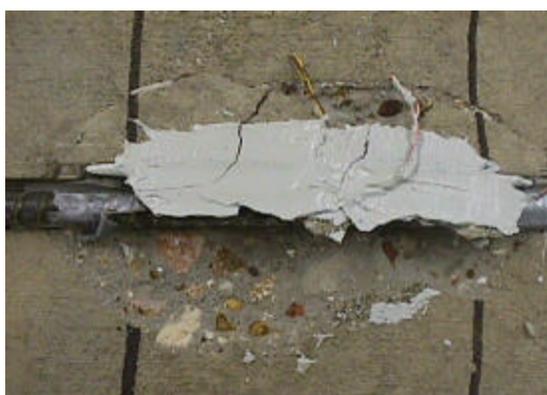
In specimens C3D12b and C3D24b, due to the larger depth of the groove, a higher level of damage was observed in the concrete at the sides of the groove (Figure 3.25a) and the epoxy cover, rather than disintegrating in very small pieces, appeared as in Figures 3.25-b. In these specimens, inclined and longitudinal splitting cracks formed in the epoxy paste and the inclined cracks propagated in the surrounding concrete (Figure 3.26-a). Also, the rod deformations were sheared off in localized areas (Figure 3.26-b). The level of damage in the rod surface was more limited than in the case of GFRP rods.

(a) (b)
Figure 3.25. Specimen C3D12b After Failure

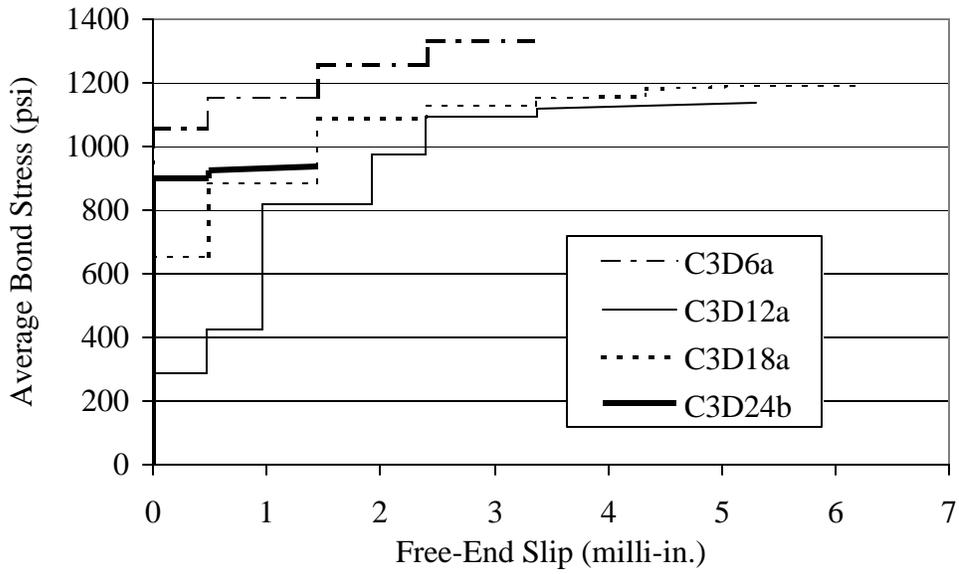
Figure 3.28. Average Bond Stress vs. Free-End Slip for Specimens C3D6a, C3D12a, C3D18a and C3D24b

3.6.4. Free-End Slip Data. Average bond stress vs. free-end slip diagrams were plotted using the data recorded from the LVDT (Figures 3.28 and 3.29). In this case, the rod free end started slipping before failure even in the specimen with the longest bonded length.

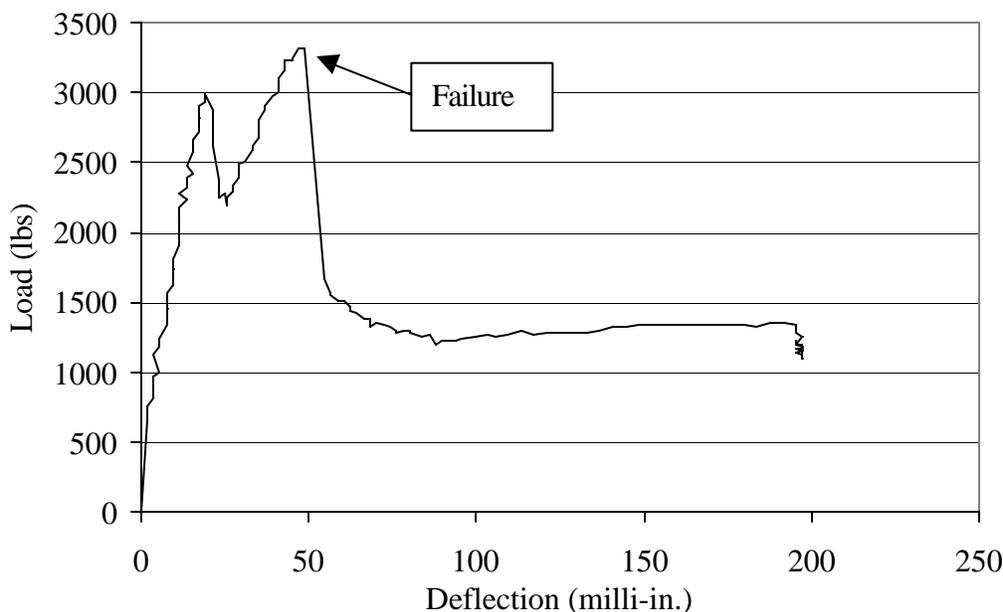
Figure 3.31. Load vs. Mid-Span Deflection for Specimen C3S12a (Failure by Pull-Out)

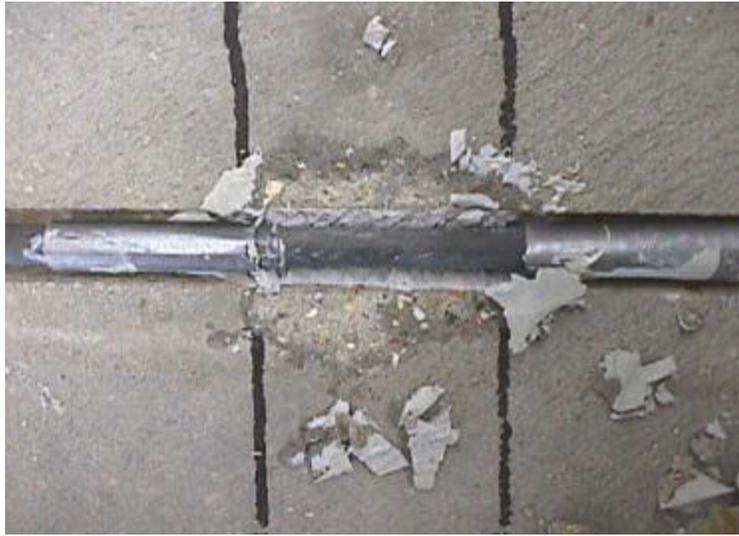
Figure 3.32. Specimen C3S6a After Failure

3.7.3. Failure Modes. Three different failure modes were observed in the specimens with CFRP sandblasted rods. Specimens C3S6a and C4S6a failed by splitting of the epoxy cover, as shown in Figures 3.32-a and 3.33-a. In specimen C3S6a, the epoxy paste disintegrated in small fragments, while the cover of specimen C4S6a broke up in two pieces along a longitudinal splitting crack. Inclined cracks in the epoxy underneath the rod and inclined white lines on the rod surface were visible tracks of the bond stresses (Figures 3.32-b and 3.33-b).

3.8.2. Crack Pattern. Internal cracks in the epoxy paste were observed in all the specimens after failure. An example is presented in Figure 3.42, which refers to specimen C3S6a. These “secondary” cracks are perpendicular to the direction of the principal tensile stresses. They indicate the trajectories along which the compressive forces leave the surface of the bars and spread out into the concrete. Unlike in the case of reinforcing bars embedded in concrete, in NSM reinforcement these inclined cracks may form not only as secondary cracks in the internal surface of the epoxy paste, but also, due to the small cover thickness, as primary cracks that can lead to bond failure (Figure 3.43).

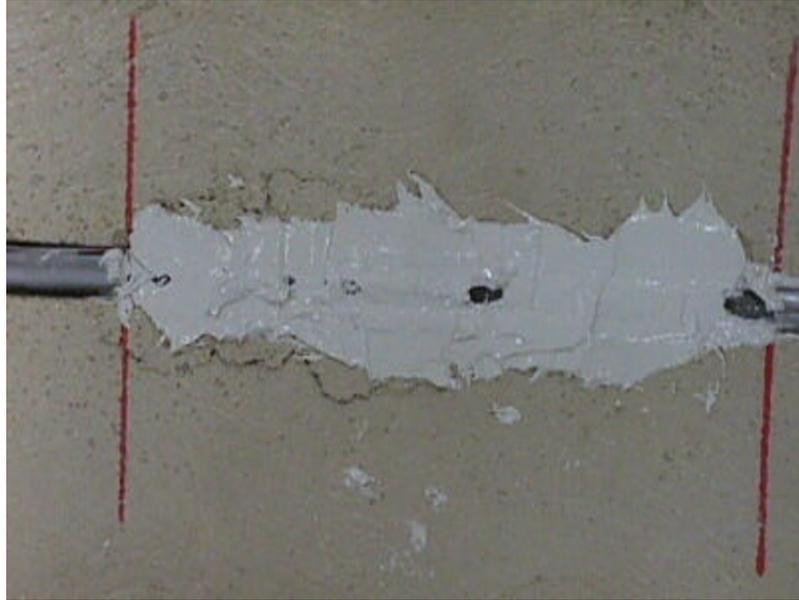
All the other specimens experienced a mixed failure mode between the previous two. After failure, either the epoxy cover appeared partially damaged (C3S18a, Figure 3.35) or a longitudinal splitting crack has developed close to the rod loaded end (C4S12a, Figure 3.36). In the only case of specimen C4S18a, some damage in the concrete was also visible (Figure 3.37).

Figure 3.37. Specimen C4S18a After Failure

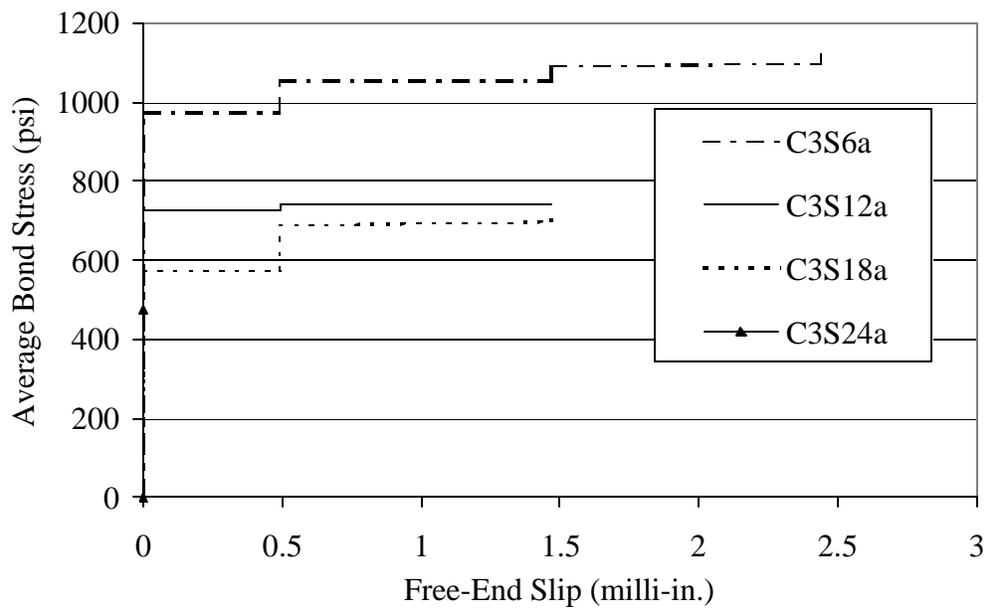
Figure 3.38. Average Bond Stress vs. Free-End Slip for Specimens C3S6a, C3S12a, C3S18a and C3S24a

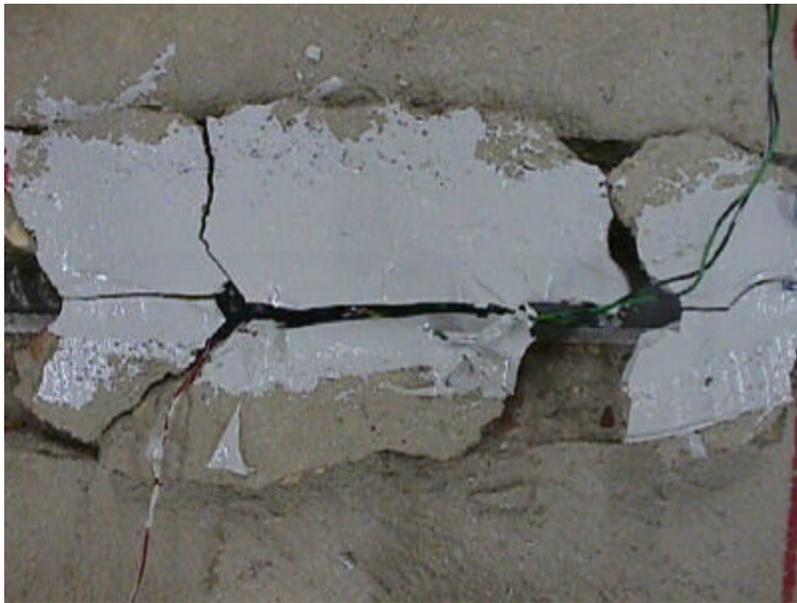
Figure 3.44. Crack Pattern in Specimen C3D24b After Failure

In the case of smooth rods, when load is first applied the inclination of the principal tensile stresses in the epoxy paste is 45 degrees. When the principal tensile stress reaches the tensile strength of the material, this angle changes and a radial stress between the rods and the surrounding material develops. In the case of deformed rods, radial stresses develop as soon as the deformations on the rod surface are brought into bearing. In both situations, the radial stress is balanced by circumferential tensile stresses which may lead to longitudinal splitting cracks, as shown in Figure 3.44 which is related to specimen C3D24b.

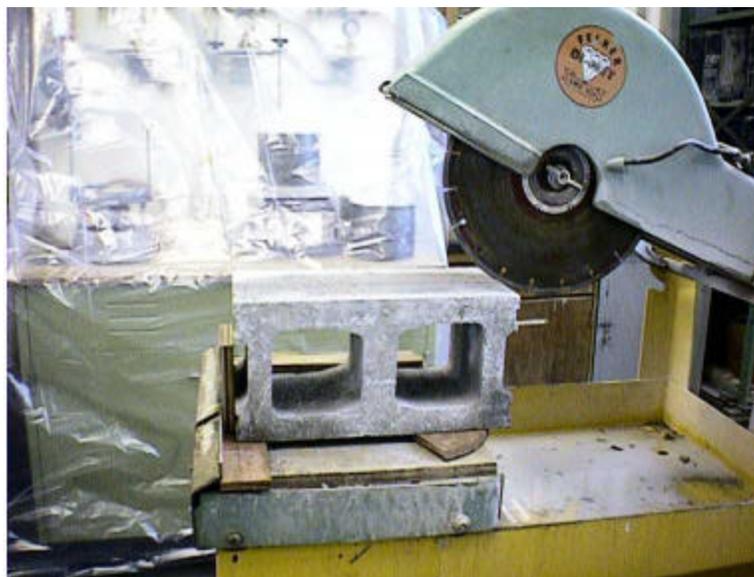
Figure 4.3. Cutting of the Grooves on the Concrete Blocks

4.3.2. Cutting of the Grooves. Each of the specimens had two grooves cut on the two sides and oriented along the longitudinal axis, where the FRP rods had to be mounted. The grooves were cut using a concrete saw (Figure 4.3). All of them had square cross-section, with size of $3/4$ in.

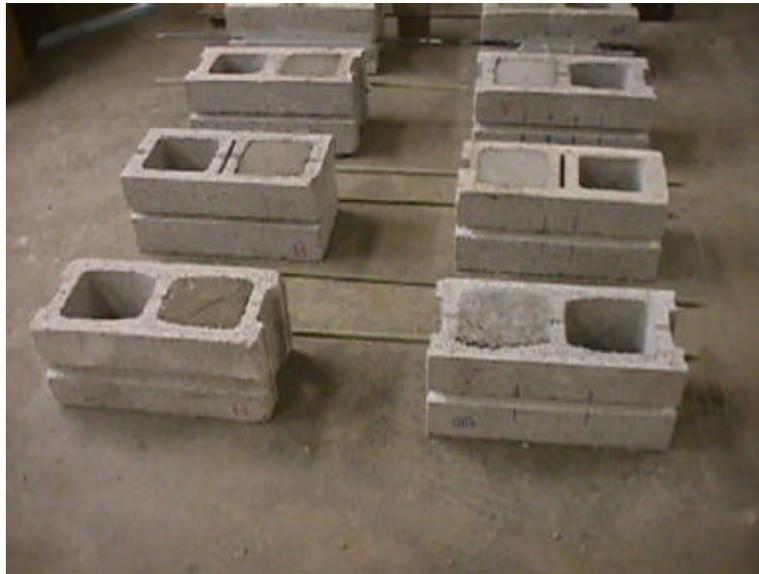
Figure 4.4. Concrete Blocks Before Preparation

4.3.4. Application of the NSM Rods. Figure 4.4 shows some specimens before application of the rods. The grooves were air blasted to remove loose particles produced by the cutting process. Then the epoxy paste was prepared by mixing the two components (resin and

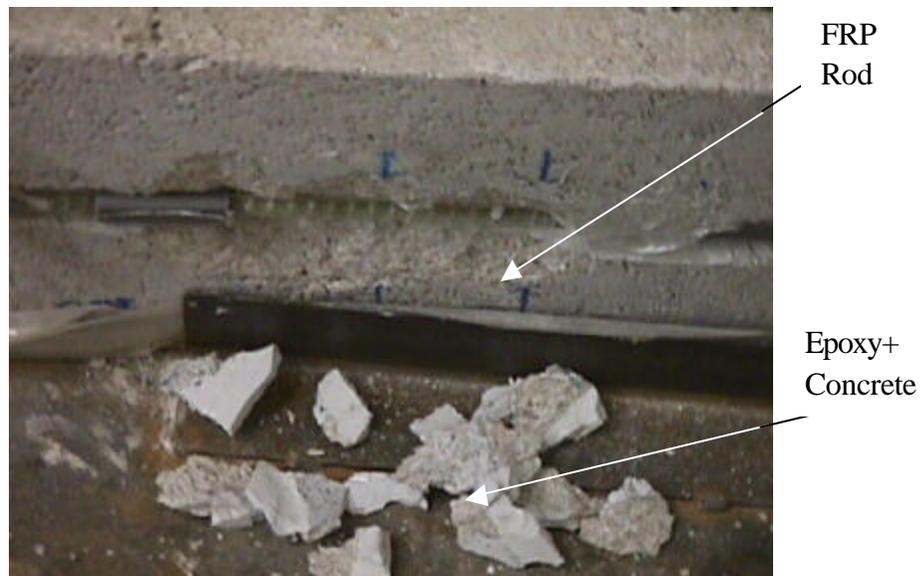
Figure 4.10. Specimen After Splitting Failure

4.5.2. Modes of Failure. As indicated in Table 4.2, two different failure modes were observed. In the specimens with deformed rods, failure occurred by splitting of the epoxy paste in which the NSM rods were embedded, accompanied by cracking of the concrete surrounding the groove. During testing, a crackling noise revealed the progressive cracking of the epoxy paste. Eventually, the epoxy cover was completely split and the load suddenly dropped. The concrete material surrounding the groove was also damaged, as shown in Figure 4.10.

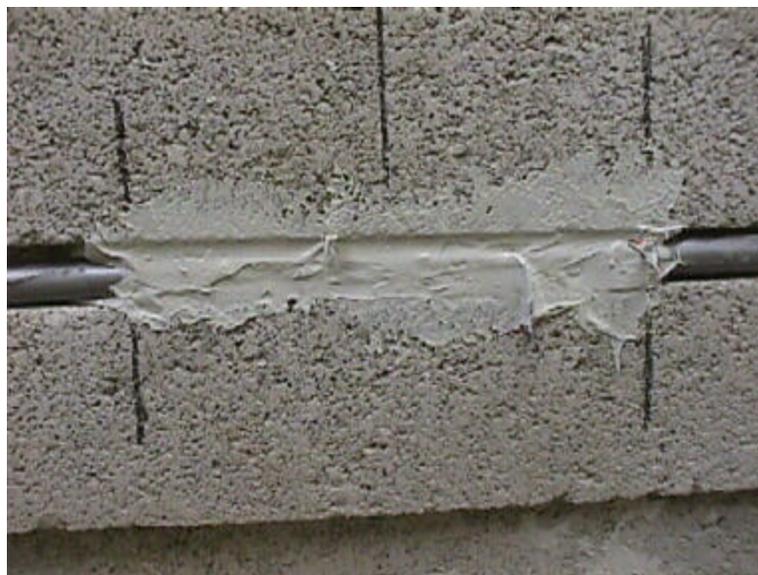
Figure 4.11. Specimen After Pull-Out Failure

Specimens with CFRP sandblasted rods all failed at the interface between epoxy and CFRP rod. This failure mode has been referred to as “pull-out” in Table 4.2. No sign of damage was visible in the test side of these specimens after failure (Figure 4.11).

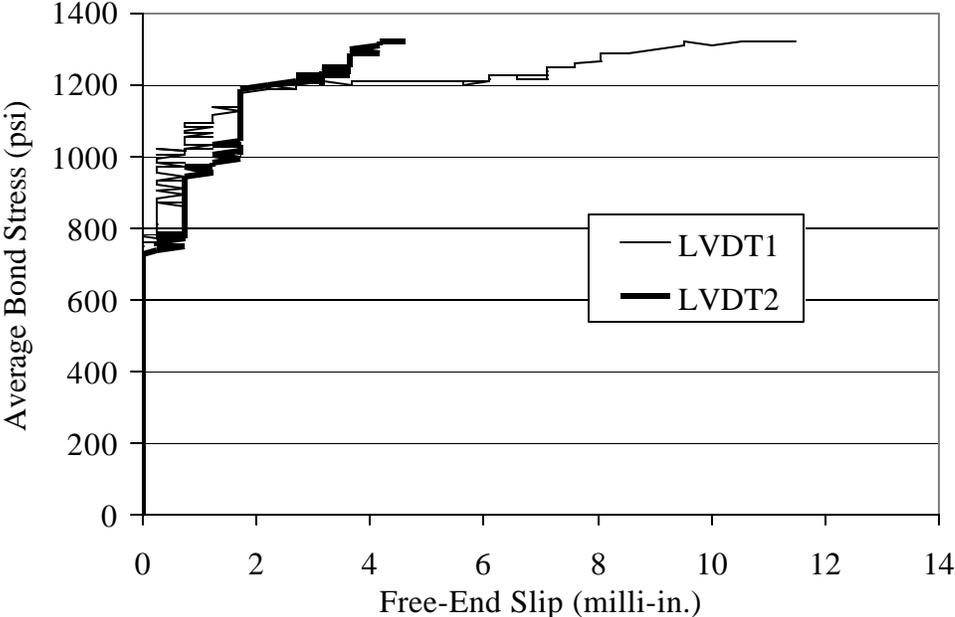
Figure 4.12. Average Bond Stress vs. Free-End Slip for Specimen GD6

4.5.3. Free-End Slip Data. Slip at the free end of the rods in the test side was measured by means of two LVDTs. No free-end slip prior to failure was recorded for any of the specimens, with the only exception of GD6. For this specimen, the average bond stress vs. free-end slip curves obtained by the two LDVTs are reported in Figure 4.12. The curves do not coincide due to the non perfect distribution of the applied load among the two rods on the two sides of the blocks.
