STRENGTHENING OF RC STRUCTURES WITH NEAR SURFACE MOUNTED FRP RODS

Laura De Lorenzis

Antonio Nanni

**CIES
99-10**

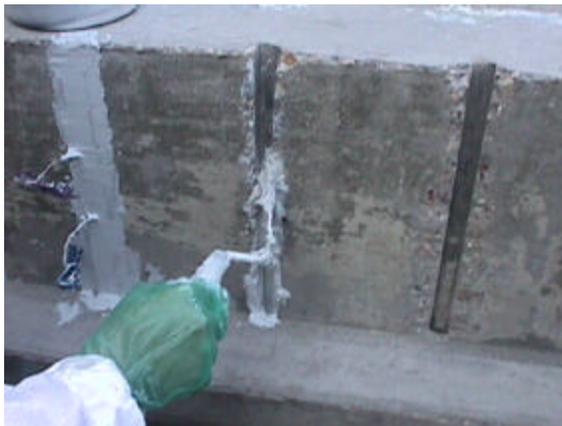
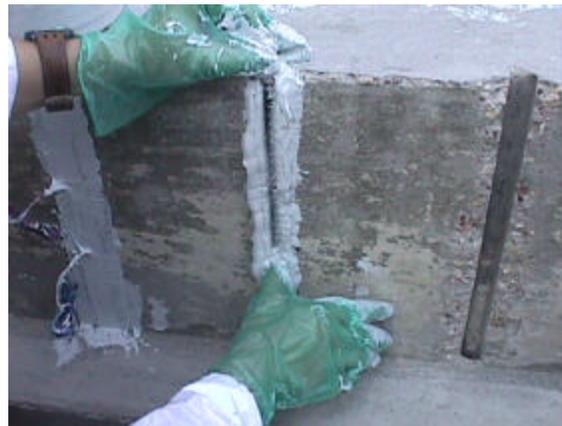
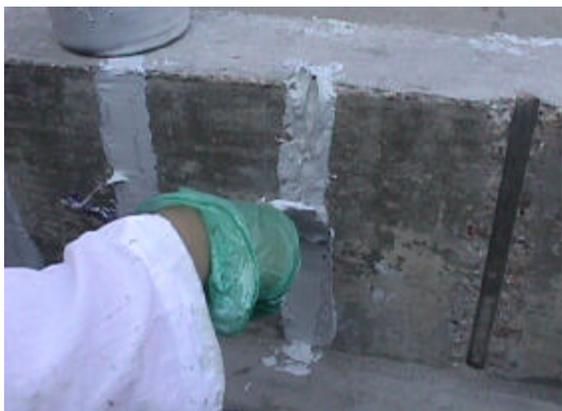
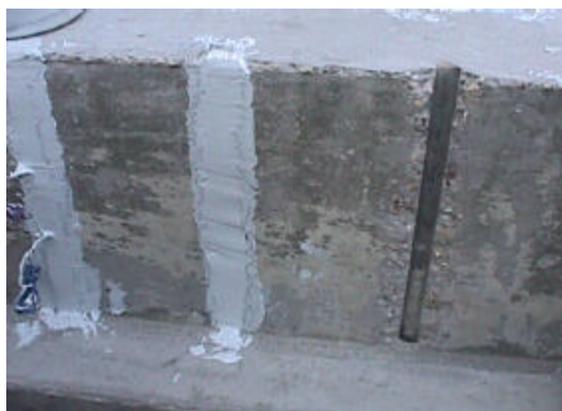
Figure 5.2. Specimen Preparation

in the groove and lightly pressed (Figure 5.2-b). This forced the paste to flow around the bar and fill completely between the bar and the sides of the groove. The groove was then filled with more paste and the surface was leveled (Figure 5.2-c).

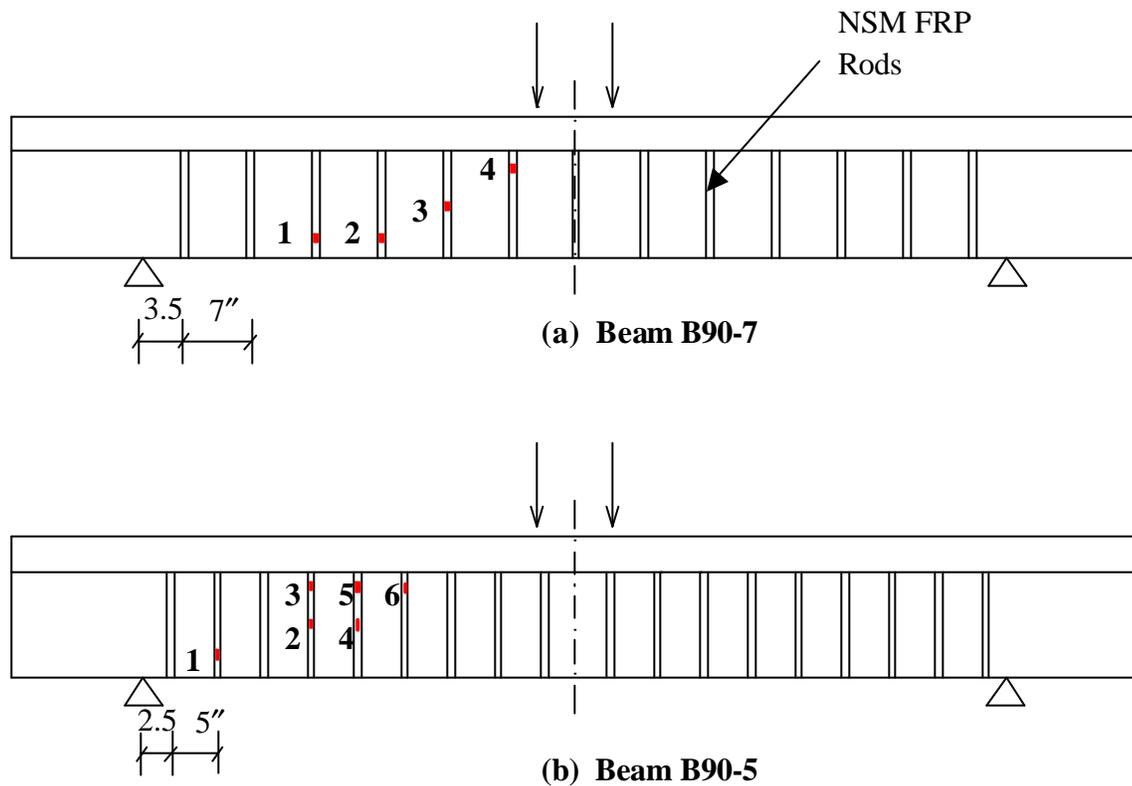
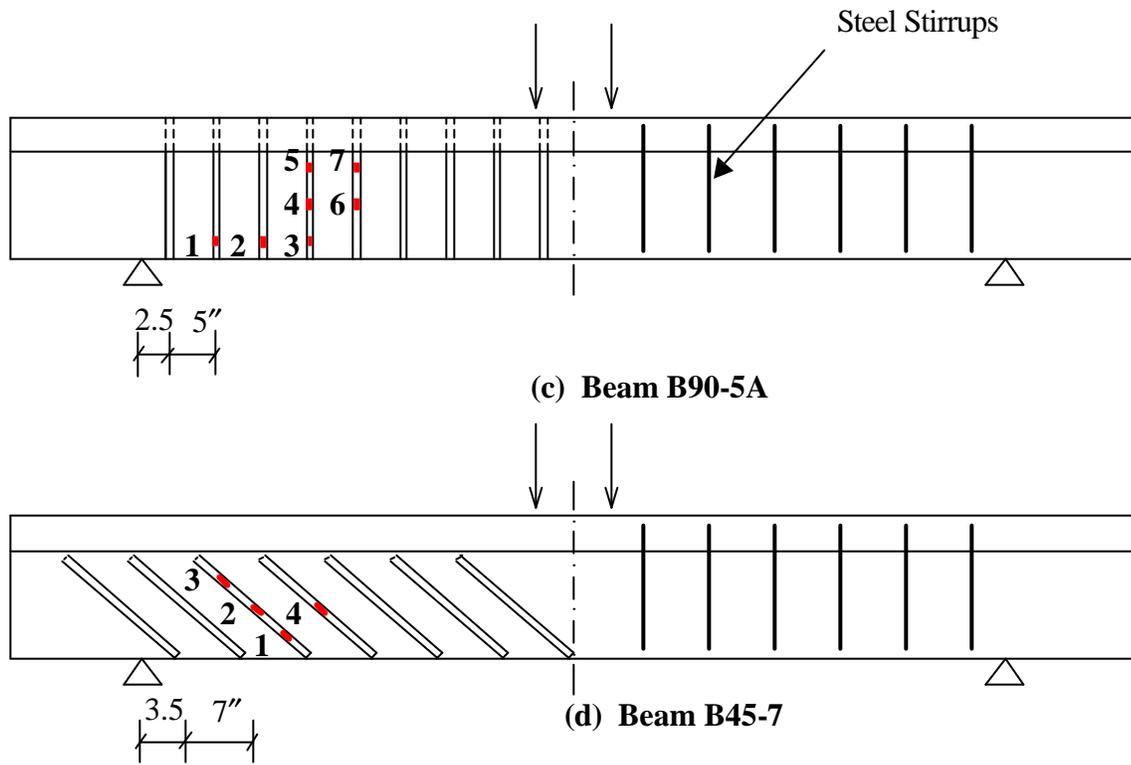
Figure 5.3. Location of Strain Gages

Beams B90-7 and B90-5 were externally strengthened with NSM rods along their whole length. Strain gages were placed symmetrically on both sides of these beams, in order to ensure that strain data would be collected at the side where shear failure would occur. In Figure 5.3, for simplicity, the strain gage location on these beams is reported only on one side. In all the other beams, half-beam was reinforced for shear with steel stirrups at a spacing of 7 in. and had no external strengthening with NSM rods. The spacing of the stirrups in this side of the beam was designed to ensure that failure would occur in the other side. The latter was the actual test side, and had the shear reinforcement previously described and indicated in Table 5.1. Only the test side needed to be instrumented with strain gages.

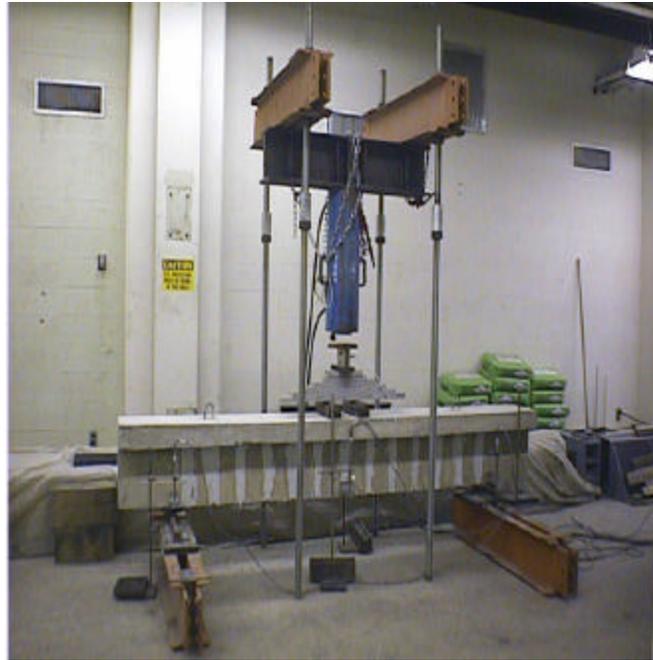
Figure 5.5. Test Setup of Beam B90-7

Load, deflections and strains were all recorded with a one-Hertz sampling rate by a LABTECH data acquisition system. Figures 5.4 and 5.5 illustrate the test setup.

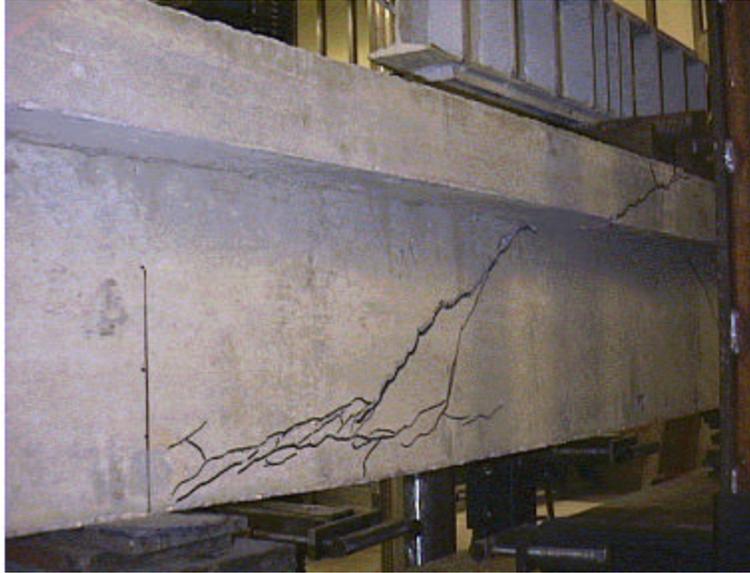
Figure 5.6. Failure of Beam BV

5.5.1. Beams Without Steel Stirrups. Beam BV was the control specimen, with no external strengthening. During loading of the beam, diagonal shear cracks formed at a load of 24.7 kips. The shear cracks initiated at the center of both shear spans almost simultaneously. The first shear crack was the critical crack in the specimen. As the load increased, this crack widened and propagated until failure resulted at a load of 40.6 kips. Figure 5.6 shows the specimen after failure.

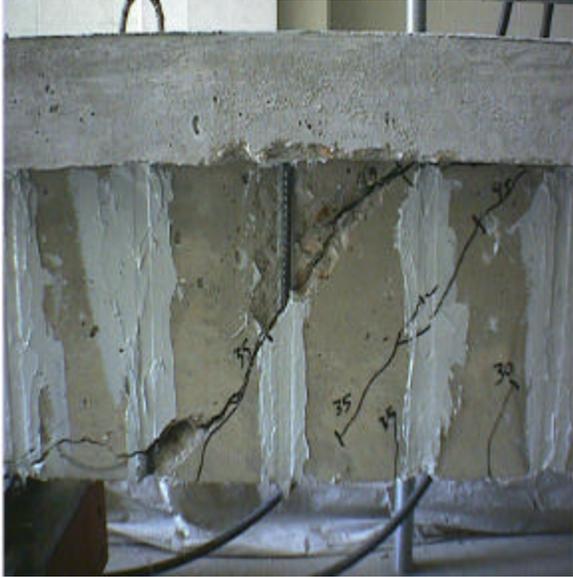
Figure 5.7. Failure of Beam B90-7

In specimen B90-7, with NSM vertical rods at a spacing of 7 in., failure occurred at a load of 51.8 kips. This corresponded to an increase in capacity of 27.6% with respect to beam BV. Diagonal shear cracks formed also in this beam, widened and propagated as the applied load increased. A crackling noise revealed throughout the test the progressive cracking of the epoxy paste in which the CFRP rods were embedded. Failure eventually occurred by splitting of the epoxy cover in one of the NSM FRP rods intersected by the major shear crack (Figure 5.7). The crack pattern of beam B90-7 is illustrated in Figure 5.8. The applied load versus the vertical strain in the CFRP rods is plotted in Figure 5.9. The highest vertical strain in the rods was recorded at 3 in. from a diagonal crack and was approximately equal to $850 \mu\epsilon$. It must be pointed out that this strain value and all those herein reported are not necessarily maximum values. They are strictly related to the location of the gages relatively to that of the shear cracks.

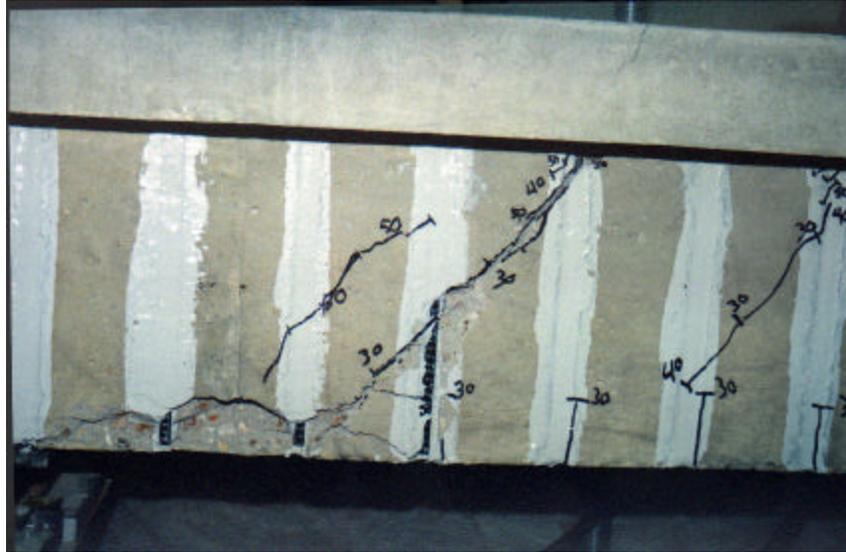
Figure 5.10. Failure of Beam B90-5

Same behavior and failure mode were registered from testing of beam B90-5, which differed from B90-7 only for the closer spacing of the CFRP rods (5 in.). The ultimate load was 57.4 kips, corresponding to an increase in capacity of 41.4% over the control beam and of 10.8% over specimen B90-7. Figure 5.10 is a picture of the failure mode. The crack pattern is illustrated in Figure 5.11. The load versus strain diagram is plotted in Figure 5.12. Strain gage 2, located at 0.5 in. from the major shear crack, recorded a maximum vertical strain approximately equal to 3000 $\mu\epsilon$. This value corresponds to 16.8% of the ultimate strain of the CFRP rods, as reported in Section 2.4 of this document.

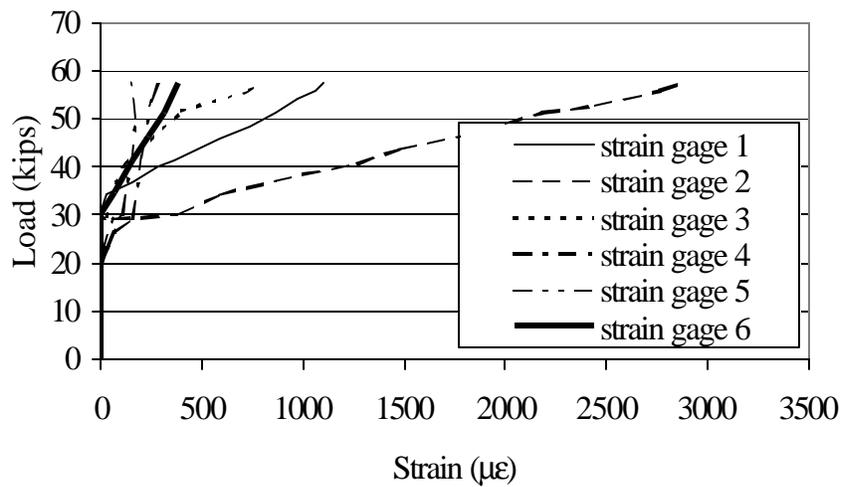
Figure 5.12. Load vs. Strain Diagram of Beam B90-5

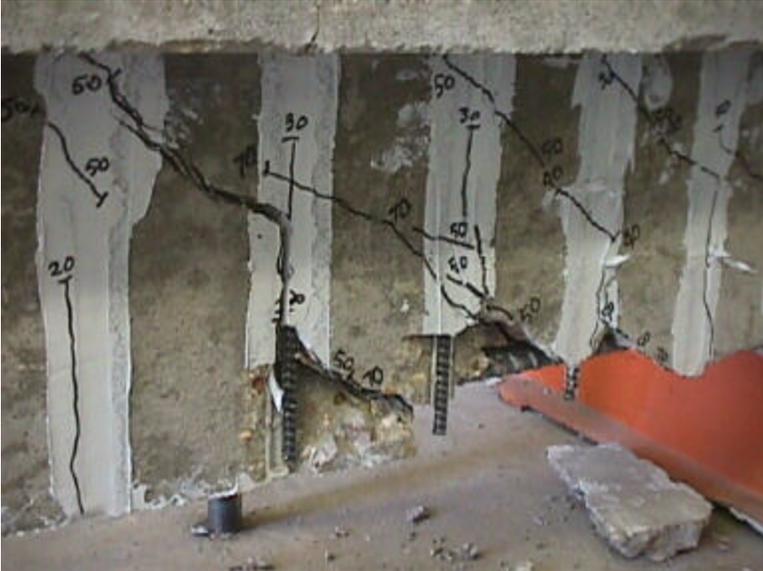
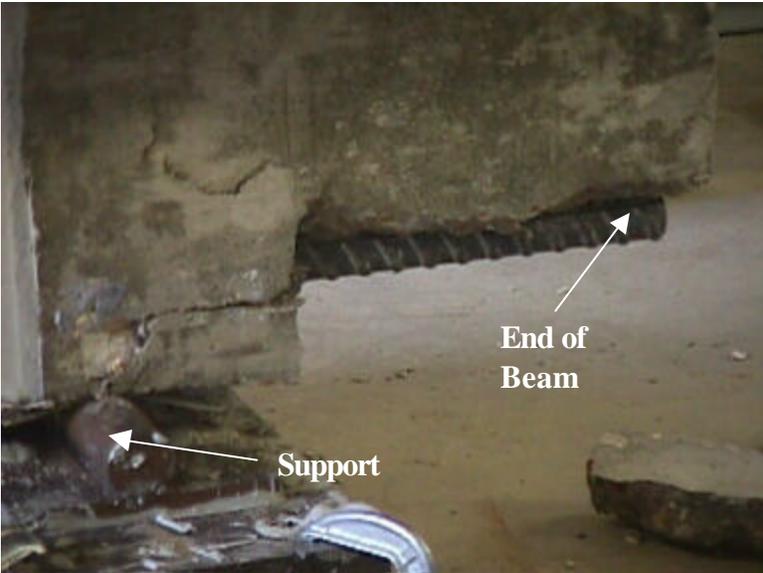
Figure 5.13. Failure of Beam B90-5A

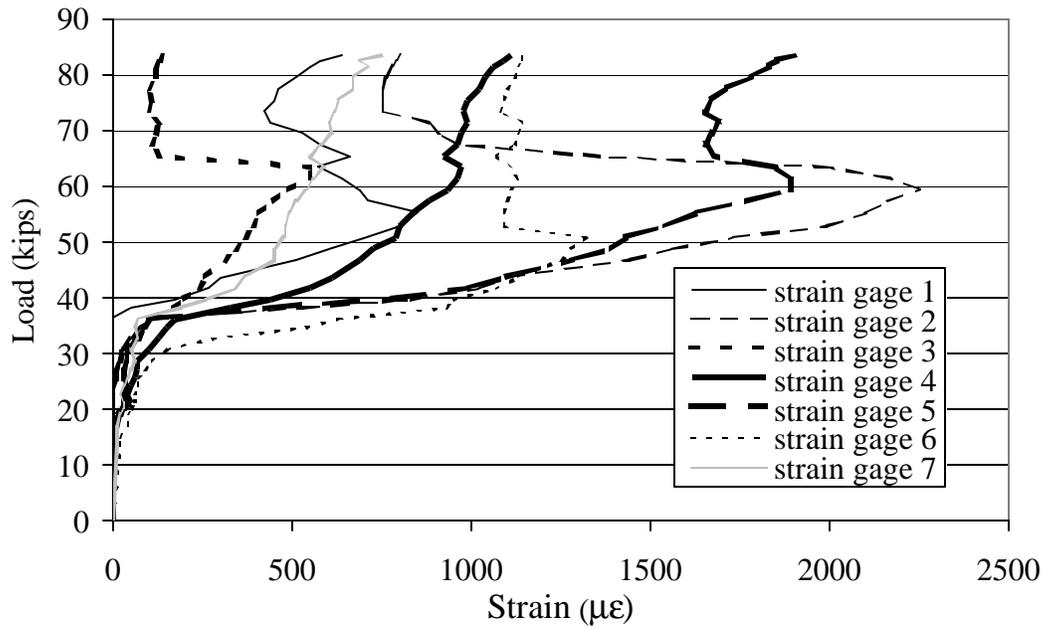
Figure 5.15. Load vs. Strain Diagram of Beam B90-5A

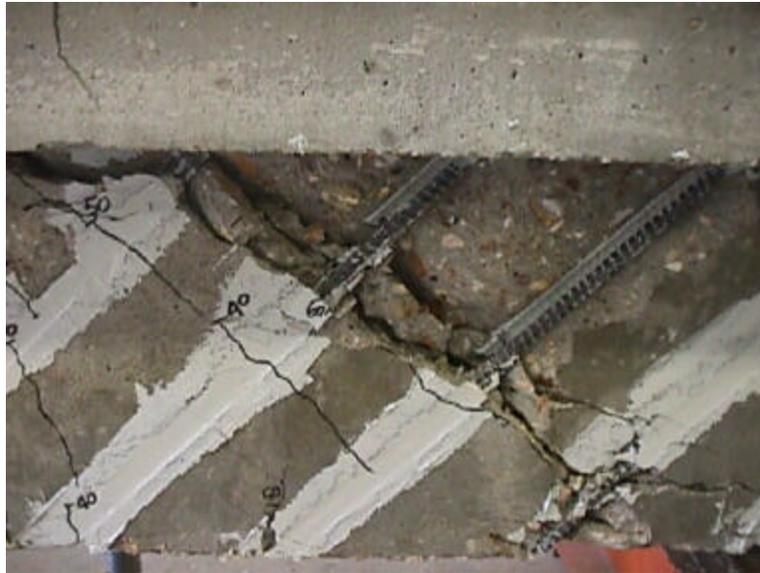
Figure 5.16. Failure of Beam B45-7

Specimen B45-7 had NSM rods at a spacing of 7 in. inclined at 45 degrees with respect to the longitudinal axis of the beam. Failure occurred at 74.4 kips, corresponding to an increase in capacity of 83.3% over the control beam. As expected, 45-degree inclined rods were more effective than vertical rods at the same spacing, as showed by the 43.6% increase in capacity of B45-7 with respect to B90-7. Failure, as in B90-7, was controlled by splitting of the epoxy cover that occurred simultaneously in two of the NSM FRP rods intersected by the major shear crack (Figure 5.16). The crack pattern is illustrated in Figure 5.17. The strain data recorded from the strain gages is reported in Figure 5.18. The maximum recorded strain was equal to approximately 4600 $\mu\epsilon$, corresponding to 25.7% of the ultimate strain.

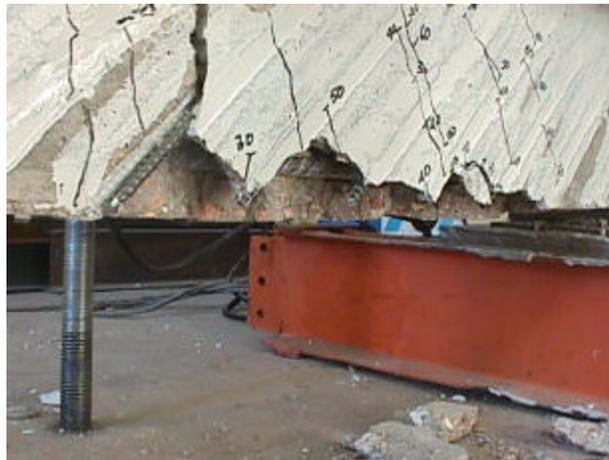
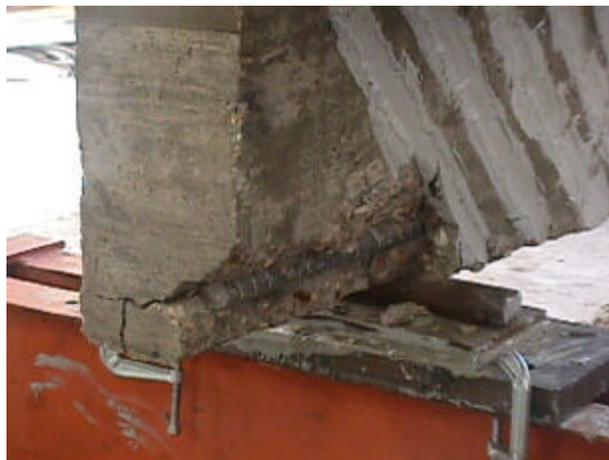
Specimen B45-5 differed from B45-7 for the spacing of the rods, equal to 5 in. Failure occurred at a load level of 80 kips, showing an increase in capacity of 97%, 7.5% and 39.4% over BV, B45-7 and B90-5, respectively. The failure mode was the same previously described for specimen B90-5A, that is, formation of splitting cracks along the longitudinal reinforcement and eventual loss of the concrete cover (Figure 5.19).

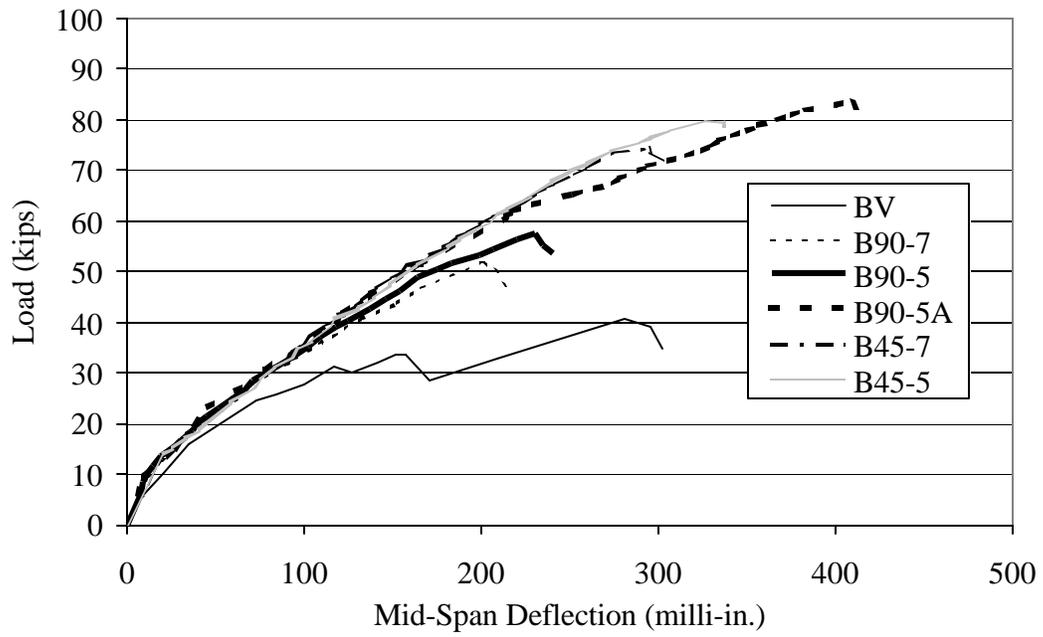
Figure 5.20. Load vs. Mid-Span Deflection of the Beams Without Steel Stirrups

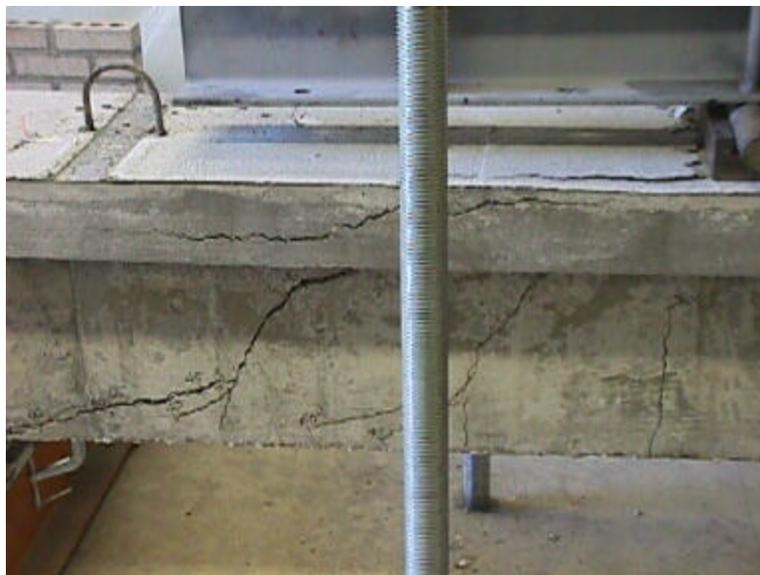
Figure 5.21. Failure of Beam BSV

5.5.2. Beams With Steel Stirrups. In beam BSV, with steel stirrups of Grade 50 steel at a spacing of 14 in., shear cracks widened and propagated up to the flange as the load increased. Failure resulted at 68.9 kips (Figure 5.21). Two strain gages were applied on each of the first two stirrups in the test side, whose location is shown in Figure 5.3. The crack pattern is illustrated in Figure 5.22. Only the strain gages on the first stirrup worked properly, and recorded very low values of strain (Figure 5.23) due to their distance from the location of the crack.

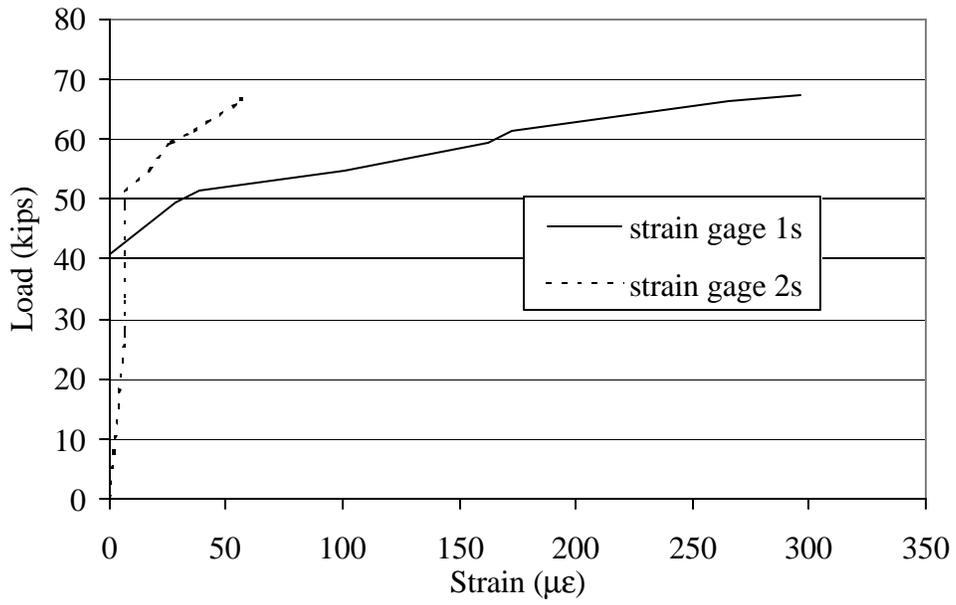
Figure 5.23. Load vs. Strain Diagram of Beam BSV

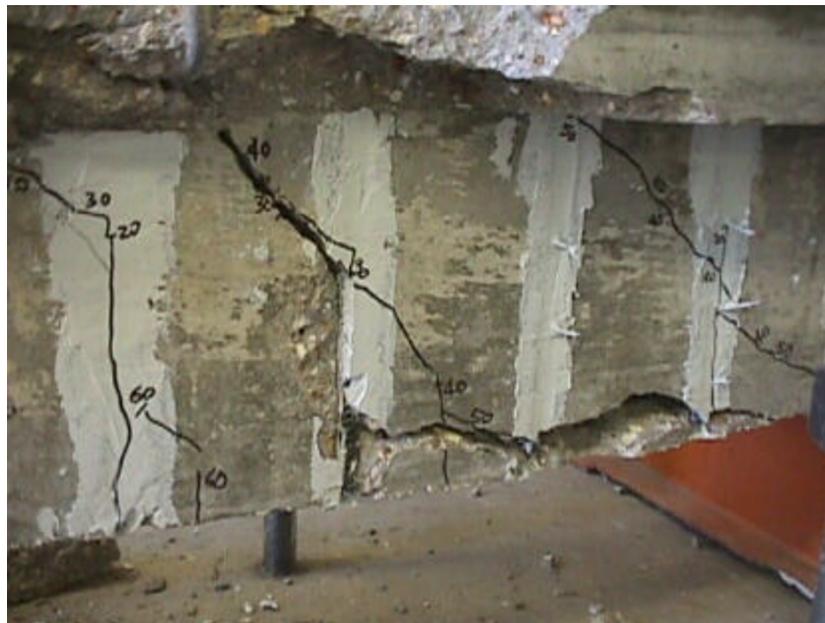
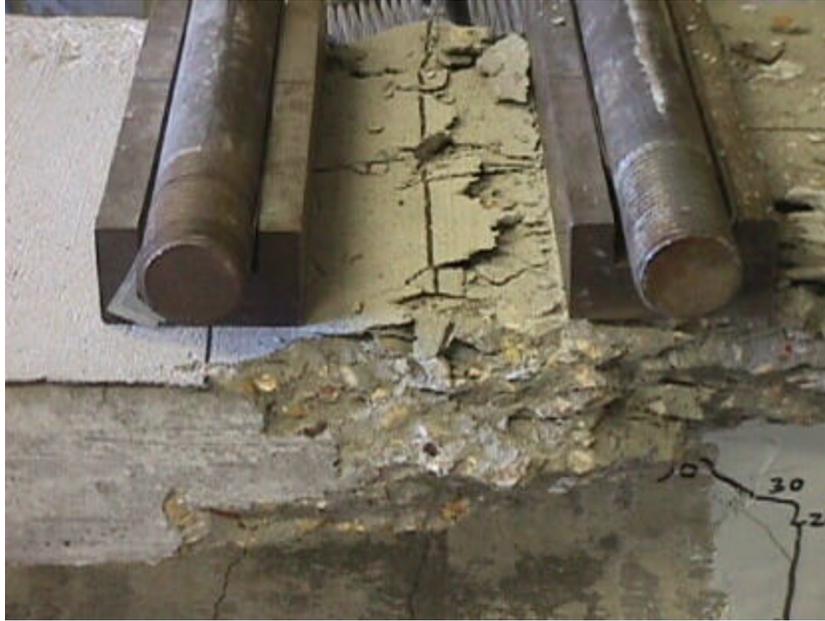
Figure 5.24. Failure of Beam BS90-7A

Beam BS90-7A had the same steel shear reinforcement as BSV, and was externally strengthened with NSM vertical rods at a spacing of 7 in. anchored in the flange. The ultimate load was 93.0 kips, that is, 35% larger than the capacity of beam BSV. The final failure mode was splitting of the concrete cover as previously described for beam B90-5A (Figure 5.24-a). In this case, however, it occurred when flexural failure was already ongoing, as evident from the crushing line in the concrete top fiber at mid-span (Figure 5.24-b) and from the load vs. mid-span deflection diagram. Another difference with respect to failure of beams B90-5A and B45-5 is that the concrete cover did not spall completely, due to the restraining action of the steel stirrups. The crack pattern is illustrated in Figure 5.25. Figures 5.26 and 5.27 show the strain data recorded from the strain gages on the steel stirrups and on the FRP rods, respectively. Of the strain gages on the steel stirrups, strain gage 4s recorded the highest value, very close to the yielding strain of the steel stirrups ($1724 \mu\epsilon$). As in the case of beam B90-5A, the inversion point in some of the load vs. FRP-strain curves reveals the occurrence of slip of the FRP rods.

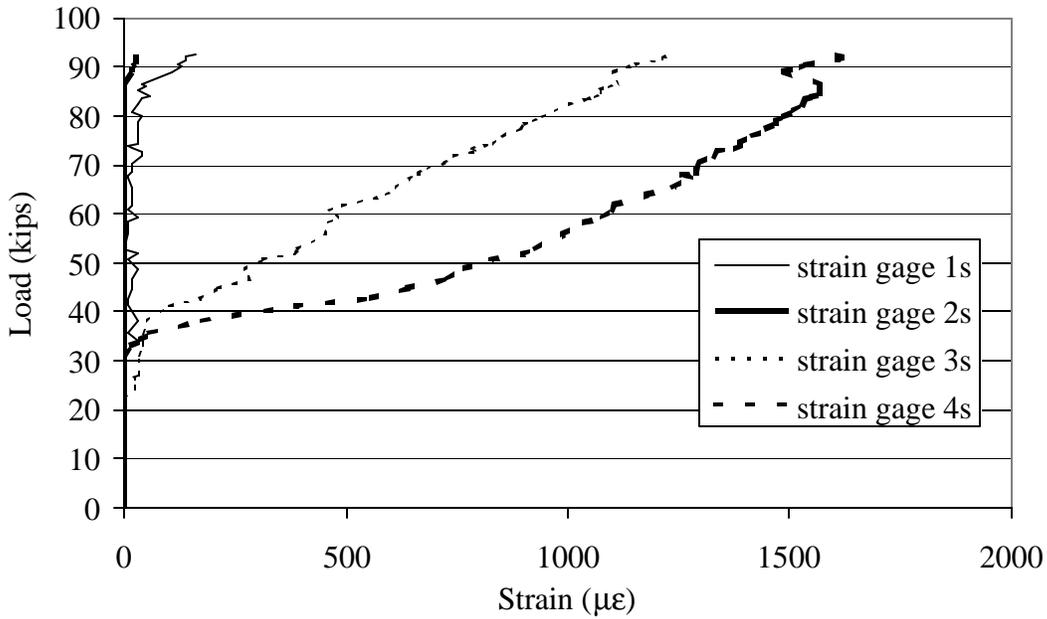
Figure 5.26. Load vs. Strain Diagram of Beam BS90-7A (Steel Stirrups)

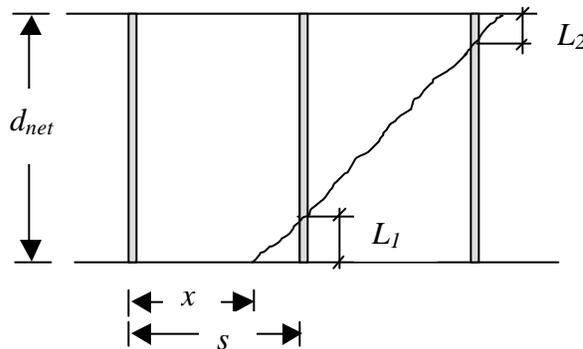
Figure 5.29. Case 1 ($\frac{d_{net}}{2} < s < d_{net}$)

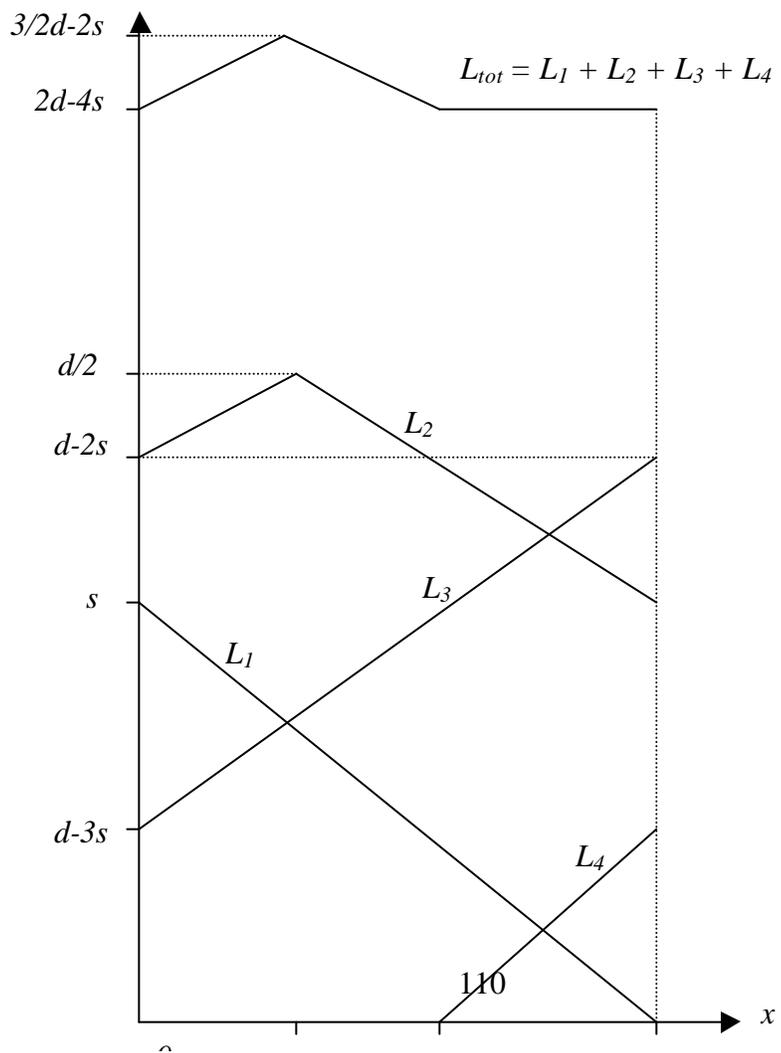
Figure 5.34. Calculation of L_{totmin} for Case 3

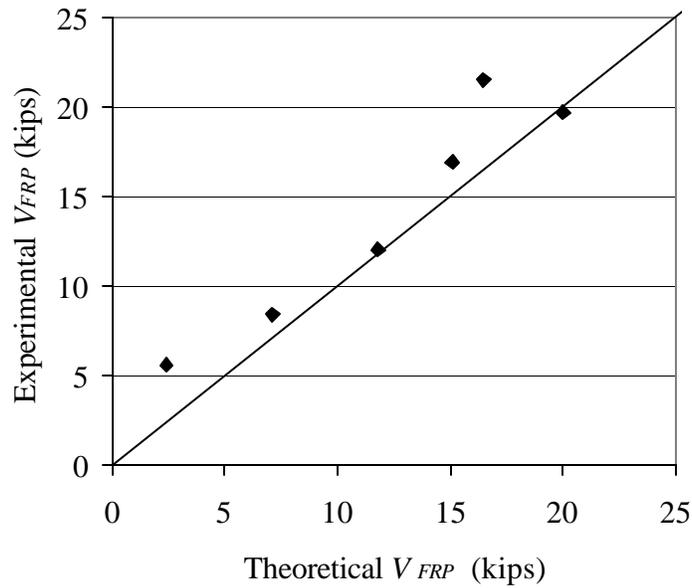
Figure 5.35. Comparison of Experimental and Theoretical V_{FRP}
