Structural Upgrade of Reinforced Concrete Column-Tie Beam Assembly using FRP Composites

by A.S. Mosallam

Synopsis: The paper discusses the potential use of fiber reinforced polymer composites for repair and retrofit of existing reinforced concrete (RC) column-tie beam assemblies. Results of an experimental program performed on large-scale specimens repaired and strengthened with two types of wet lay-up composite systems are presented. Each column-tie beam assembly specimen was subjected to a constant axial load simulating gravity loads, and incremental cyclic lateral loads simulating potential seismic forces. Displacements, strains and loads were continuously monitored and recorded during all tests. Evaluations of the observed strength and ductility enhancements of the strengthened specimens are made and limitations of such retrofit methods are highlighted for design purposes. Experimental results indicated that the two composite systems used in this study succeeded in enhancing the strength, stiffness and the ductility of the column-tie beam assembly. As compared to the unstrengthened specimens, the strengths of the retrofitted specimens were 152% and 154% for carbon/epoxy and E

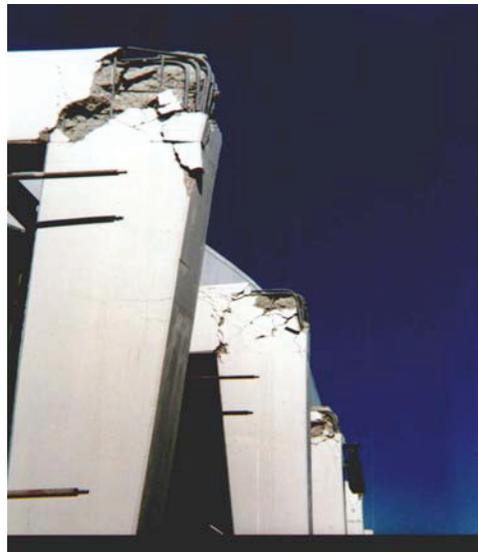
Figure 1— Local Failure of Beam-Column Connections during Northridge Earthquake, California, 1994. [8]

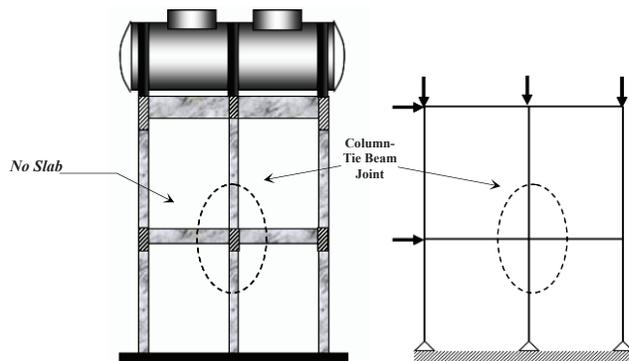
Figure 3— Condenser and Elevated Tank Frame in Oil Refineries.

Column-tie connections are found in many structures including space frames that are commonly used in oil refineries and petrochemical facilities (see [Figure 3](#)) and some parts of moment frame buildings (see [Figure 4](#)). For this special connections, no gravity loads are applied to the tie beam (no floor slabs), except of its own weight, and all vertical loads are transferred via columns as shown in [Figures 3 and 4](#). In this case, the joint is exposed to minimum shear and relatively higher moments and axial loads in the column region. In this paper, a pilot study on repair and rehabilitation of this type of joint using two types of FRP composites is presented.

A total of four full-scale reinforced concrete column-tie beam assemblies tested under sustained axial column load and full lateral reversed cyclic loading conditions. The specimen represents a typical construction similar to those shown in **Figures (3) and (4)**. The ends of the columns were pinned simulating inflection points. The column-tie beam assemblies were configured to induce moment limit-states and related failure modes. As shown in **Figure (6)** extremes of dimensions and weak reinforcement details were employed per the recommendations of section 5.3.1 of the ICC-ES AC 125 [11].

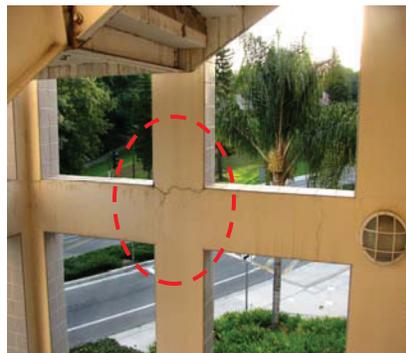
Figure 4— Typical Column-Tie Beam Joint in RC Buildings.

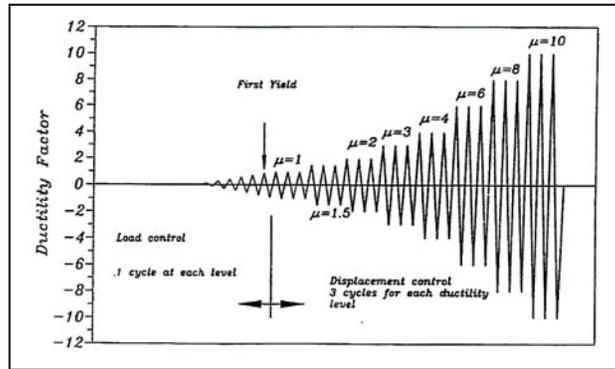
Figure 5— Typical Lateral Loading History.
 [Source: Fig. 1 – ICC-ES AC 125]

The loading regimes used in all evaluation tests described herein adhered to the ICC AC125 requirements as shown in **Figure (5)**. In this loading scenario, the effect of seismic forces was simulated by applying reversed cyclic loading to the tip of the beam member while maintaining a constant axial load to the column. Per the ICC-AC 125 requirement, the lateral reversal load and displacement histories were divided into two phases. Initially, the tests were conducted under a load control mode until the yielding load of the connection’ steel reinforcements. At this stage, a displacement control mode was utilized.

In performing this test, the loading history shown in Figure (5) was employed. Initially, load-control regime was adopted until the first yield, after which displacement-control loading was used. Figure (8) shows the control specimens during testing and the progression of failure. The load-deflection hysteresis curve for one of the unstrengthened control specimen is shown in Figure (9). The failure of the control specimen was brittle with an average ultimate lateral load of 19.55 kips that corresponds to a moment capacity of 36.90 kip-ft (50 kN-m) and a maximum rotational angle of 0.03 radian. The average idealized yield displacement of the control specimens was 0.34" (8.64 mm). Table (2) presents a summary for the average experimental values obtained from the control joints tests.

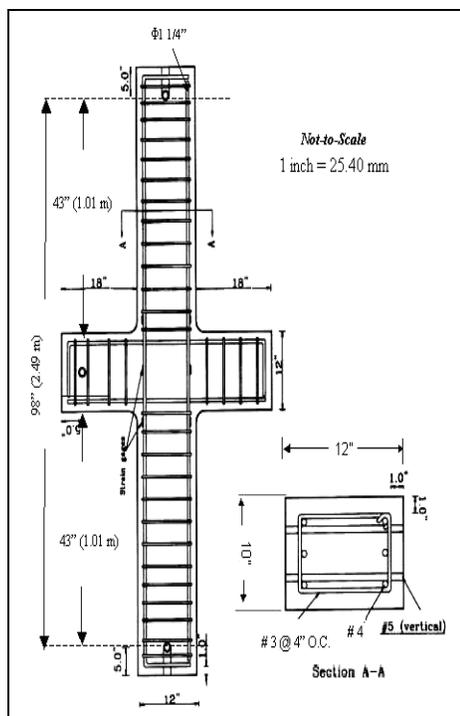
Figure 6—Dimensions and Reinforcement Details for Interior Control (*Unstrengthened*) Moment Frame Joints.

In order to develop a baseline for comparing and quantifying the contributions of the composite strengthening systems, two identical control (*unstrengthened*) joint specimens were tested. Figure (6) shows the dimensions and reinforcement details for an unstrengthened interior column-tie beam joint (refer to Figures 3 and 4). The typical test setup for all specimens is shown in Figure (7).

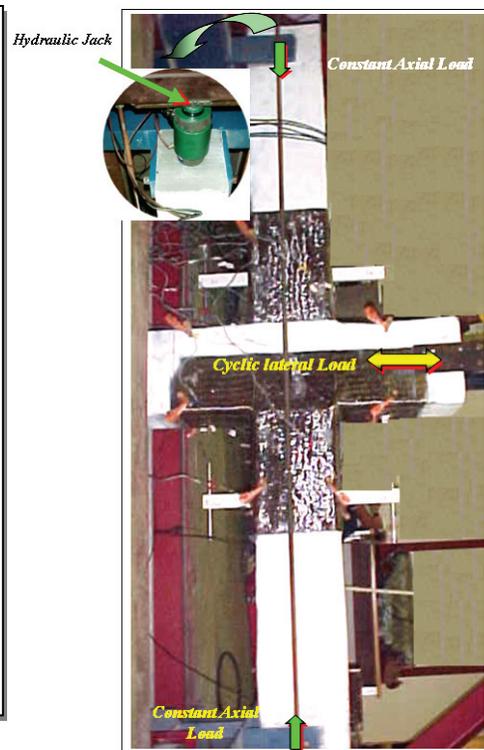
Figure 7—Typical Test Setup.

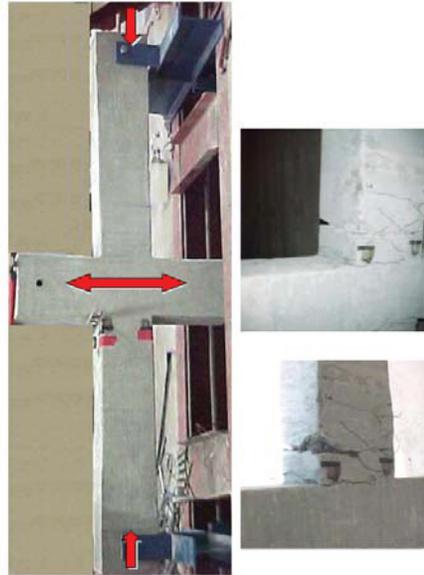
Figure 8—Control Column-Tie Beam Assemblies Test Setup and Progression of Failure.

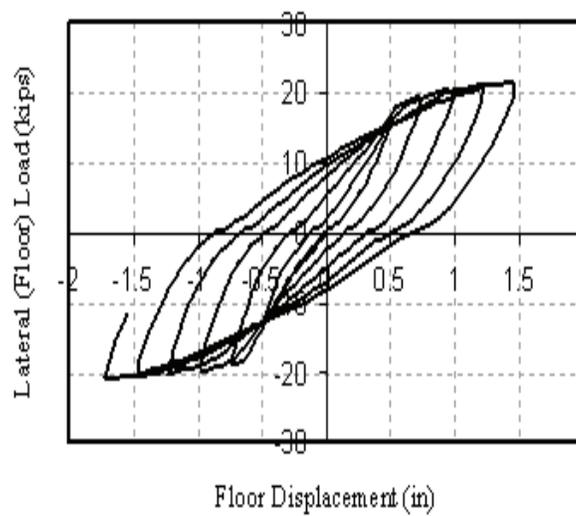
Figure 9— Experimental Load-deflection Hysteresis for Unstrengthened Specimens.

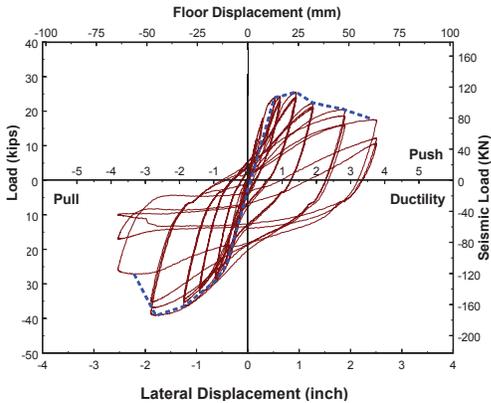
Figure 10— Experimental Load-deflection Hysteresis for Carbon/Epoxy Retrofitted Specimens.

Initially, the connection exhibited high stiffness which lasted for the first four cycles and up to a lateral displacement of about 1" (25.4 mm). At this stage, the joint reached its maximum load capacity of 29.85 kips (132.8 kN) which corresponds to a maximum flexural capacity of 55.10 kip-ft (74.71 kN-m). In the following cycles, gradual degradation in both stiffness and strength was noticed as shown in Figure (10). The idealized yield displacement was 0.67" (17 mm) and the ultimate displacement was 2.23" (56.64 mm). The joint relative rotation measured using the four LVDT's at the ultimate load was 0.041 rad. The maximum calculated ductility of this specimen was 3.6.

Test results indicated that the flexural strength of the column-tie beam assemblies strengthened with the carbon/epoxy system was 1.53 times the average strength of the unstrengthened "as-built" specimen (29.85 kips (133 kN) vs. 19.55 kips (87 kN)). The ultimate lateral displacement at failure for the strengthened specimen was 1.24 times the corresponding displacement of the unstrengthened specimen (2.32" (59 mm) vs. 1.87" (47.5 mm)). In addition, test results indicated that the use of the carbon/epoxy FRP system resulted in an appreciable stiffness enhancement to the strengthened specimen as compared to the control one. The initial rotational stiffness has been increased to 15,000 kip-ft/rad (20,317 kN-m/rad) as compared to only 4,175 kip-ft/rad (5,655 kN-m/rad) for the control joint specimen with gain in the initial rotational stiffness of 260%.

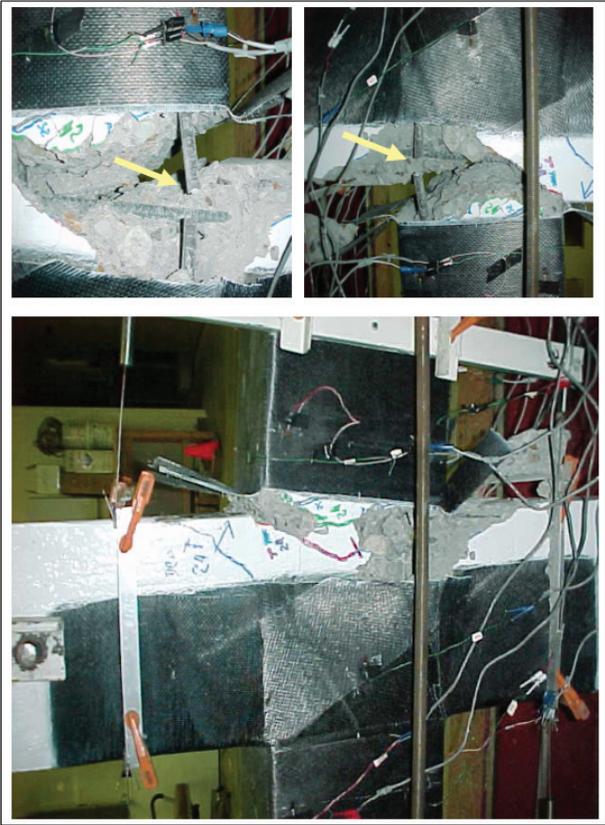
Figure 11— Ultimate Failure Mode of Carbon/Epoxy Retrofitted Specimen.

The ultimate failure of this specimen was a combination of spalling of the unstrengthened concrete portion of the joint that was extended to the top side of the tie beam (refer to Figure 11). This local joint damage resulted in a large joint rotation followed by a rupture of column's steel rebars at joint location as shown in Figure (11). The maximum-recorded FRP laminate strain was 0.68% which is about 60% of the rupture strain of the carbon/epoxy composite system.

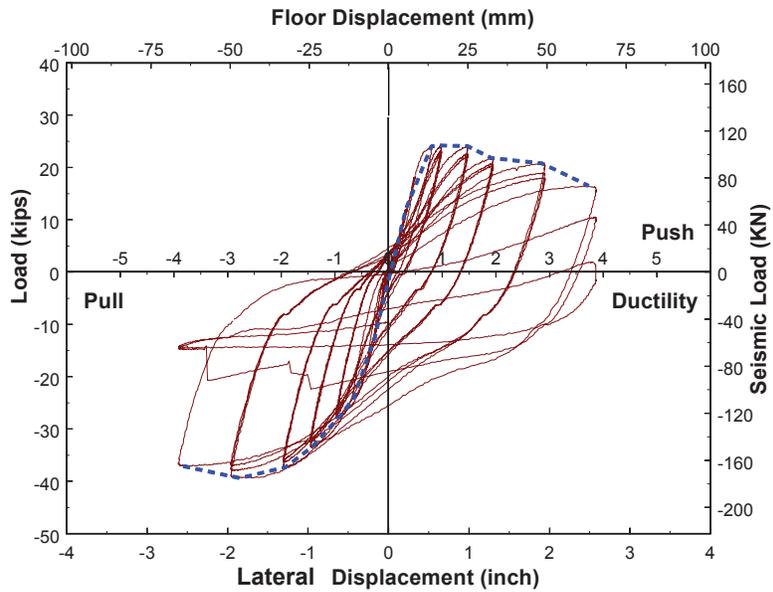
Figure 12— P - δ Hysteresis Loops for E-Glass/Epoxy Retrofitted Specimen.

Similar to the previous evaluation test, the objective of this test was to demonstrate the structural performance and the effectiveness of the E-glass/epoxy composite system in enhancing the cyclic performance of a deficient reinforced concrete moment frame joints. The FRP lamination schedule for this specimen was similar to the carbon/epoxy strengthened specimens described earlier. After applying the composites, the composites material was allowed to cure for at least 72 hours under the laboratory environment. Strain gages at different critical locations and in different fiber directions were bonded to the external composite laminate as well as to the internal steel rebars. Figure (12) shows the $P-\delta$ hysteresis loops for the E-glass/epoxy composite strengthened joint specimen. Similar to the carbon/epoxy joint specimen, the joint exhibited a relatively high stiffness which lasted for the first five load levels (fifteen cycles), after which a gradual degradation in both stiffness and strength was observed. At this stage, the joint reached its maximum average load capacity of 32.7 kips (145.5 kN) which corresponds to a maximum flexural capacity of 60.36 kip-ft (81.51 kN-m). As shown in Figure (12), the strength degradation following the fifth cycle was very moderate (*only 9% drop*). The idealized yield displacement for this specimen was

0.65" (16.51 mm) and the ultimate displacement was 2.52" (64 mm). The joint relative rotation measured using the four LVDT's at the ultimate load was 0.045 rad. As shown in Figure (13), the ultimate ductility of this specimen was 3.9. Damage progression and ultimate failure are illustrated in Figure (14). The maximum laminate strain measured during this test was 2.15% which is about 95% of the rupture strain of the E-glass/epoxy composite system.

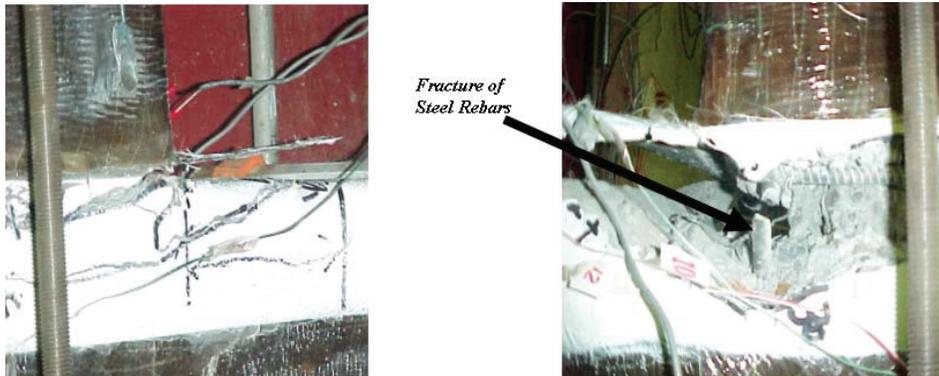
Figure 13— Damage Progression and Failure Mode of the E-Glass/Epoxy Retrofitted Specimen.

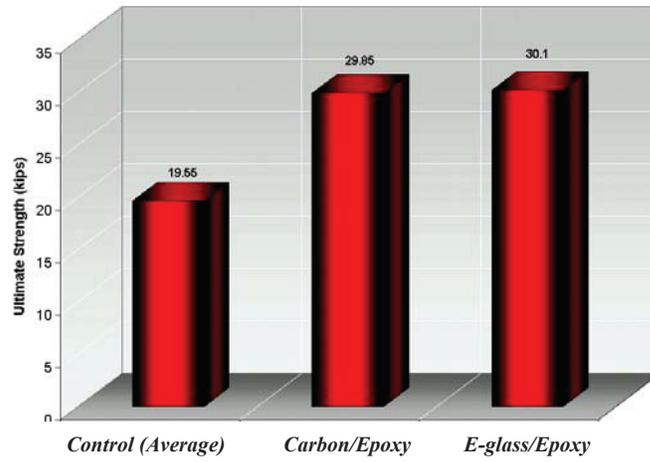
Figure 14—Strength Comparison between Strengthened and Unstrengthened (*As-Built*) Column-Tie Beam Joint Specimens.

Test results indicated that the strength of the column-tie beam joint assembly strengthened with E-glass/epoxy composite system is 1.54 times the average flexural strength of the unstrengthened "control" specimen (30.10 kips/133.9 kN vs. 19.55 kips/87 kN). The ultimate lateral displacement at failure for the strengthened specimen was 1.34 times the corresponding displacement of the unstrengthened specimen (2.52" (64 mm) vs. 1.87" (47.5 mm)).

Experimental results indicated that the two FRP composite systems succeeded in enhancing the strength, stiffness and the ductility of the seismically-deficient reinforced concrete column-tie beam connections. As compared to the unstrengthened joint specimens, the strengths of the strengthened specimens were 152% and 154% for the carbon/epoxy and E-glass/epoxy composite systems, respectively. Figure (14) presents a graphical comparison between the strength capacity of the strengthened and the average strength capacity of the as-built (*control*) joint specimens. In addition, test results indicated that the use of the FRP composite strengthening systems resulted in an appreciable increase in the maximum lateral (*floor*) displacement at the cyclic ultimate load (20% increase for the carbon/epoxy and 35% for the E-glass/epoxy). Figure (15) presents the load-displacement envelopes for strengthened and unstrengthened (*control*) test specimens. As shown in this figure, both the strength and stiffness of the strengthened specimens were upgraded. This figure also indicates that the FRP strengthened specimens have a lower rate of strength deterioration and higher ductility up to failure (*increased up to 35%*) as well as higher initial stiffness as compared to the as-built specimen.

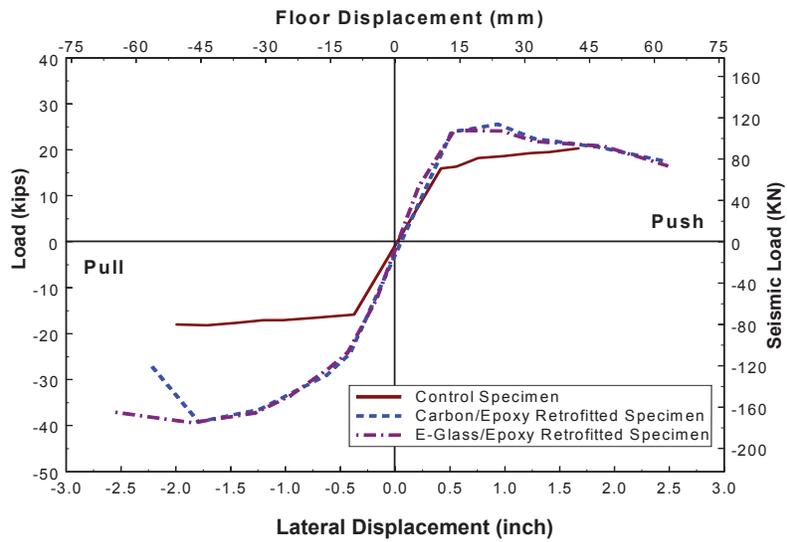
Figure 15— Comparison between Load-Displacement Envelopes for Strengthened and Unstrengthened (*Control*) Test Specimens.
