Paterson, N.J.

CIPP of Leaking High-Pressure Gas Main

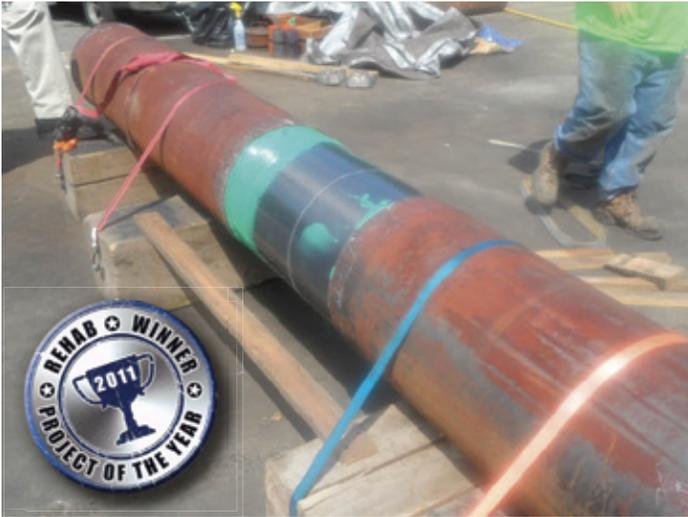
The simulated test of what the **PipeMedic™** carbon laminate sleeve would look like once installed.

The process of cutting the standpipe and installation of the PipeMedic™ laminate was simulated and tested at PPM under the watchful eye of GTI. The GTI test results indicated that the simulated drip pot pipe section met the pressure requirements of industry standards for cured-in-place liners. During the actual project, it took just a few minutes for the robotics system, which had an Aries camera attached, to travel down the main and an hour to cut away the standpipe in several cuts with the cut pipe sections dropping into the bottom of the pot. Using the robotic device, the PipeMedic™ laminate coated with epoxy resins was inserted into the pipe. After the resin cured, the CIPP process for the entire 700-foot pipe was pretty straightforward.
