CARBON FRP REPAIR OF UTILITY PULL BOXES

Name: Tucson Electric Power Pull Box
Type: Utility Pull Box
Location: Tucson, Arizona
Completed: May 2007

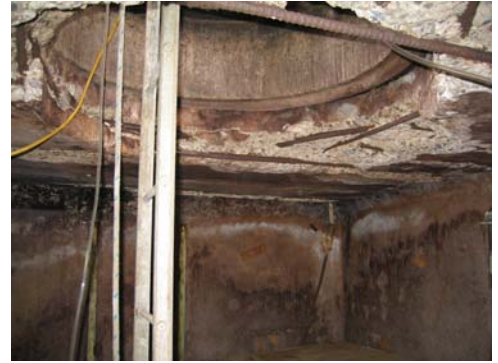
Tucson Electric Power Company (TEP) had several underground pull boxes that exhibited severe corrosion problems in the top slab (ceiling). The degree of concrete and steel reinforcement deterioration compromised the structural integrity of the box and the value of the power cables servicing important industrial facilities in the area.

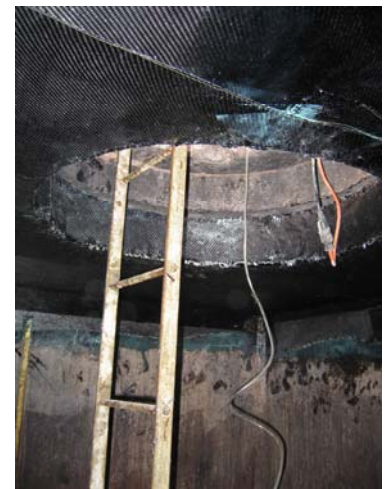
QuakeWrap[®] FRP Repair System was selected to provide the desired solution. After concrete repair work was completed, a layer of QuakeWrap[®] FRP biaxial carbon fabric was installed. The biaxial FRP fabric provided an air tight membrane to prevent future corrosion and at the same time reestablished the structural strength of the ceiling and side walls that were reduced due to deteriorated steel reinforcement.

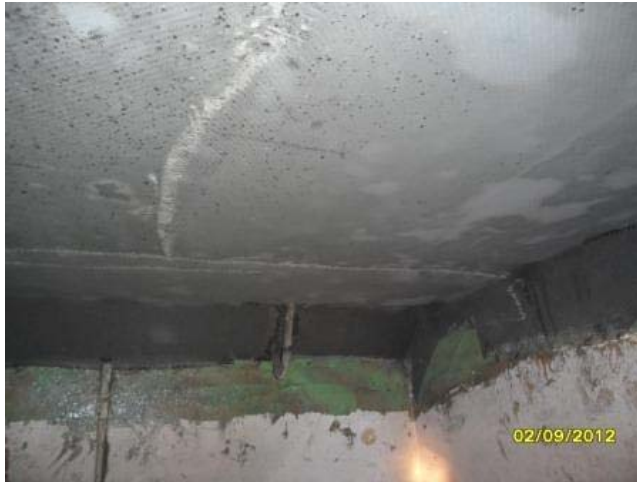
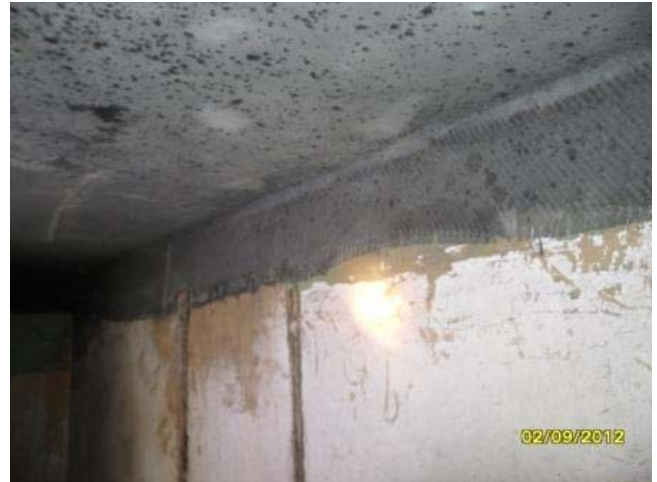
In February 2012, a team consisting of TEP and QuakeWrap Engineers inspected several of these pull boxes to access their condition. All FRP installations looked in excellent shape. Due to the humid environment in these buried structures, there was some mildew built up on the surface of the FRP. However, no structural degradation of the FRP was observed **after 5 years in service**.
