FRP REPAIR OF CONCRETE TANKS IN MINING FACILITY

Name: Tyrone Mines
Type: Industrial Facility
Location: Tyrone, New Mexico
Completed: November 2005

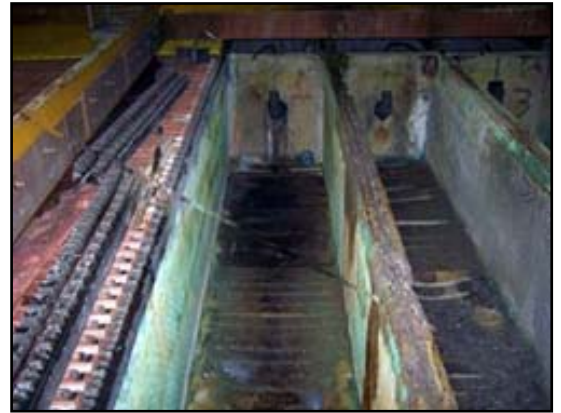
Severe corrosion of the tanks had caused the existing buffer and liners sheets to crack and leak. As a result, the acidic solution in the tanks was able to contact the concrete walls eroding the concrete and corroding the steel reinforcement, significantly reducing the walls strength. Also the cedar board tank flooring warped, allowing the acidic solution to damage the tank floor.
