FRP RETROFIT OF CIRCULAR TANK

Name: Buckeye Paper Mill
Type: Tank
Location: Memphis, TN

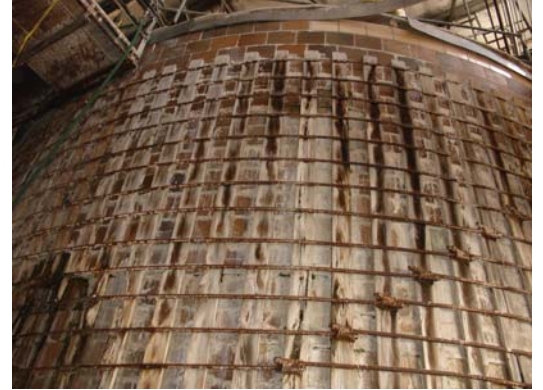
The exterior steel hoop reinforcement of 32 ft diameter and 26.5 ft high ceramic tile tanks exhibited severe damage due to highly corrosive environment in a paper mill tank. A corrosion proof retrofit system was required to substitute the hoop reinforcement.
