## FRP REPAIR OF CONCRETE TANKS IN MINING FACILITY

**Name:** Tyrone Mines  
**Client:** Phelps Dodge Mining  
**Location:** Tyrone, New Mexico

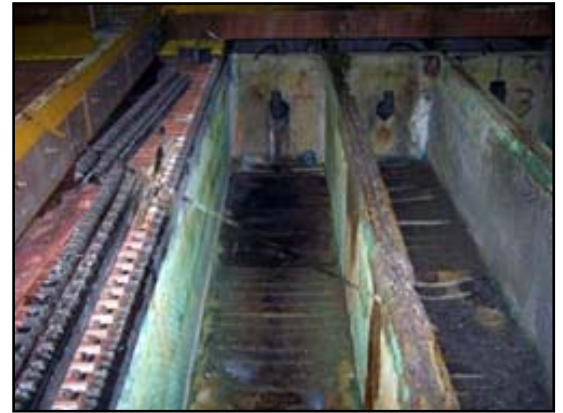
Severe corrosion of the tanks had caused the existing buffer and liners sheets to crack and leak. As a result, the acidic solution in the tanks was able to contact the concrete walls eroding the concrete and corroding the steel reinforcement, significantly reducing the walls strength. Also the cedar board tank flooring warped, allowing the acidic solution to damage the tank floor.

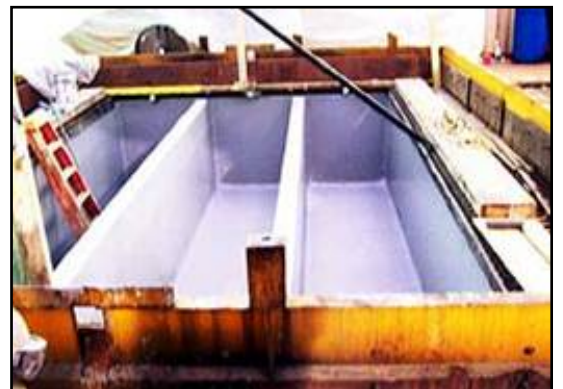
- Tanks containing 15% sulfuric acid @ 140°F
- Damaged tanks were weakened and acidic solutions leaked
- Patent-pending system was installed with a 5-year warranty
  - Quick repair with little downtime
  - Tanks are stronger than original “as-built” condition
  - Long-lasting repair reduced maintenance costs

A special QuakeWrap® FRP Repair System was developed to line the concrete tank walls. QuakeWrap® composite glass fabric was used along with a protective mat (to protect glass fabric against damage due production equipment). The new liner increased the wall strength while containing the acidic solution within the glass fiber system, effectively preventing future corrosion damage.
