## REPAIR OF EARTHQUAKE DAMAGED TILTUP WALLS WITH GLASS FRP

**Name:** Mitsubishi Corp.  
**Type:** Warehouse  
**Location:** Compton, California  
**Completed:** November 1996

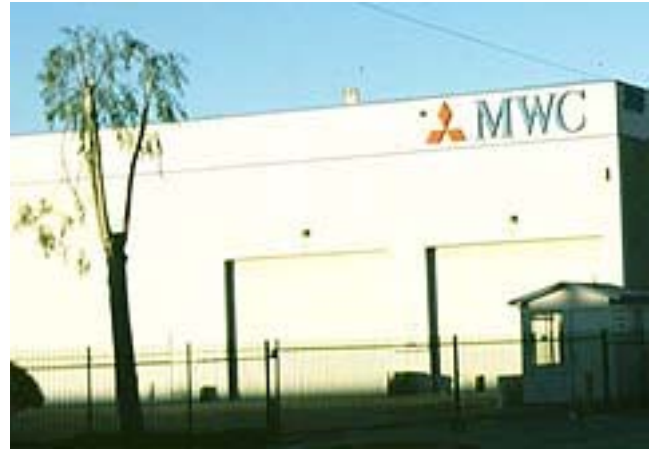
A number of tilt-up walls in the Mitsubishi warehouse in Pasadena, California were cracked. While crack injection was a possibility, FRP retrofit was seen as a better solution to strengthen the warehouse walls.

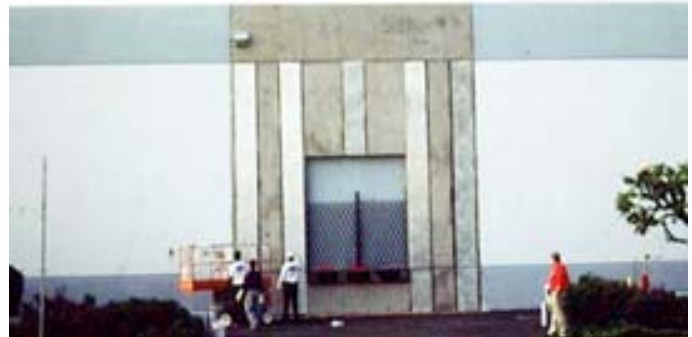
Use of QuakeWrap® glass fabric instead of crack injection allowed for considerable cost savings. At the same time, the walls were strengthened to resist larger loads.

- Mitsubishi, an FRP supplier, chose QuakeWrap, Inc. instead of the company division for the retrofit work.
- Warehouse needed to remain in use through project
  - 12,000 ft<sup>2</sup> of QuakeWrap® glass fabric was used
  - Fabric laid in strips rather than covering entire surface
  - Finished walls were painted to match original appearance
