Fiber-Reinforced Polymer Pipe Lining

Emergency repair to penstock allows power plant to enter service

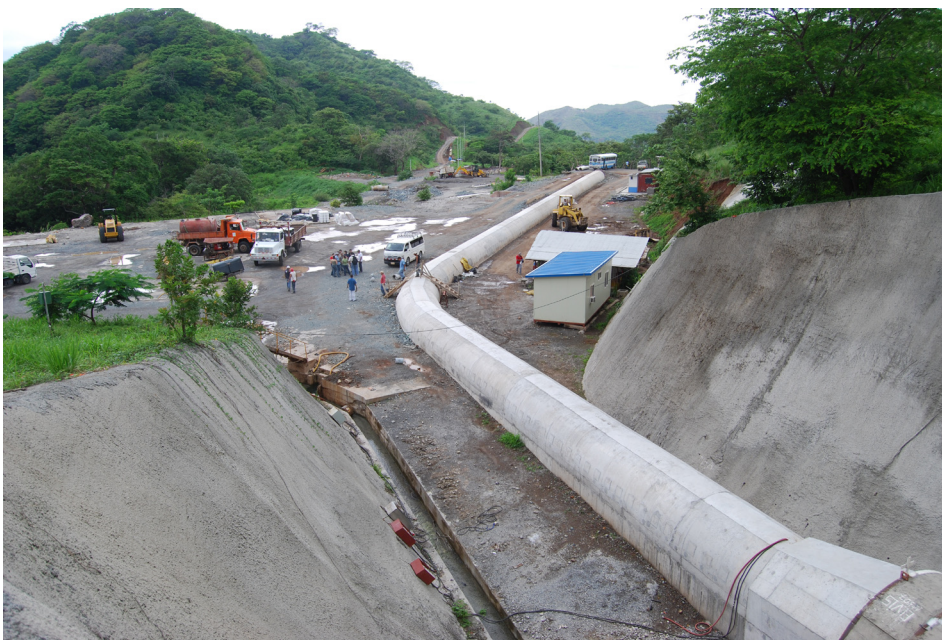
The low-pressure penstock at the El Encanto plant conveys river water from an upstream dam to the plant's turbine complex. The cast-in-place reinforced concrete pipeline (Fig. 1) has an **inside diameter of 7 ft. (2.1 m) and a total length of 5,742 ft. (1,750 m).** The water flows by gravity, but it is also pressurized.

Fig. 1: Above ground segment of the El Encanto penstock
