**ASSESSMENT AND REHABILITATION
OF WEST 7TH STREET BRIDGE
FULTON, MO**

August 2002

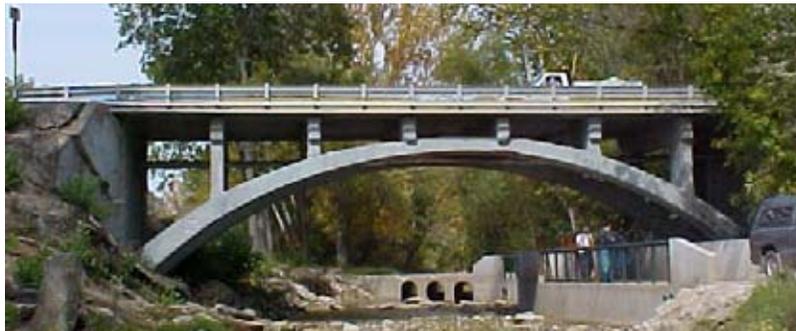
Figure 1-1. West 7th Street Bridge

This report describes the superstructure conditions, sampling of materials, material characterization and recommendations for the repair and strengthening of the West 7th St. Bridge over Stinson Creek in the City of Fulton, Missouri (see Figure 1-1). The report also presents a summary of the subsurface site conditions, geotechnical data, laboratory work, and evaluation of alternatives for the bridge abutment wingwalls. The part dealing with the superstructure includes the following subjects:

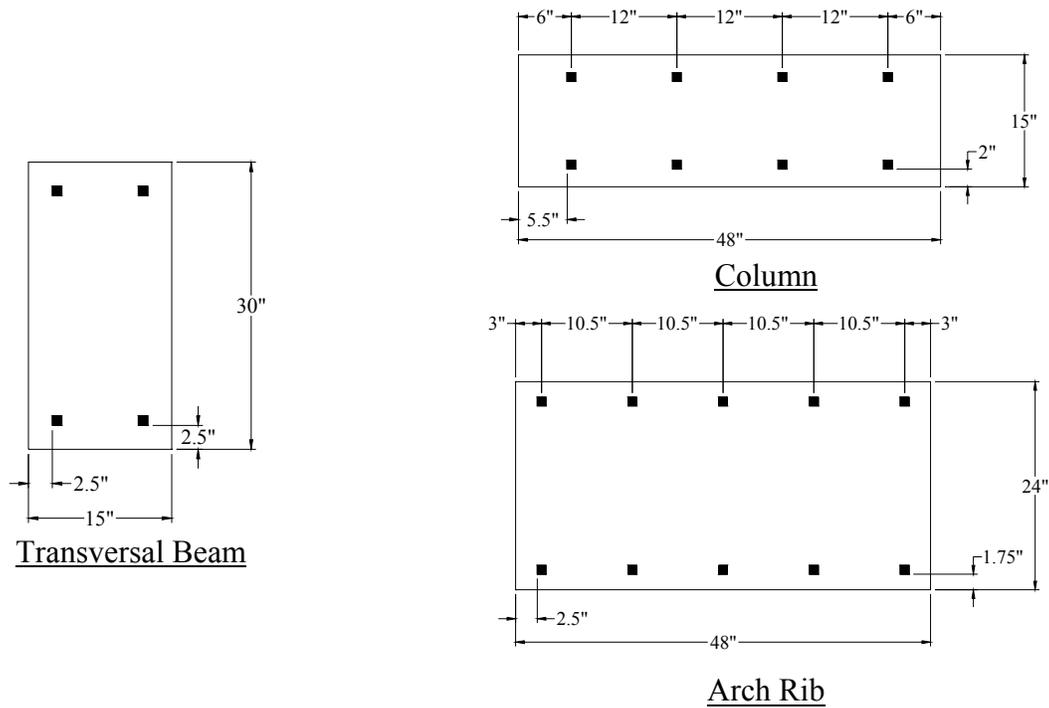
Figure 3-1. Internal Steel Reinforcement

Original drawings showing the internal reinforcement of the bridge were not available. A field survey was then conducted by personnel of the University of Missouri-Rolla (UMR). The survey included inspection of superstructure and substructure systems. The survey of the superstructure included the evaluation of the concrete condition, coring of concrete samples and location of steel reinforcement in the arch ribs, columns, and transversal beams. It was found that the structural elements were internally reinforced with square 1x1 in. steel rebars and lacked shear reinforcement (i.e. no stirrups/ties were detected). Details of the steel reinforcement are shown in 3-1.

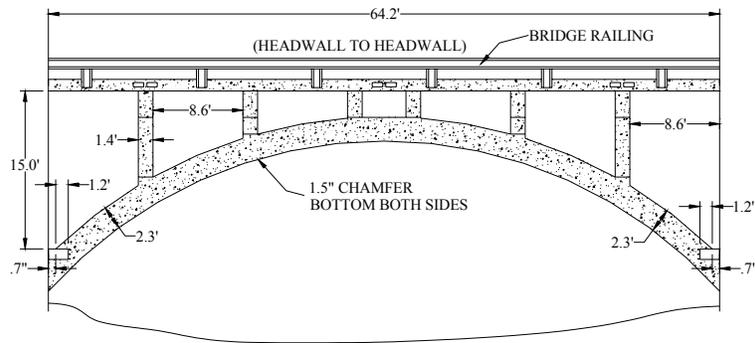
Figure 3-4. Bridge Geometry

A preliminary analysis was conducted using a commercially available finite element software. The modeling was based on the dimensions provided by the City of Fulton (see 3-4).

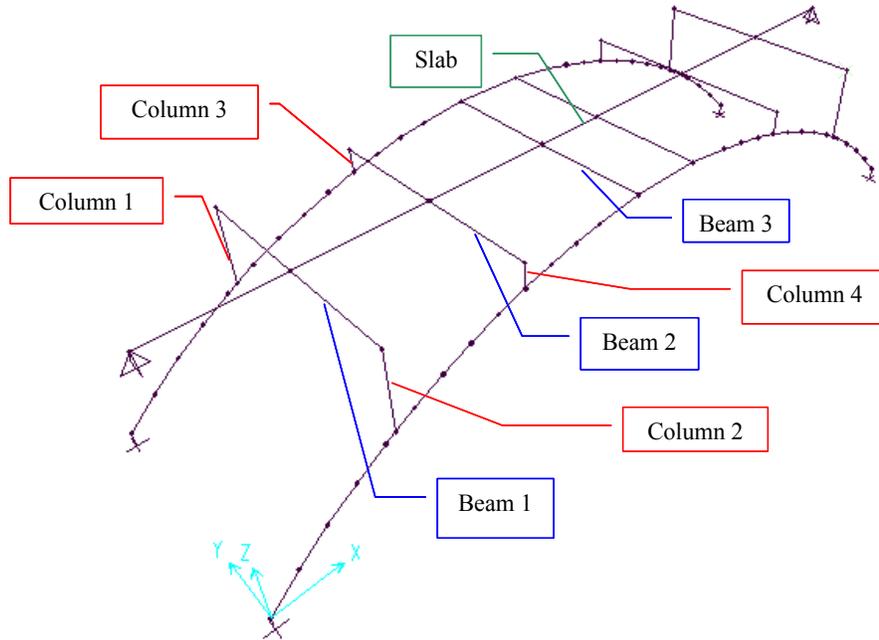
Figure 3-6. Bridge Idealization for Analysis

Figure 3-6 shows an idealization of the bridge used for analysis. Table 3-1 summarizes maximum values for axial load, bending moment, and shear force for beam, column, and arch element identified in Figure 3-6.
