# **Performance of an RC Corner Beam-Column Joint Severely Damaged under Bidirectional Loading and Rehabilitated with FRP Composites**

**by M. Engindeniz, L.F. Kahn, and A.-H. Zureick**

**Synopsis:** This paper presents the performance of a full-scale reinforced concrete corner beam-column-slab specimen that was first severely damaged under bidirectional quasi-static loading, then rehabilitated and retested. The specimen was built using the pre-1970s construction practices including the use of low-strength materials (3000 psi [21 MPa], Grade 40 reinforcing bars) and deficiencies in reinforcement detailing. The rehabilitation process consisted of: (1) epoxy injection, (2) addition of a bar within the clear cover of the column at the inside corner, and (3) external application of a multilayer composite system made of unidirectional carbon-epoxy layers placed at different orientations. The carbon fiber-reinforced polymeric system was heat-cured at a temperature of  $80^{\circ}\pm10^{\circ}\text{C}$  ( $176^{\circ}\pm18^{\circ}\text{F}$ ) for 6 hours. The performance was evaluated both before and after rehabilitation based on the progression of damage and the hysteretic behavior incl

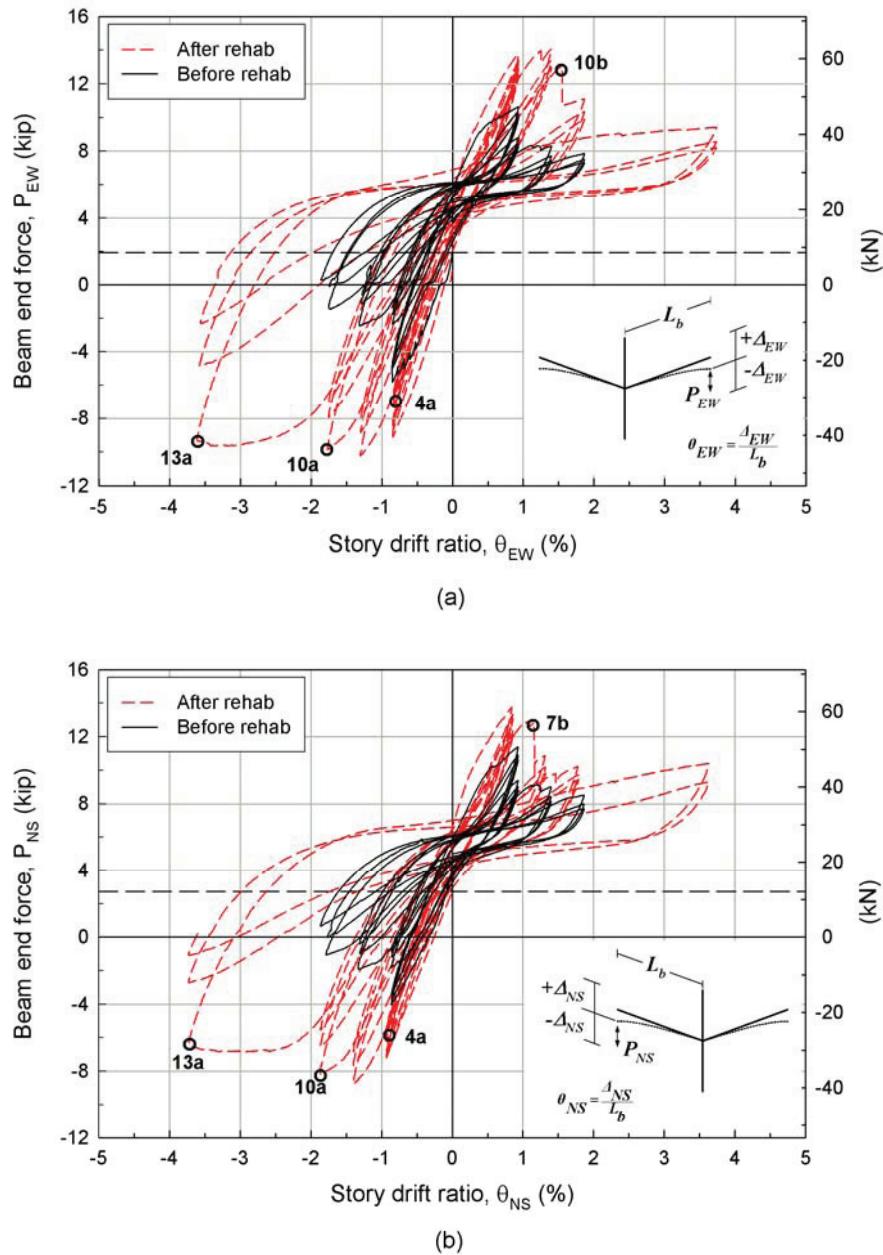
The strong column-weak beam behavior manifested itself in the force-drift hysteresis loops ([Figure 6](#)) as increases in the negative peak loads that were maintained until the first peak at  $-3.73\%$  drift, after which deflection the peak loads decreased due to significant damage in the beams. The maximum negative loads were increased by 57% and 70% for the EW and NS beams, respectively, when compared with those obtained for the as-built specimen. For the positive loading direction, up to 40% and 27% increases in the maximum loads were achieved for the EW and NS beams, respectively, until the FRP strips on the side of the beams debonded. Debonding of the strips are marked "7b" and "10b" on the hysteretic plots in [Figure 6](#). Percent increases in the peak loads were calculated with respect to the initial loads on the actuators at the deformed position used as reference for cyclic loading, represented by horizontal dashed lines in [Figure 6](#).

(4a) First yield in beams, (7b) Debonding of FRP strips on NS beam,  
 (10a) Extensive yielding in beams and first yield in column,  
 (10b) Debonding of FRP strips on EW beam, (13a) Joint failure

Figure 6 — Force-drift hysteresis loops: (a) EW, and (b) NS.

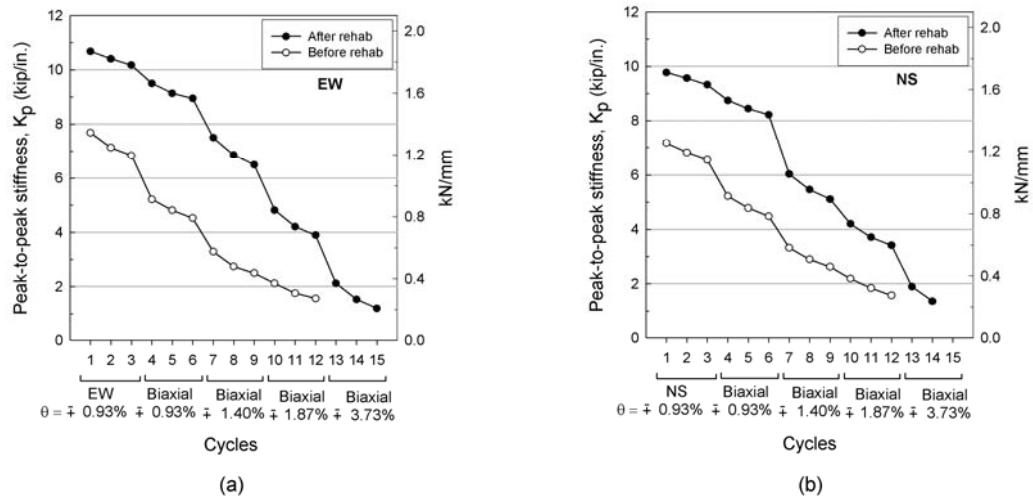
The increases in peak-to-peak stiffness ( $K_p$ ) during the bidirectional cycles ranged from 82 to 160% for the EW direction and from 68 to 117% for the NS direction ([Figure 7](#)). Unlike in the as-built specimen, much of the initial stiffness was maintained through the bidirectional cycles especially until debonding of the FRP strips on the beams.

Figure 7 — Stiffness degradation: (a) EW, and (b) NS.

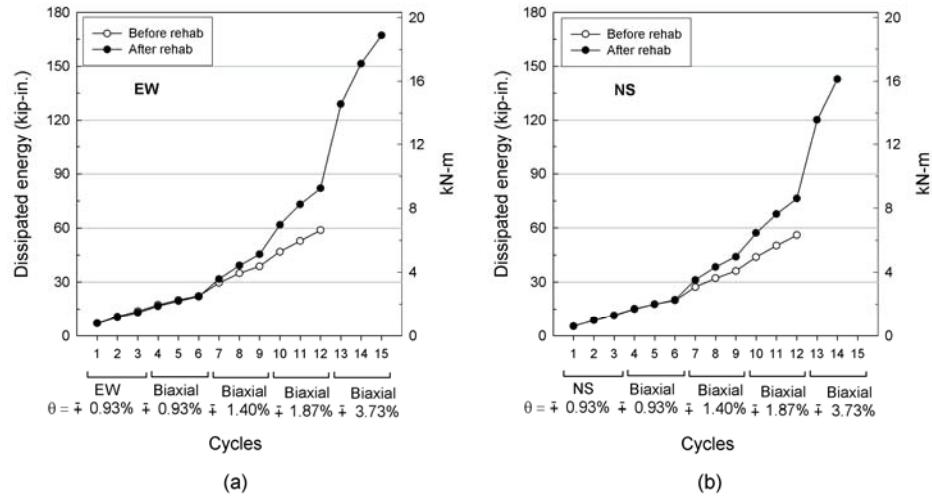
The energy dissipated by the specimen was calculated as the area enclosed by the force-displacement curves. Cumulative plots of the dissipated energy in both EW and NS directions are presented in [Figure 8](#). Although the total energy increased continuously, the increase was not proportional to the increase in the applied displacements due to the combined effects of increased pinching and strength degradation.

The increase in the amount of energy dissipated by the specimen after the onset of yielding in the beams is clearly observed in [Figure 8](#). Until the end of the  $\pm 1.87\%$  drift cycles, where loading of the as-built specimen was terminated, the rehabilitated specimen dissipated 39% and 37% more energy in the EW and NS directions, respectively. During the  $\pm 3.73\%$  drift cycles, the amount of the dissipated energy was doubled; a majority of this energy was dissipated during the first cycle where a complete ductile failure of the beams was achieved.

Figure 8 — Cumulative dissipated energy: (a) EW, and (b) NS.

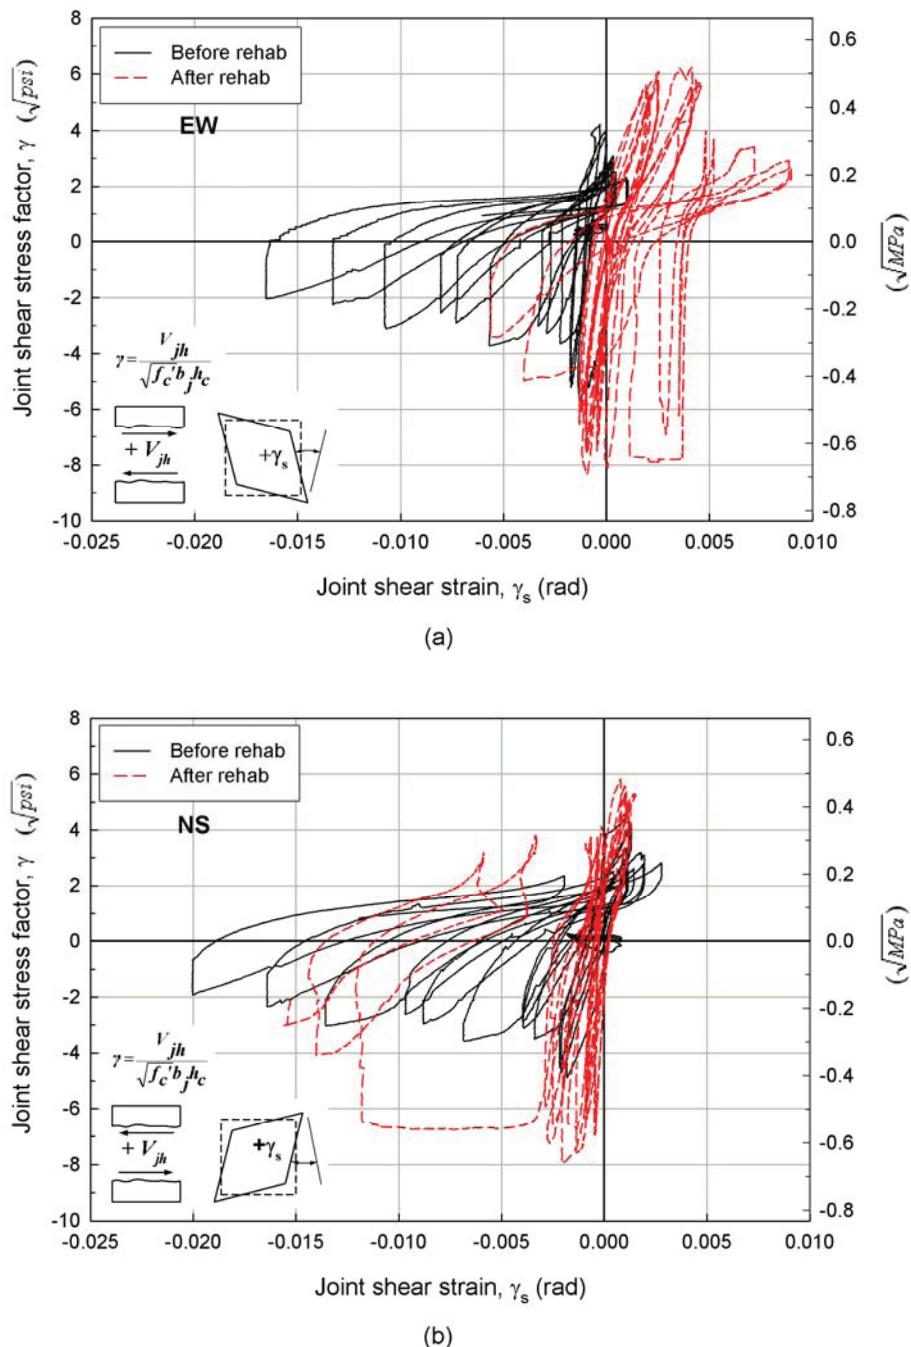
The plot of the joint shear stress factor ( $\gamma$ ) versus the joint shear strain ( $\gamma_s$ ) is presented in [Figure 9](#), where  $\gamma = V_{jh} / \sqrt{f'_c b_j h_c}$  as defined in ACI 352R-02, Sec. 4.3.1. The horizontal joint shear force ( $V_{jh}$ ) was determined as the difference between the column shear force and the total tensile normal force ( $T$ ) acting on the beam-joint interface.  $T$  was estimated by assuming a constant moment-arm of  $jd=0.875d$  between the tension and compression resultants at this section (i.e.  $T=M/0.875d$ ).  $\gamma_s$  for each joint panel was taken as the average of four joint shear strain estimates obtained from the LVDT configuration in [Figure 3c](#). The resulting  $\gamma$  versus  $\gamma_s$  plots were in line with all

The shear stress-strain behavior of the joint was improved significantly toward a desirable "rigid joint" behavior ([Figure 9](#)). Notable distortion of the joint occurred only after crushing of the joint concrete at the first peak at  $-3.73\%$  drift. The maximum joint shear stress factors ( $\gamma$ ) of  $8.3 \sqrt{\text{psi}}$  ( $0.69 \sqrt{\text{MPa}}$ ) and  $8.0 \sqrt{\text{psi}}$  ( $0.66 \sqrt{\text{MPa}}$ ) obtained for the negative loading direction for the EW and NS directions represent increases of 46% and 63% over the values obtained for the as-built specimen. As previously discussed, the actual shear strength of the joint may be underestimated by the "constant moment-arm approximation" used in determining the reinforcing bar tensile forces at the beam-joint interfaces. For example, another estimate of  $\gamma$  can be obtained for the load state where all the EW beam top bars and two slab top bars near this beam have yielded. Assuming that the second layer of beam top reinforcements have also yielded (not instrumented), and not considering any strain hardening, a  $\gamma$  value of approximately  $10.8 \sqrt{\text{psi}}$  ( $0.90 \sqrt{\text{MPa}}$ ) was obtained. Such a  $\gamma$  value is very close to that recommended by the ACI 352R-02 for use in the design of new corner joints that have members required to dissipate energy through reversals of deformation into the inelastic range (i.e. Type 2 joints:  $\gamma=12 \sqrt{\text{psi}}$  [ $1.00 \sqrt{\text{MPa}}$ ]).

Figure 9 — Joint shear stress-strain hysteresis loops: (a) EW, and (b) NS.
