REPAIR OF CRACKED ALUMINUM OVERHEAD SIGN STRUCTURES WITH GFRP COMPOSITES

By Chris P. Pantelides¹ and Justin Nadauld²

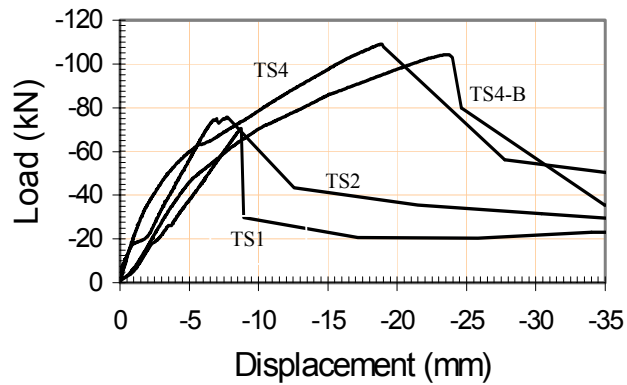
details of the field specimens. The four new specimens were constructed by tack welding the diagonals in four spots to the main chord to hold them in place so that the GFRP composite could be applied. These specimens simulated the case when the weld would have been severed completely and the diagonals and chord would be completely separate members. For the first two specimens, TS1 and TS2, the wrap extended up the diagonals 305mm (12 in.) from the center of the chord; for TS4 and TS4-B the wrap extended 457mm (18 in.) from the center of the chord. Specimens TS1 and TS2 failed at a lower tensile load than TS4 and TS4-B as shown in Fig. 5. It is obvious from Fig. 5, that the specimens with the longer GFRP composite bond length performed better and resisted a load 1.46 times higher than the specimens with the shorter bond length. This suggests that the bond-dependent tensile capacity of the connection is proportional to the bond length. In addition, the maximum strain in the GFRP composite was increased by a factor of 2.0 in the chord (position #1 in Fig. 4), and in the diagonal (position # 2 in Fig. 4) for the specimens with the longer bond length. The displacement at peak load was increased by a factor of 2.6, which is desirable for giving warning of impending collapse.

Fig. 5. Load vs. displacement: new fabricated specimens wrapped with GFRP composite

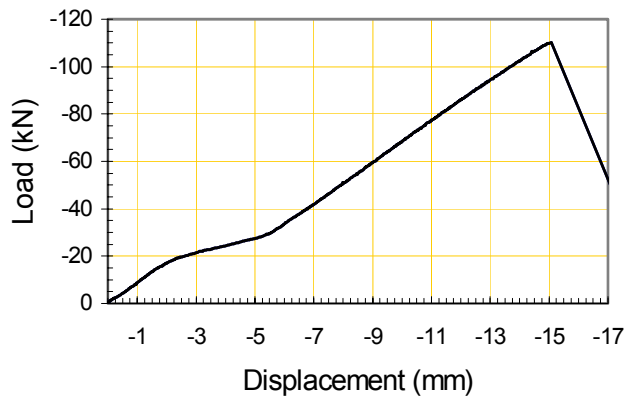
Specimen TS3 was tested as-is to determine the actual tensile capacity of the welded aluminum connection obtained from the field. This tensile capacity was then compared to the allowable stress for welded tubular members. The experiment showed that specimen TS3 had a maximum tensile capacity of 110 kN (24.74 kip) at a displacement of 15mm (0.59 in.), as shown in Fig. 6. This corresponds to a tensile failure stress of 96.6 MPa (14 ksi), which is 1.16 times the allowable stress for welded tubes according to the *Aluminum Association Specifications* (1986).

The failure of the as-is welded specimen from the field (Specimen TS3) was a typical weld failure as can be seen in Figs. 6 and 8. As Fig. 6 shows, deterioration of the weld started approximately at a displacement of 2mm (0.08 in.); after a displacement of 5.6mm (0.22 in.) the load displacement curve became linear showing gradual degradation of the welded connection. The maximum strain measured at position #2 on the diagonal (Fig. 4) reached 0.19%, which is just under the offset strain of 0.2% corresponding to the expected minimum value of yield strength across a butt weld (ASCE Task Committee on Lightweight Alloys 1962).

Fig. 6. Load vs. displacement for welded connection without visible crack – specimen TS3

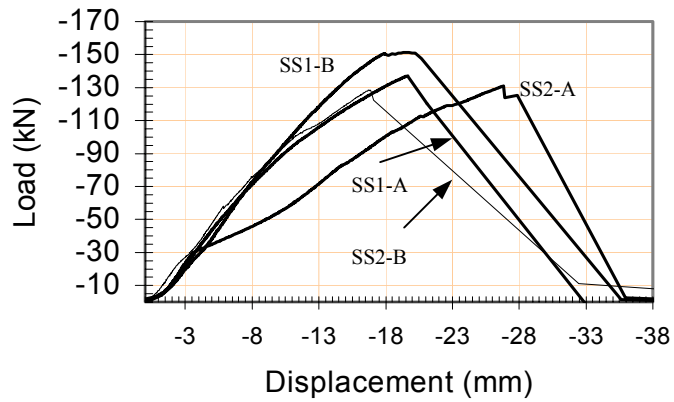
Specimen SS1-B was the only specimen repaired with GFRP composite without any visible crack in the weld. This test had the highest tensile load of all tests, which was measured as 151 kN (33.93 kip) as shown in Fig. 7. This tensile load corresponds to a tensile failure stress of 132.4 MPa (19.2 ksi), which is 1.60 times the allowable stress for welded tubes according to the *Aluminum Association Specifications* (1986). It is evident from the strain gage data that the weld failed completely at a vertical displacement of 18 mm (0.708 in), as shown in Fig. 8. The strain in the GFRP composite at position #1 (Fig. 4), temporarily decreased after weld failure but subsequently it increased at the GFRP composite tensile failure point; compared to the previous peak at weld failure, the strain in the GFRP increased by a factor of 1.57. At that point, the GFRP composite carried the entire load until it failed in tension at a load of 151 kN (33.93 kip) and a vertical displacement of 20 mm (0.785 in) as shown in Fig. 7.

composite. Specimen SS1-A had a crack that was 140 mm (5.5 in.) long which corresponds to 52% of the total weld length; specimen SS2-A had a 64 mm (2.5 in.) long crack corresponding to 24% of the total weld length; and specimen SS2-B had a 178 mm (7.0 in.) long crack corresponding to 66% of the total weld length, as shown Fig. 1. The GFRP composite repair design details were the same for all repaired specimens as outlined in the section on GFRP composite application. It is interesting to note from the results, shown in Fig. 7, that all three repaired specimens (SS1A, SS2A, and SS2B) failed at similar loads regardless of the crack length. This demonstrates the effectiveness of the GFRP composite repair regardless of the crack length. The failure mode was similar to that of specimen SS1-B, which involved complete weld failure followed by tensile failure of the GFRP composite; as the weld began to fail, the GFRP composite took over and carried the load until the GFRP failed in tension. As in test SS1-B, before the weld completely failed, both the weld and the GFRP composite were carrying the load. This explains why the cracked welds failed at similar loads – even though the original crack lengths in the weld differ significantly. However, from Fig. 7 it can be observed that the specimen with the largest crack in the weld (SS2B) failed at the smallest applied displacement (16.9mm or 0.664 in.), and the specimen with the smallest crack (SS2A) failed at the largest vertical displacement (26.8mm or 1.055 in.).

Fig. 7. Load vs. displacement: tests SS1-A, SS1-B, and SS2-B
