Strengthening of Coolidge High School Gymnasium

Project Name & Location: Retrofit of Roundhouse Gymnasium
Coolidge High School
Coolidge, AZ

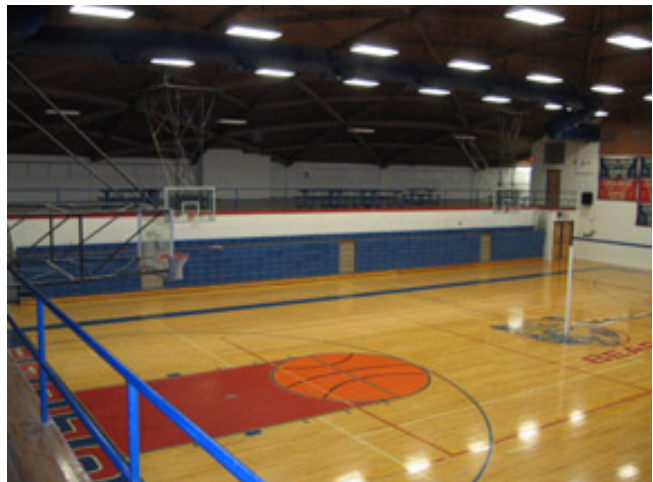
The mezzanine floor above the locker rooms (far side) awaits installation of bleachers

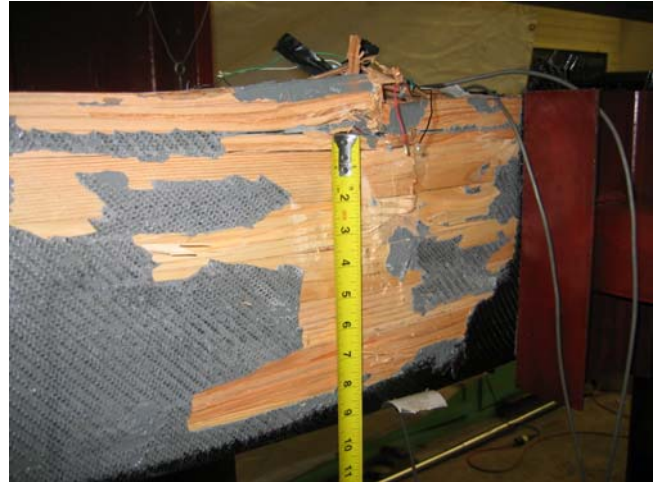
At the conclusion of the test, the carbon fabric was removed to reveal the extent of damage even though the beam was supporting such high loads
