CARBON FRP REPAIR OF UNDERWATER BRIDGE PIERS

Name: Bay View Bridge

Type: Bridge Structure

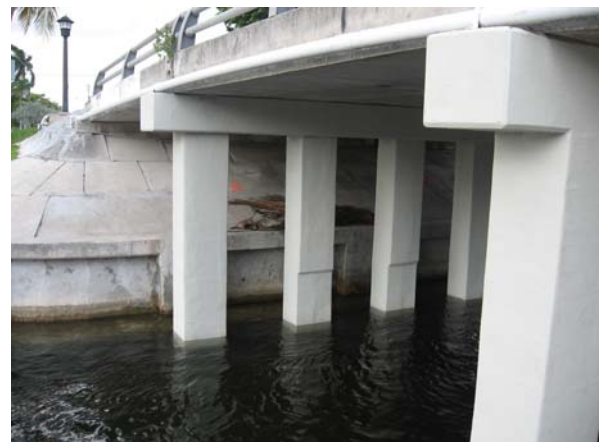
While QuakeWrap was repairing a seawall nearby, this bridge was visited on April 8, 2012. The condition of bridge **after five years in service** is shown here.

There is marine and algae growth in the submerged portion of the bridge and some of the paint has come loose. The same condition can be seen on the adjacent concrete wing walls. However, no damaged to the FRP was observed. The paint in the dry portion of the piles looked in excellent condition.
