CARBON FRP REPAIR OF UNDERWATER BRIDGE PIERS

Name: Bay View Bridge

Type: Bridge Structure

Completed: June, 2007

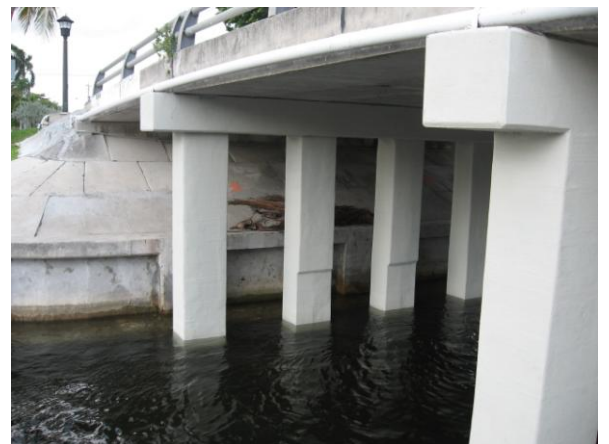
While QuakeWrap was repairing a seawall nearby, this bridge was visited on April 8, 2012. The condition of bridge **after five years in service** is shown here.

There is marine and algae growth in the submerged portion of the bridge and some of the paint has come loose. The same condition can be seen on the adjacent concrete wing walls. However, no damaged to the FRP was observed. The paint in the dry portion of the piles looked in excellent condition.
