FRP REPAIR OF CORRODED PEDESTALS OF A COOLING TOWER

Name: Tucson Main Library
Type: Office Building
Location: Tucson, Arizona
Completed: June 2005

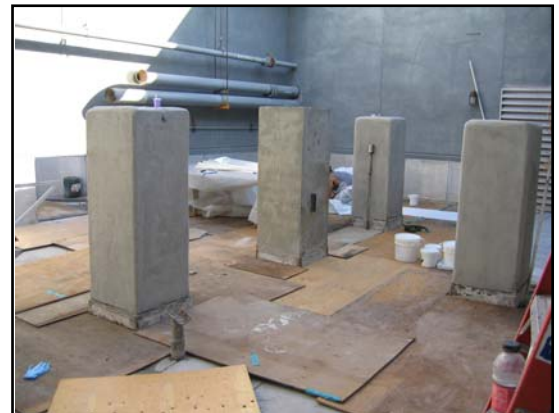
At the time the above project was completed, we offered a two-year warranty on the repairs. Nearly **7 years later**, the above site was visited and the repaired pedestals were inspected. As can be seen in the following pictures taken on 3/7/2012, the pedestals are in perfect condition.
