# **FRP Repair Methods for Unreinforced Masonry Buildings Subject to Cyclic Loading**

**by P.B. Foster, J. Gergely, D.T. Young,  
W.M. McGinley, and A. Corzo**

**Synopsis:** Unreinforced masonry building specimens were evaluated under cyclic lateral loading. Various fiber reinforced polymer (FRP) composite configurations were used to repair and retrofit the masonry structures. In the first phase, three different composite systems were used to repair pre-damaged masonry structures. These systems included: a wet lay-up woven glass fabric; a near surface mounted (NSM) extruded carbon FRP plate; and a glass FRP grid attached via a high elongation polyurea resin. Retesting of the repaired structures revealed increases as much as 700% in terms of energy dissipation and 300% in terms of pseudo-ductility. The second phase involved retrofitting similar undamaged building specimens with FRP composites. Significant increases in strength, ductility and energy dissipation were observed. The seismic performance of each structure was increased with the addition of a minimal amount of composite material as compared to the unreinforced structures.

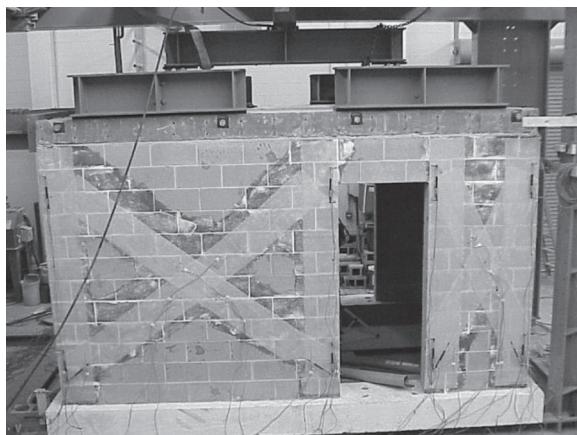
Figure 4 – GFRP composite layout for the repaired symmetric CMU structure.

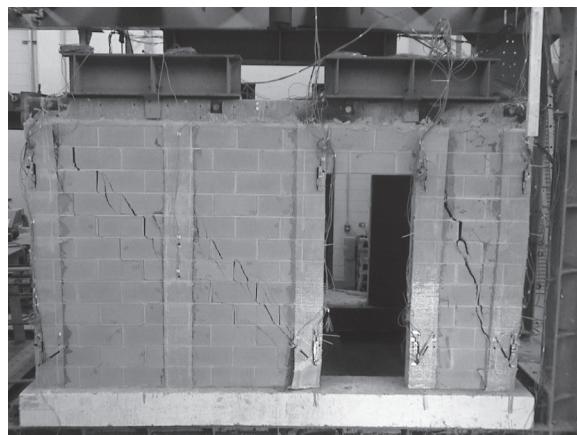
Figure 5 – Damage sustained during experimental load testing of the symmetric retrofitted CMU structure.

The retrofitted CMU structure shown in Figure 5 performed well under the cyclic lateral load. The structure resisted approximately 35% more load than the URM baseline building, with a maximum applied load of 547 kN (123 kips). The displacement accompanying that load level was 12.2 mm (0.48") in push. Surprisingly, the stiffness of the structure did not significantly degrade until the lateral load reached a level of 400 kN (90 kips). The mode of failure observed was diagonal tension cracking in all piers .

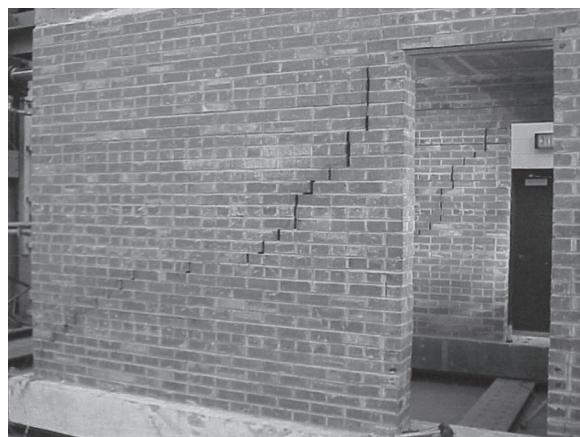
Figure 7 – Damaged incurred during experimental testing of the symmetric unreinforced brick structure.

The baseline brick building depicted a well-balanced behavior between the push and pull cycles. Also, the linear portion of the curve was seen until a lateral load level of 222 kN (50 Kips). At the peak failure load, the damage to the masonry system was nearly catastrophic (see Figure 7). The large piers exhibited massive diagonal tension cracks as well as bed joint sliding in several locations. The entire front half of the structure moved away from the remaining portions, leaving the structure in two pieces. As a result, the lateral stiffness of the structure was near zero, although the gravity load was maintained at failure.
