GALVANIC CORROSION OF CARBON AND STEEL IN AGGRESSIVE ENVIRONMENTS

By Mohammadreza Tavakkolizadeh,¹ Student Member, ASCE,
and Hamid Saadatmanesh,² Member, ASCE

ABSTRACT: The demand for the use of carbon-fiber-reinforced plastics (CFRP) in rehabilitation of deteriorating infrastructure is increasing worldwide. The design characteristics of reinforced concrete or steel members can be enhanced significantly by epoxy bonding CFRP laminates to the critically stressed tension areas. There is, however, a concern regarding possible galvanic corrosion when carbon and steel are bonded together. This paper presents the result of a study on the galvanic corrosion between CFRP laminates and steel. A total of 38 specimens made of steel and carbon fibers were prepared and tested. Two simulated aggressive environments and three different amounts of epoxy coating were used in addition to samples with no coating at all. Furthermore, the effect of the sizing agent on the galvanic corrosion rate was investigated, and three different solvents were used to remove the sizing agents from the surface of the carbon fibers. Potentiodynamic polarization and galvanic corrosion tests were conducted. The result

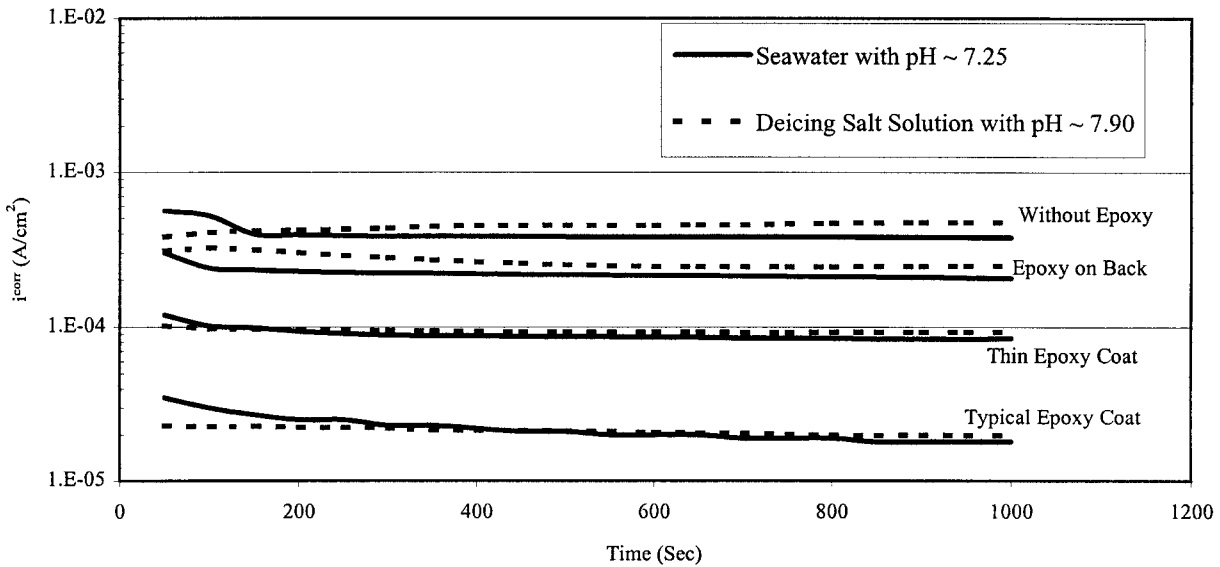
FIG. 15. Galvanic Coupling Results of Composite Made with Original Carbon Fibers and Steel in Seawater and Deicing Salt Solution

Considering the results shown in Fig. 15, the effect of the epoxy coating on the carbon specimens was very pronounced. When the thickness of the epoxy increased, the corrosion rate for steel decreased. In seawater, a decrease in corrosion rate from 3.77×10^{-4} A/cm² for the bare fibers to 1.8×10^{-5} A/cm² for the coated fibers with an average coating thickness of 0.25 mm, as commonly used in practice, was observed. Even for a thin film of the epoxy coating with average thickness of 0.1 mm, the corrosion rate decreased to 8.5×10^{-5} A/cm². In the deicing salt solution, a decrease in corrosion rate from 4.69×10^{-4} A/cm² for the bare fibers to 2.0×10^{-5} A/cm² and 9.3×10^{-5} A/cm² was observed for the fibers with an average coating thickness of 0.25 and 0.1 mm, respectively.

As shown in Fig. 15, the corrosion current densities are fairly similar in both deicing salt solution and seawater. The deicing salt solution exhibited a slightly higher rate of corrosion, especially for carbon fibers without epoxy coating or with a thin layer of epoxy on the backside only. The values of the galvanic corrosion rates for the specimens with the thin film of epoxy coating confirmed the results of the polarization tests shown in Figs. 13 and 14. Table 3 presents a summary of these results.
