# Out-of-Plane Behavior of Brick Masonry Walls Strengthened with Fiber Composites

Juan I. Velazquez-Dimas, Mohammad R. Ehsani, and Hamid Saadatmanesh

*ACI Structural Journal*, V. 97, No. 3, May-June 2000.

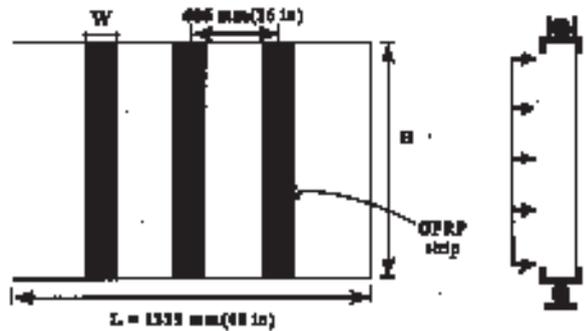
Fig. 1 Overall view of the test specimen.

The first course of bricks for the four walls was laid in a machined steel channel that formed part of the support during the test. As can be observed in Fig. 1, all walls were simply supported at the top and bottom, and the other two sides remained free. With these boundary conditions, it was intended to simulate the portion of the masonry walls found in low-rise buildings free of corner and wall-to-wall joint interference.

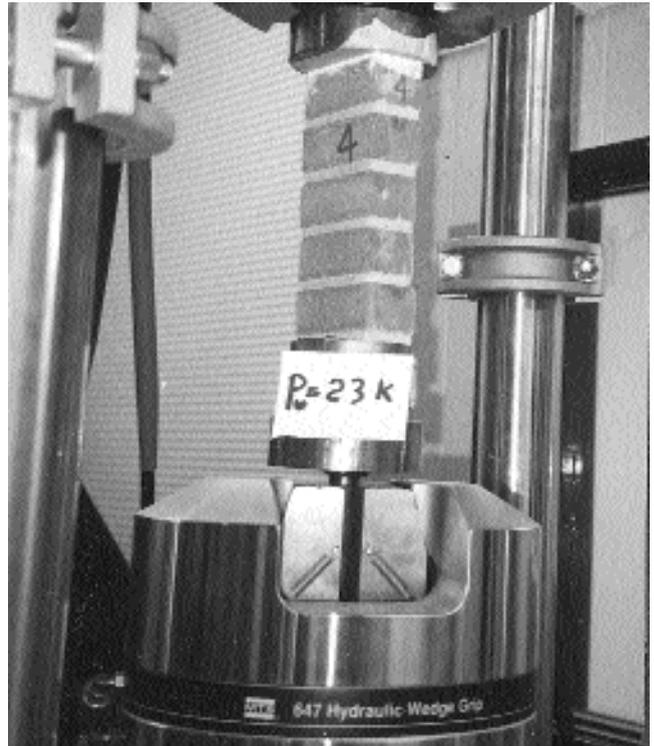
Fig. 2 Test of brick prisms for determination of compression capacity of brickwork.

the bricks. From prisms constructed with five bricks, the compressive capacity of the brick-mortar assemblage was determined. Figure 2 shows a typical test specimen. The modulus of rupture for brickwork was also determined from brick beams constructed with 10 bricks. The last properties were determined at 28 days and at testing time, as shown in Table 2. The density for brick-mortar assemblages was determined from coupons for modulus of rupture. From mortar cubes of 50 x 50 x 50 mm (2 x 2 x 2 in.), the mortar compression capacity was also obtained at 28 days and at testing time for all specimens. A sieve analysis was carried out for the sand used in the mortar. Using sand from river passing mesh No. 8, a 1/4 in. mortar bed joint was used to match the half-scale bricks used in this investigation. A unidirectional glass fabric weighing 18 oz per yd<sup>2</sup> was used for retrofitting all the walls. The tensile strength of the composite fabric was obtained according to ASTM D-3039 to be 369 N/mm (2106 lb/in.) width based on the average of six coupons.

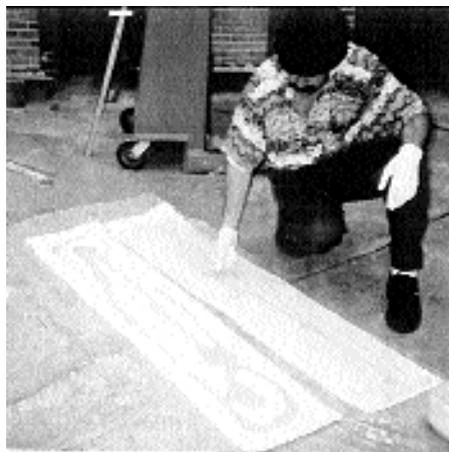
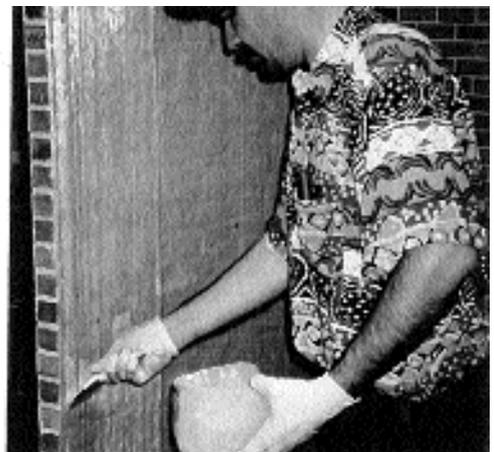
Fig. 3 Steps in retrofit procedure: (a) spreading the epoxy over the fabric; (b) bonding the fabric to the wall.

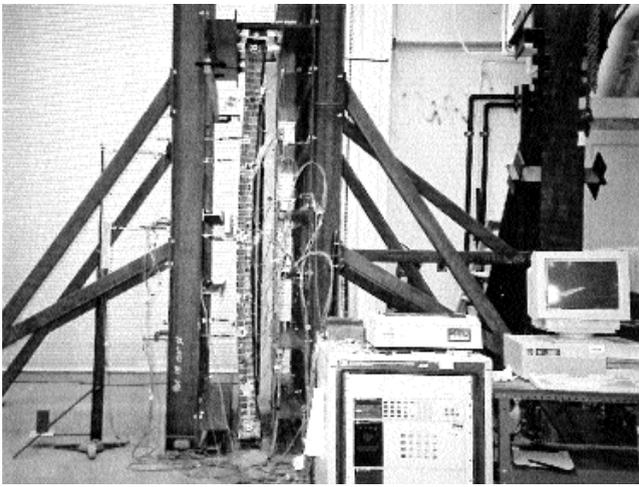
Fig. 4 Test setup.

The four walls were tested in a steel reaction frame. The specimens were simply supported along the top and the bottom edges, and the two vertical sides were free. With these boundary conditions, it was intended to reproduce a portion of the wall free of corner and joint interference. A roller condition was provided at the top, i.e., vertical displacements and rotations were allowed. The specimens were subjected to cyclic out-of-plane loading. The lateral pressure was applied through an airbag system that was moved from one face of the wall to the other; more details about the test setup are presented elsewhere (Velazquez-Dimas 1998). The load was applied to the walls in two stages: a load-controlled stage, which consisted of two pairs of cycles to observe the uncracked behavior; and a displacement-controlled stage,

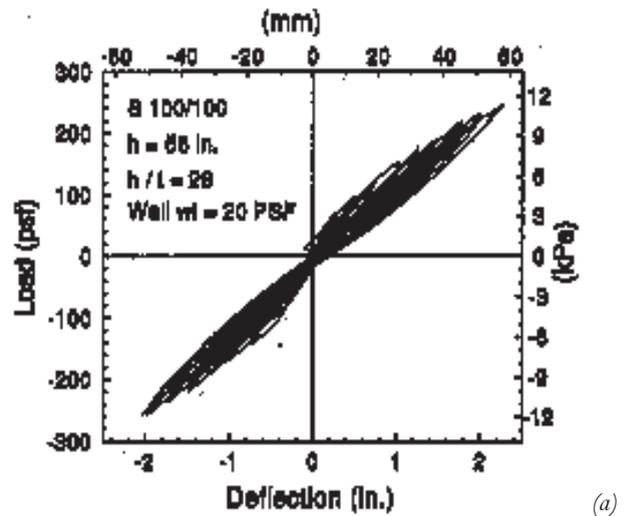
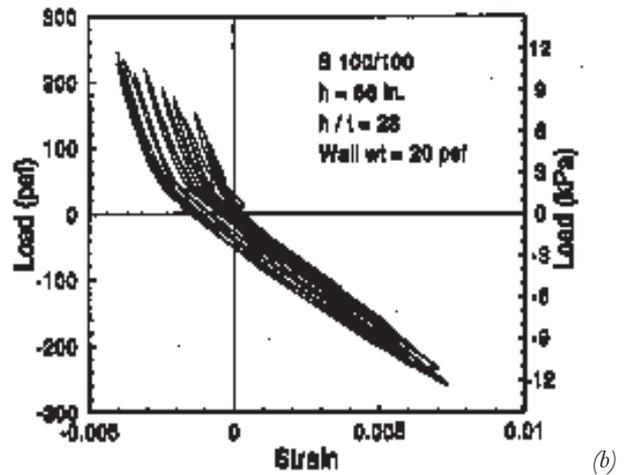
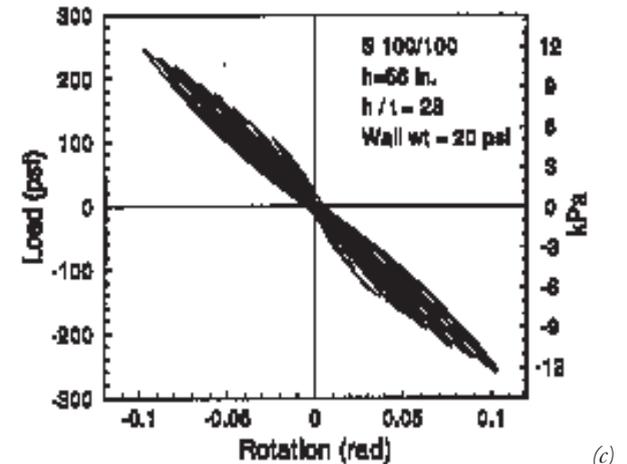
Fig. 5 Typical measurements for Specimen S 100/100: (a) load versus deflection at mid-height; (b) load vs. the longitudinal strain in the composite strip; and (c) load versus rotation at the top support.

Delamination is another factor that produces loss of stiffness. The first delaminated areas were observed on the north face during the fourteenth cycle at an applied pressure of 7.6 kPa (158 psf), and a deflection of 25 mm (1.0 in.). These delaminated areas were marked on the central composite strip above the middle brick course. Delaminated areas are often accompanied by sounds of the epoxy breaking away from the brick surface, and result in enlarged hysteretic loops. Similar behavior was observed for the south face as shown in Table 1, where close correlation is shown for both faces. In Fig. 5(a),

the first significant stiffness degradation seemed to be more influenced by the formation of large cracks along bed joints rather than the formation of the first delaminated areas. After these two major damages occurred, the additional cycles of loading resulted in further delamination of the fabric strips.

Rotations on the west and the east wall edges of the wall were also measured. From the recorded data, this wall rotated at the top and the bottom supports up to 6 degrees. This gave an indication of how the composite strips can transform a brittle wall into a flexible one. In Fig. 5(c), a typical load-versus-rotation curve is depicted for a clinometer attached to the top west corner. This curve also confirms the symmetry that was mentioned previously. In addition, measured rotations at midheight were almost zero, indicating that the pressure applied by the airbag system was symmetrical.

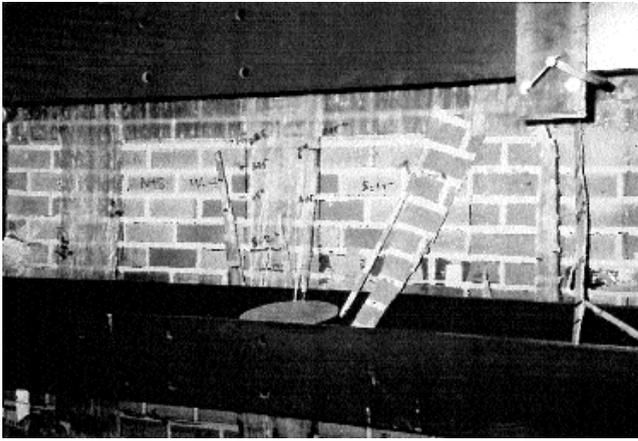
Fig. 6 Failure of the composite strips on the north face of Specimen S100/100.

Tensile failure occurred on all three north composite strips. Prior to the fracture of the north strips, cracking sounds indicated the imminent failure. While the central and the west strips failed above the middle brick course, the east strip broke at midheight. Although the balanced reinforcement ratio suggests simultaneous tension and compression failure of the wall, no compression failure of the brick was observed. This may be attributed to the uneven wall surface that would create local stress concentration points at the edges of each brick. Due to the failure on the north face, the composite strips of the south face did not fail. A vertical crack passing through the brick was detected underneath the central strip at failure. This indicated that the flexural capacity of the brickwork perpendicular to the bed joint was reached. Therefore, a minimum amount of horizontal reinforcement needs to be provided to avoid such failure.

nearly 13 times the weight of the wall, and the maximum deflection was almost 4% of the span. Figure 6 shows the failed north composite strips.

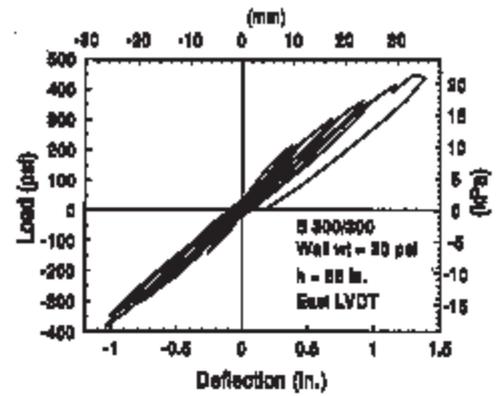
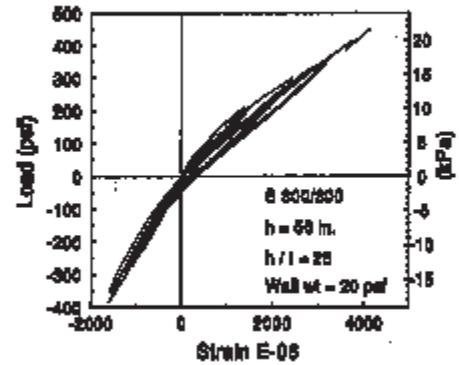
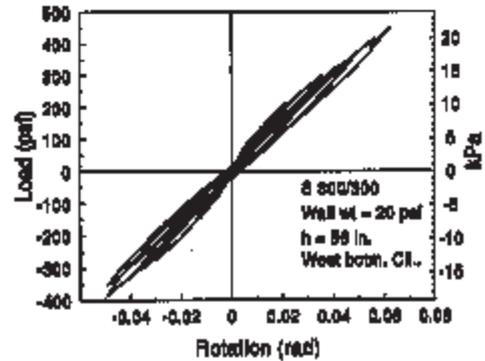
Fig. 7 Typical measurements for Specimen S300/300: (a) load versus deflection at midheight; (b) load versus the longitudinal strain in the composite strip; and (c) load versus rotation at the bottom support.

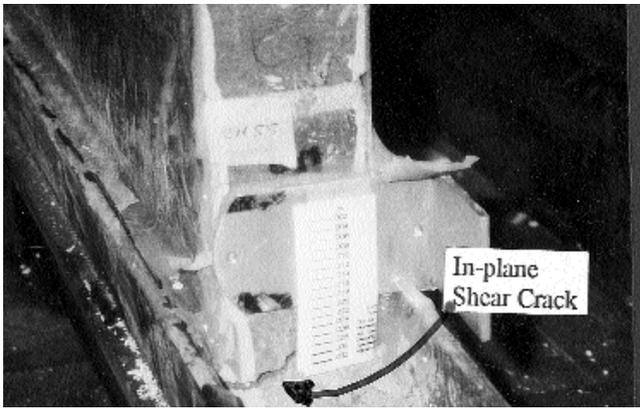
Fig. 8 Shear failure along the bottom brick course of Specimen S300/300.

The failure occurred during the thirteenth cycle while pushing from the north face at an applied pressure of 22.8 kPa (475 psf). This was characterized by formation of a fully longitudinal crack through the bottom brick course, indicating shear failure of the brick. In fact, as expected, due to the high reinforcement ratio, no tension failure of the composite strips or compression failure of the bricks occurred. This is evident by the maximum tensile strain in the composite reaching 0.4%. Since the applied shear stresses at the supports were approximately 344 kPa (50 psi), the shear capacity of the brickwork was exceeded according to the UBC and the ACI/ASCE/TMS specifications. Figure 8 shows the failure of the wall.

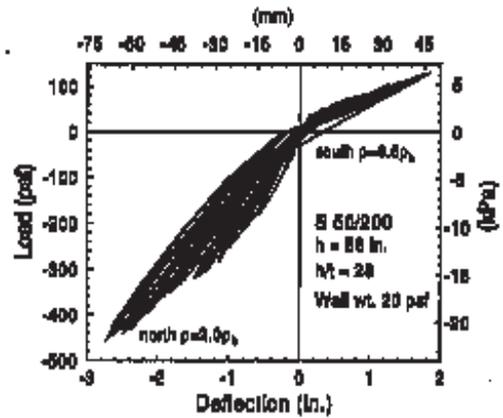
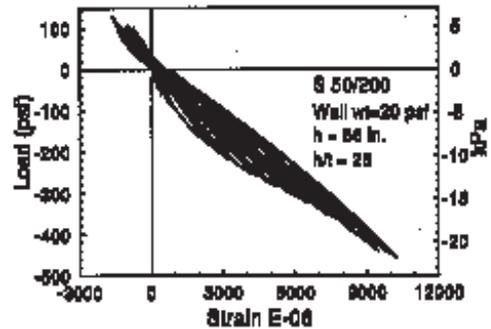
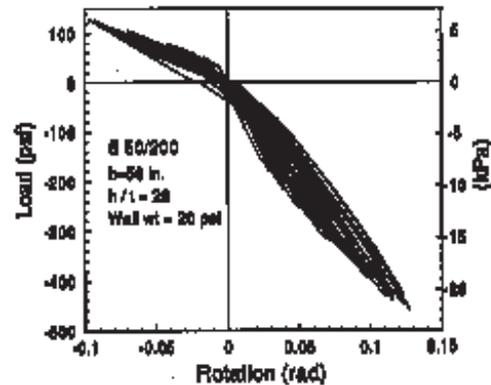
Fig. 9 Typical measurements for Specimen S 50/200: (a) load versus deflection at midheight; (b) load versus the longitudinal strain in the composite strip; and (c) load versus rotation at the top support.

Delaminated areas reached more than 75% of the area of the composite strips by the end of the test. Longitudinal strain in excess of 1.1% was measured on composite fabric on both wall faces. It is important to remark that the ratios of the applied pressure on both faces for the first major crack, first delamination, and the ultimate load were proportional to the reinforcement ratios. Figure 9 shows typical curves for all measured parameters. The general information is described in Table 3.

eters for the north face were 30 times the allowable deflection, or a span drift of 5% ( $l/20$ ). Figure 10 shows the failure of the north face and the delaminated pattern of the same face just before the failure. From the load-versus-deflection curve, it can be observed that the hysteretic loops for the north face were more enlarged. Thus, a better energy dissipating mechanism was developed on the north face.

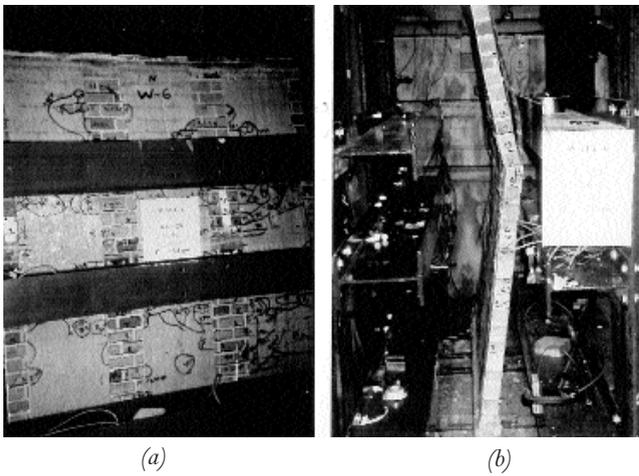
Fig. 10 Failure of the north face of Specimen S50/200: (a) delamination pattern prior to failure; (b) wall at failure.

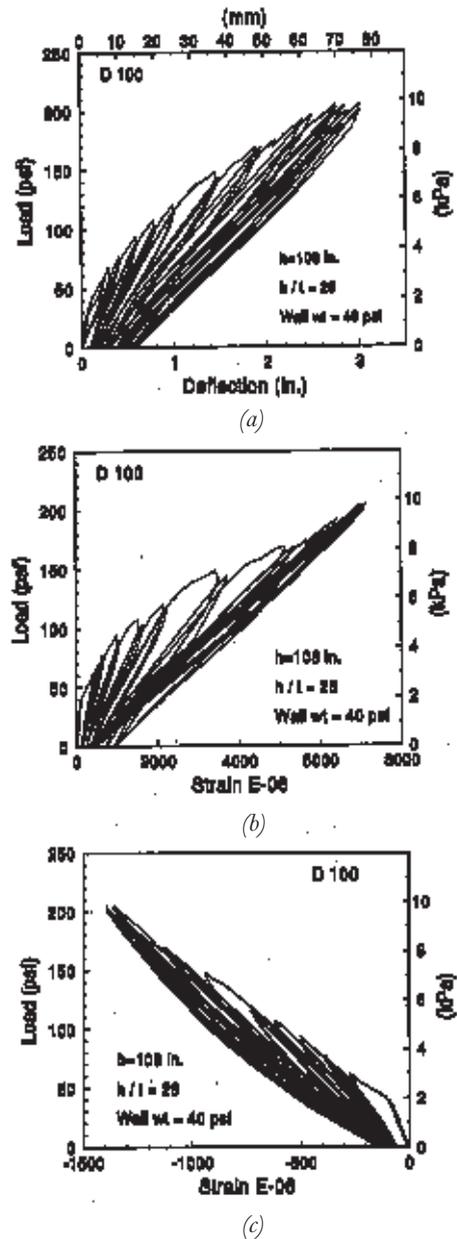
Fig. 11 Typical measurements for Specimen D100: (a) load versus deflection at mid-height; (b) load versus the longitudinal strain in the composite strip; and (c) load versus compressive strain in brick.

The lack of full composite action between the two wythes of this wall is attributed to two factors: a) the weak interface between the wythes due to the low area represented by headers; and b) because of the partially-filled gap between the wythes. Figure 11 shows typical curves for strain and deflections. The predicted behavior by beam theory was in agreement with experimental results for deflections up to 25 mm (1.0 in.); little agreement exists for points corresponding to higher deflection levels. This deflection level is close to the first major stiffness degradation due to early delamination.

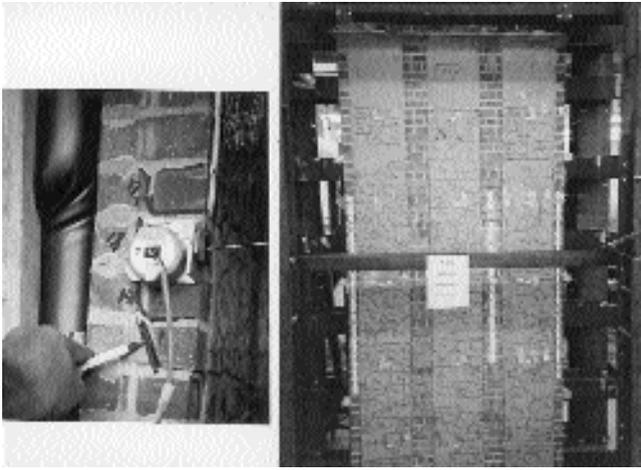
Fig. 12 Interface splitting failure and delamination pattern for Specimen D100.

In addition to bed-joint cracks and delamination areas, two failures were detected on the wall: splitting of the wythes and sliding of the north wythe along two bed-joint cracks. These two failures were detected in the lower part of the wall. No splitting failure was detected crossing the header courses. This is due to the high interface shear capacity of headers given by the bricks. A section of the wall between the headers, however, did split. This is attributed to the low shear capacity of the poorly grouted gap. The in-plane shear capacity of the headers was calculated from the compressive strength of the brick units according to ACI/ASCE/TMS specifications to be 552 kPa (80 psi). The theoretical shear stress at the point of

Two failure modes were detected on Wall D100. Excessive delamination took place on all composite strips, peeling off more than 80% of the areas by the end of the test. An interface shear failure, i.e., splitting of the wythes, also occurred at the lower half part along the east and the west sides. The latter was attributed to the low shear capacity of the poorly compacted mortar between the two wythes. According to the ACI/ASCE/TMS specifications and following the beam theory approach, the shear stresses caused by the applied pressure were in excess of the allowable values. No interface failure was detected along the header courses, however, since the shear capacity of the brick units was much higher than that caused by the applied pressure. The dissipated energy at different displacement levels for Walls S100/100 and D100 are compared in Fig. 13. In spite of their differences in terms of the number of wythes and the presence of a partial gap in Specimen D100, both of these specimens dissipated similar amounts of energy for displacements up to 50 mm (2.0 in.).

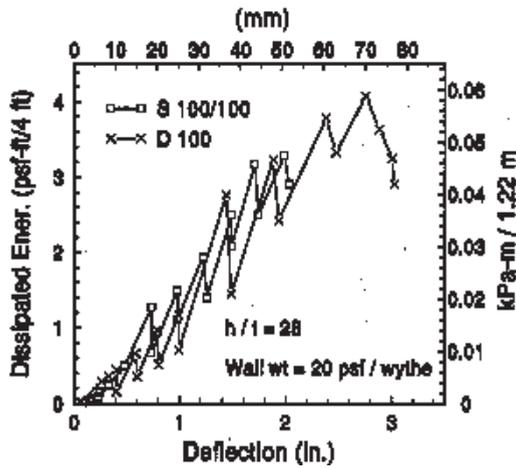
Fig. 13 Dissipated energy versus midheight deflection for Specimens S100/100 and D100.

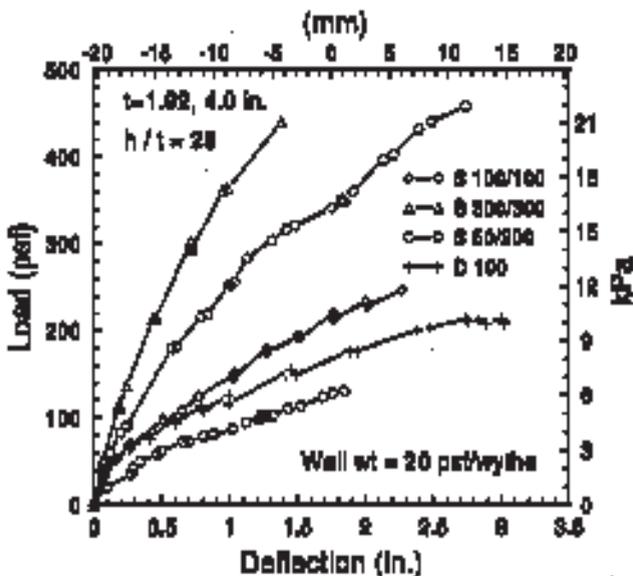
Fig. 14 Maximum load envelopes for all test specimens.

From Fig. 14, where the load-versus-deflection envelopes for all walls is presented, it can be observed that the maximum measured deflection did not depend too much on the amount of reinforcement. The maximum supported pressures, however, showed to be linearly dependent on the amount of reinforcement. The same trend was also observed for pressures at first visible crack, as well as for the first delaminated area. From Table 3, it can also be observed that the ultimate strain on composite strips was not dependent on the reinforcement ratio. Vertical cracks crossing the brick courses were detected on Walls S100/100 and S50/200. These failures occurred since the flexural capacity perpendicular to the bed-joint was reached. To avoid such failures in field applications, precautions must be taken by providing some reinforcement in the horizontal direction.
