PERFORMANCE OF EXTERIOR RC BEAM-COLUMN JOINTS UP-GRADED WITH CFRP COMPOSITES UNDER SEISMIC LOADING

Tarek H. ALMUSALLAM, Saleh H. ALSAYED, Yousef A. AL-SALLOUM and Nadeem A. SIDDIQUI
Department of Civil Engineering, King Saud University, P.O. Box 800, Riyadh 11421, Saudi Arabia

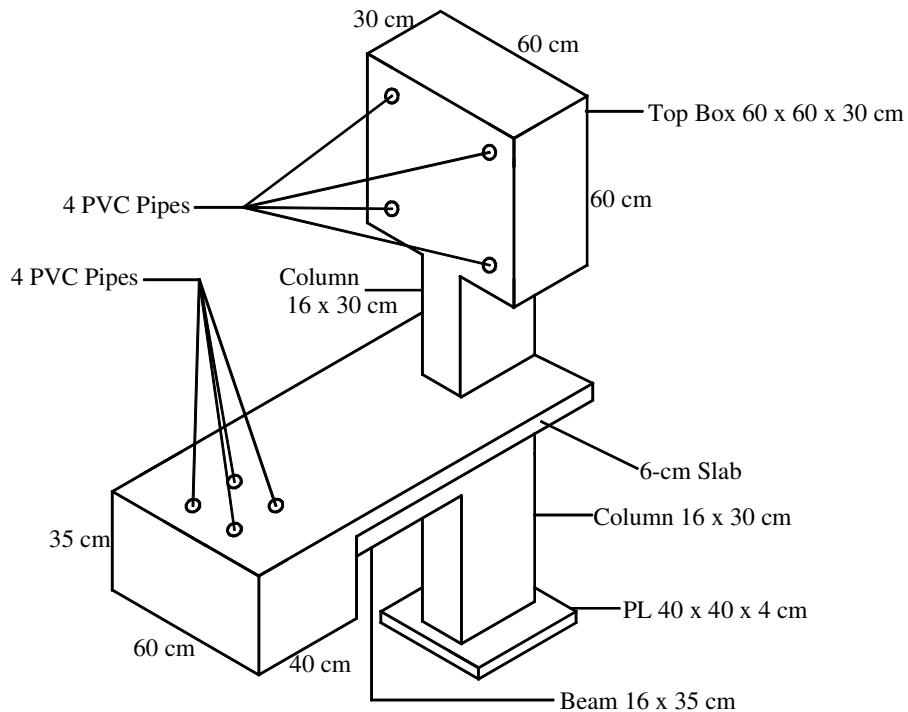
Fig. 1 Schematic diagram of exterior joint specimen.

Having decided the size of the test specimen, a reinforced concrete joint specimen was cast (Fig. 1). The specimen was then subjected to cyclic lateral load histories so as to provide the equivalent of severe earthquake damage. The damaged specimen was then repaired through injecting epoxy into the cracks and externally bonding the specimens with CFRP sheets, as shown in Fig. 2.

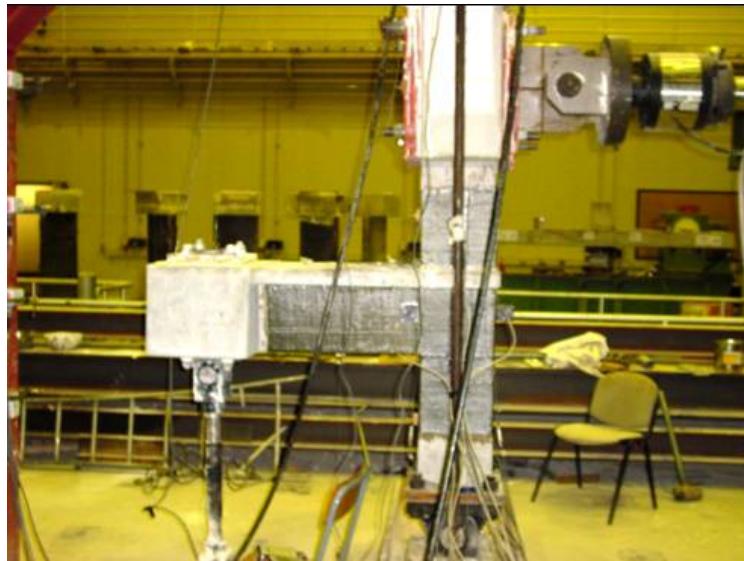
Fig. 2 Picture showing FRP repaired specimen.

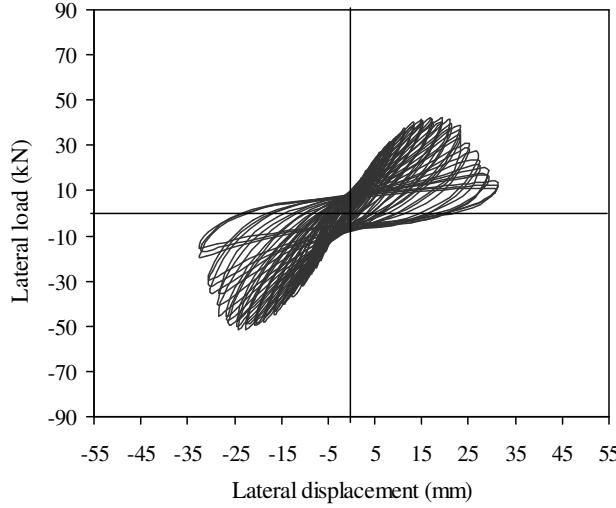
Fig. 3 Load-displacement hysteretic plot for control specimen.

The hysteretic behavior of exterior joints was examined in terms of shear strength (measured in terms of ultimate load) and deformation capacity. The load-displacement relationships for specimens before and after the repair are shown as hysteretic curves in Figs. 3 and 4. Fig. 3 shows that the ultimate load for repaired specimen is substantially higher than its corresponding original (before repair) specimen (Figs. 3 and 4). This is primarily due to the increased confinement of joint resulting from externally

bonded CFRP sheets. A further comparison of deformation capacity of repaired specimens with the original (i.e. before repair) specimen illustrates that the use of CFRP increases the deformation capacity of repaired specimens considerably.

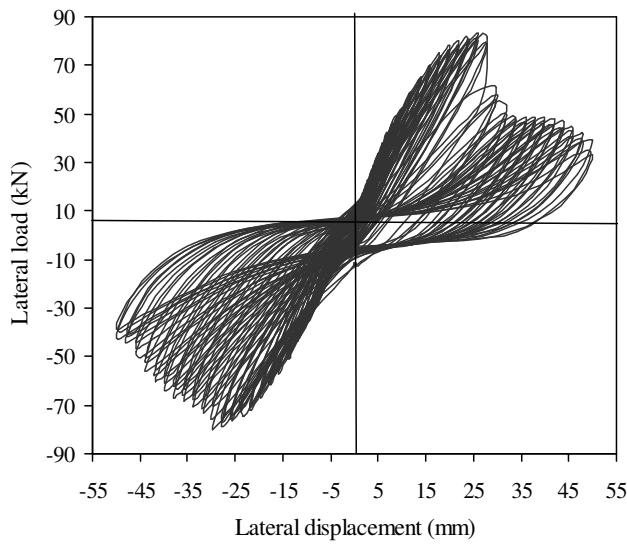
Fig. 4 Load-displacement hysteretic plot for CFRP upgraded specimen.
