# **REHABILITATION OF INFILLED NONDUCTILE CONCRETE FRAMES USING CARBON FIBER REINFORCED POLYMER**

*Ghassan Al-Chaar, USAERDC, Champaign, IL*

*Daniel P. Abrams, University of Illinois at Urbana-Champaign, IL*

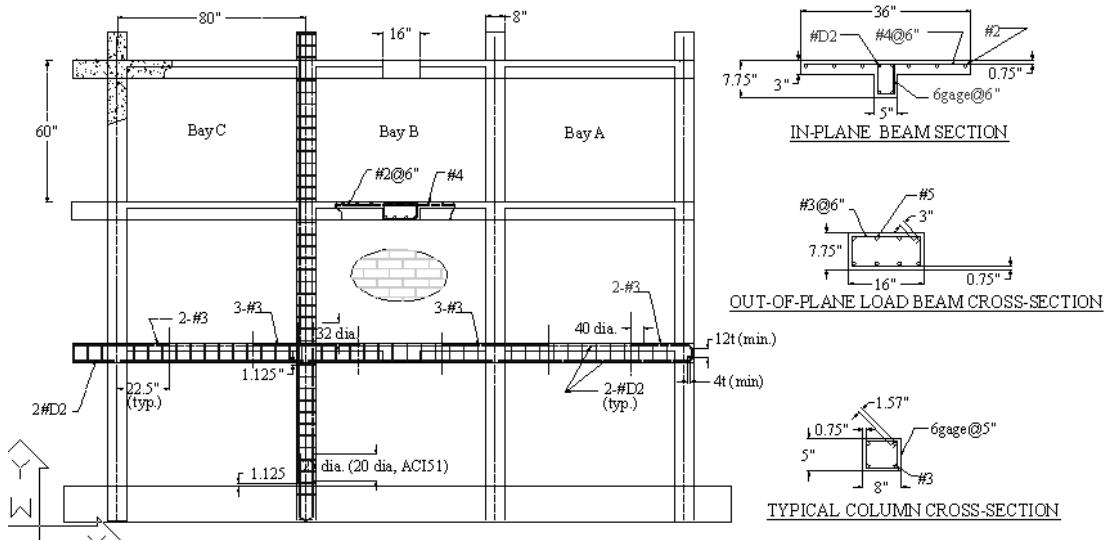
Figure 1. Half-Scale Experimental Model.

A half-scale three-story, three-bay reinforced concrete (R/C) frame infilled with concrete masonry units (CMU) was subjected to a cyclic loading protocol in order to better understand the structural behavior of this complex system (Al-Chaar 2001). The experimental model was constructed using design philosophies and corresponding code requirements of the 1950s. Therefore, the R/C frame lacked the seismic detailing required by modern building codes. Figure 1 illustrates the dimensions and reinforcement details used for the half-scale model in this experiment.

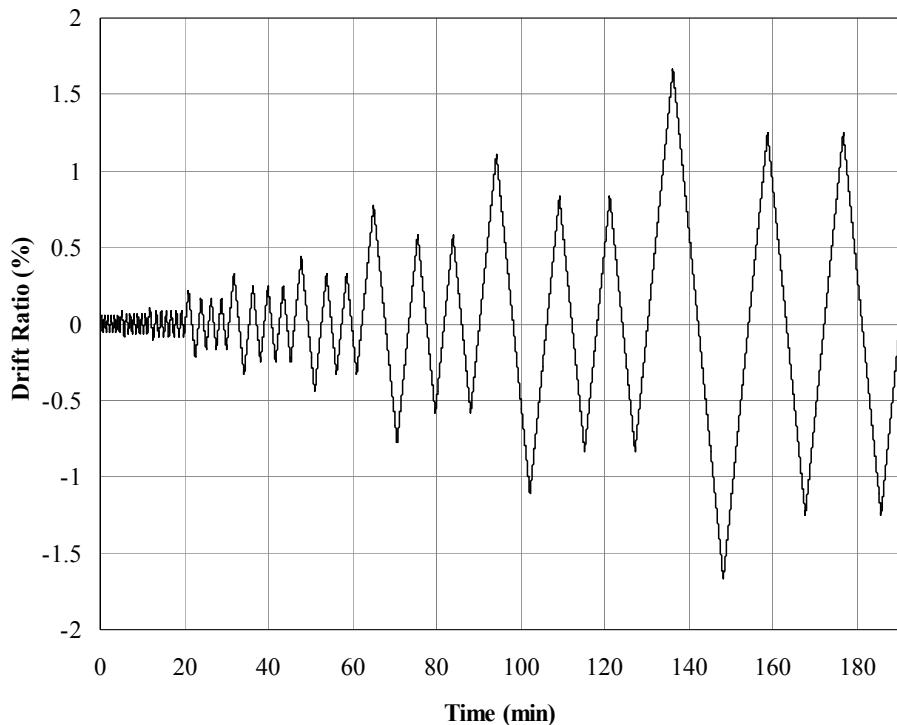
**Figure 2.** Cyclic Loading History.

Lateral loading on the third floor was based on a displacement-controlled cyclic loading protocol that represents demands from a hypothetical earthquake. The loading protocol is depicted in Figure 2. The lateral drift ratio refers to the third floor displacement over the entire height of the model. Lateral forces applied at the first and second floors were applied in force-control. These forces followed an inverted triangular distribution and were governed by the third floor lateral force.

After completing the loading protocol the test structure was repaired and rehabilitated to restore structural integrity, then subjected to another loading sequence according to the same pattern shown in Figure 2. The following discussion summarizes the rehabilitation methods applied and their success at restoring the structural properties of the system.

Once the test structure was rehabilitated, it was again subjected to the cyclic loading protocol shown in Figure 2. The load-deformation response of the rehabilitated structure was compared to the original structural response to determine the effectiveness of the rehabilitation. Story shear, drift ratio, and stiffness during relevant cycles were evaluated.

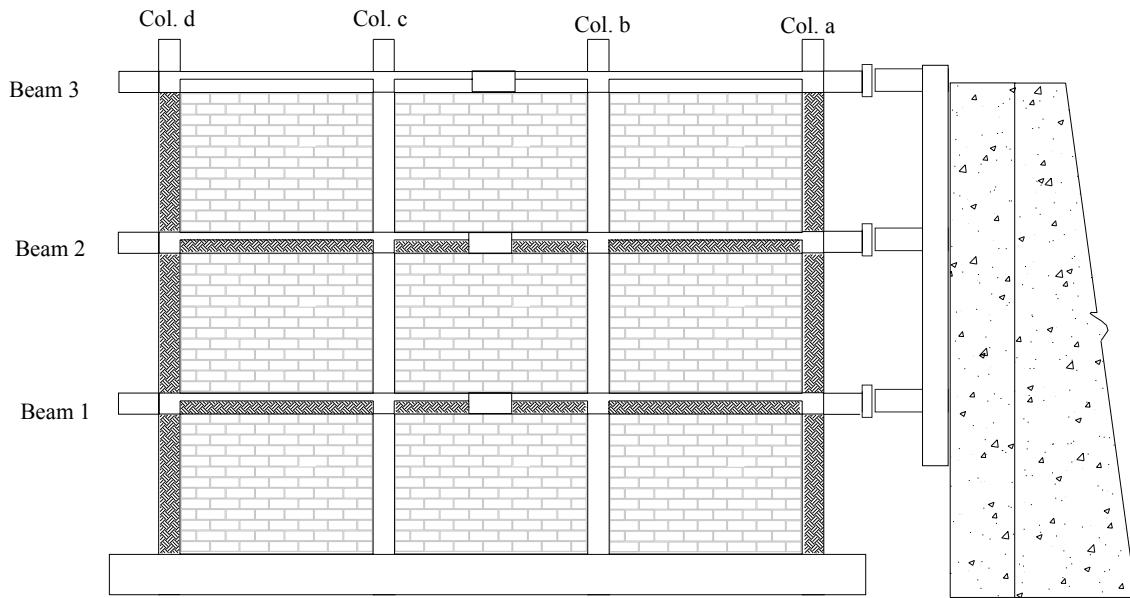
**Figure 3.** CFRP Placement.

CFRP composite with a fiber orientation of  $+45^\circ/-45^\circ$  was used to strengthen the reinforced concrete frame according to the layout illustrated in Figure 3. The rehabilitation design was intended to completely wrap the exterior columns of the first and second stories, strengthening them without increasing the stiffness of the model. However, the third story columns were only three-quarters wrapped, which would prevent third-floor failure that might occur during testing due to strengthening of the lower stories by the CFRP overlays. The beams, on the other hand, were only wrapped at the stems of the T-beams, and only at the first and second stories. The third story of the model did not sustain enough damage to warrant removal of the infill or further rehabilitation with CFRP.

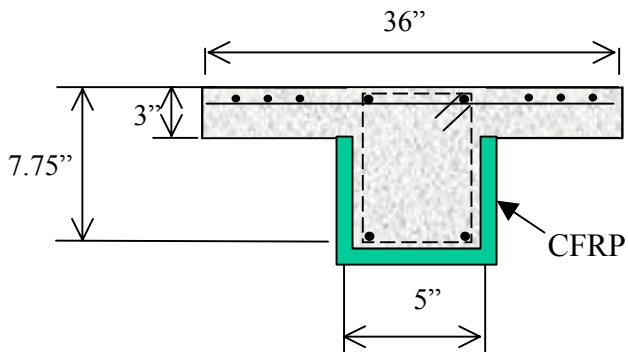
**Figure 4.** Dimensions and CFRP Placement of T-Beam Section

The goal of the CFRP rehabilitation was to regain the original moment capacities of the beams in the undamaged frame. A single ply of CFRP was applied to the stems of the damaged T-beams (see Figure 4). The CFRP was 0.0371 inches thick, with a tensile strength of 10.85 ksi and an initial modulus of elasticity of 1281 ksi. The moment capacities were calculated following ACI 440-00 Equation 9.2 except for including the contribution of the CFRP applied to the sides of the beam. The resulting moment capacities are tabulated in Table 1 for all three floors of the original and rehabilitated models.

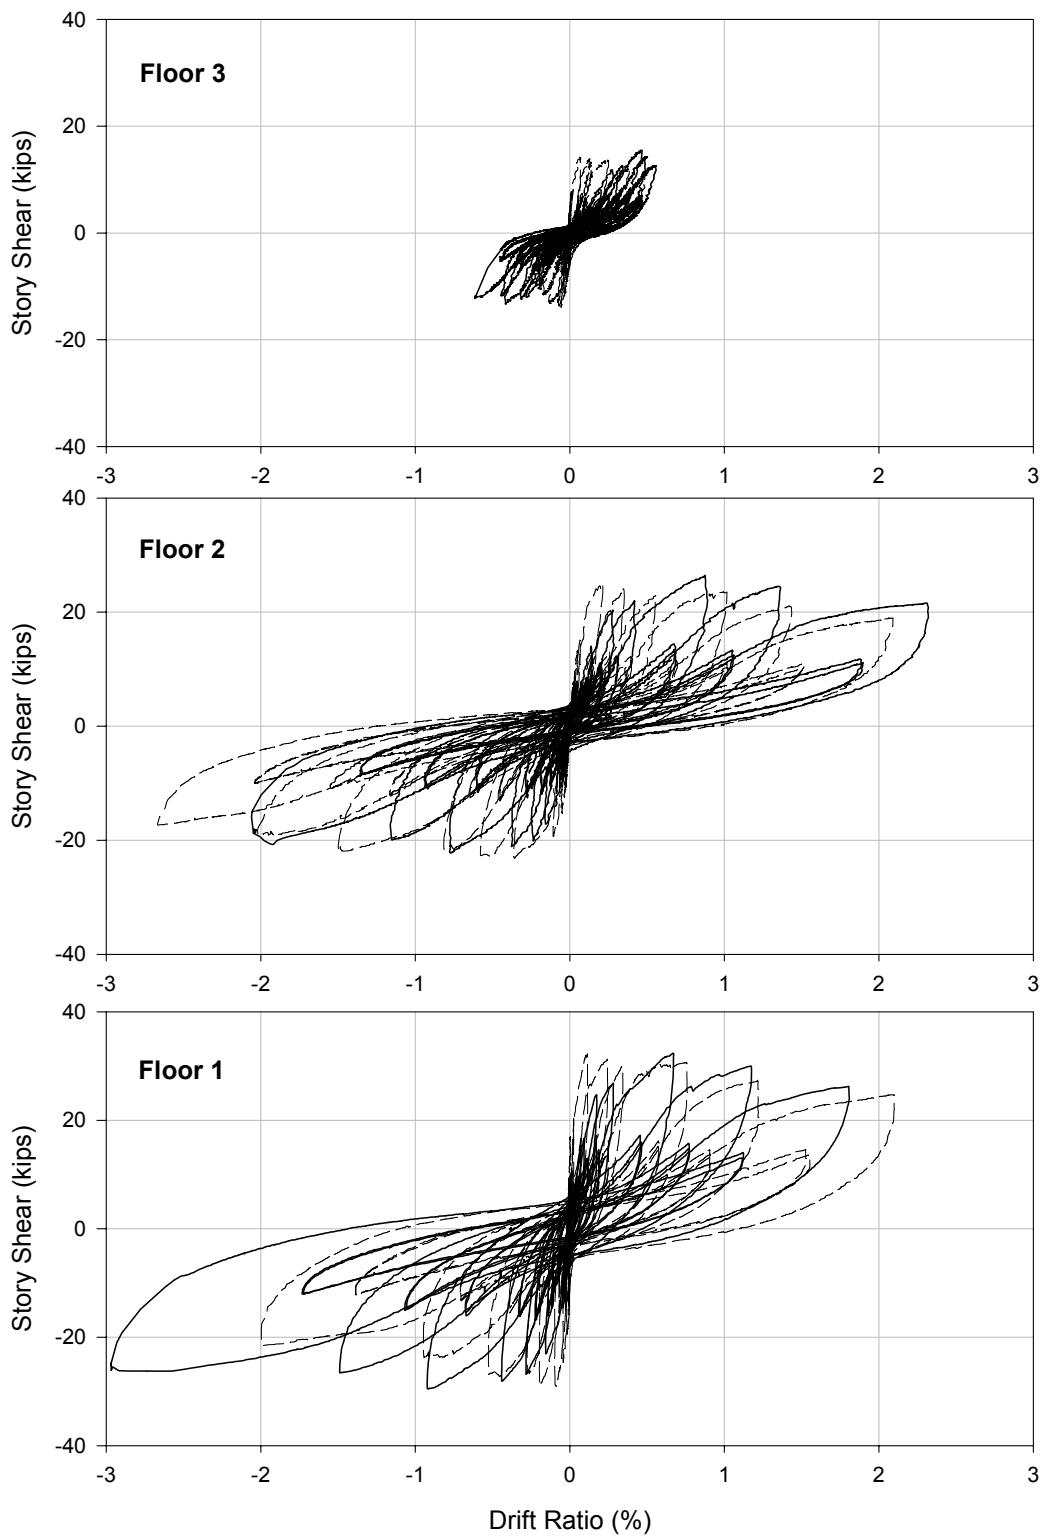
**Figure 5.** Load-Deformation Behavior for Each Story of the Original and Rehabilitated Test Structures.

The hysteretic behavior of the rehabilitated specimen is shown with the behavior of the original model in Figure 5. The solid black lines represent the load-deformation response of the rehabilitated model and the dashed gray lines illustrate the behavior of the original specimen. The peak lateral load for the rehabilitated model occurred during the 32<sup>nd</sup> cycle at a corresponding base shear of 32.39 kips in the positive stroke direction. In the negative stroke direction, a slightly smaller base shear of 29.53 kips was observed. These values were very slightly higher than the original test, where the peak values of base shear in each direction were 32.21 kips (positive) and

Also noticeable in Figure 5 is the relatively large first-story drift that occurred during the final negative, primary cycle of the rehabilitated model. This magnified first-story translation can be attributed to a sharp decline in lateral stiffness resulting from severe shear cracking near the top of Column 1c during the preceding positive stroke. Another observation from Figure 5 is that the drift ratio of the third story was much lower than the values observed in the first or second stories. This phenomenon occurred in both the original and rehabilitated models. The main cause of this behavior stemmed from the prescribed inverse triangular distribution of lateral forces and the resulting story shear distribution shown in Table 2. The shear on the first and second stories was roughly double the value applied to the third story. This story shear distribution caused the drift ratios for the first and second stories to be much greater than the third story. This behavior was amplified once the lower stories accumulated damage. The weakened first and second stories, therefore, captured most of the imposed displacement required of the third story.

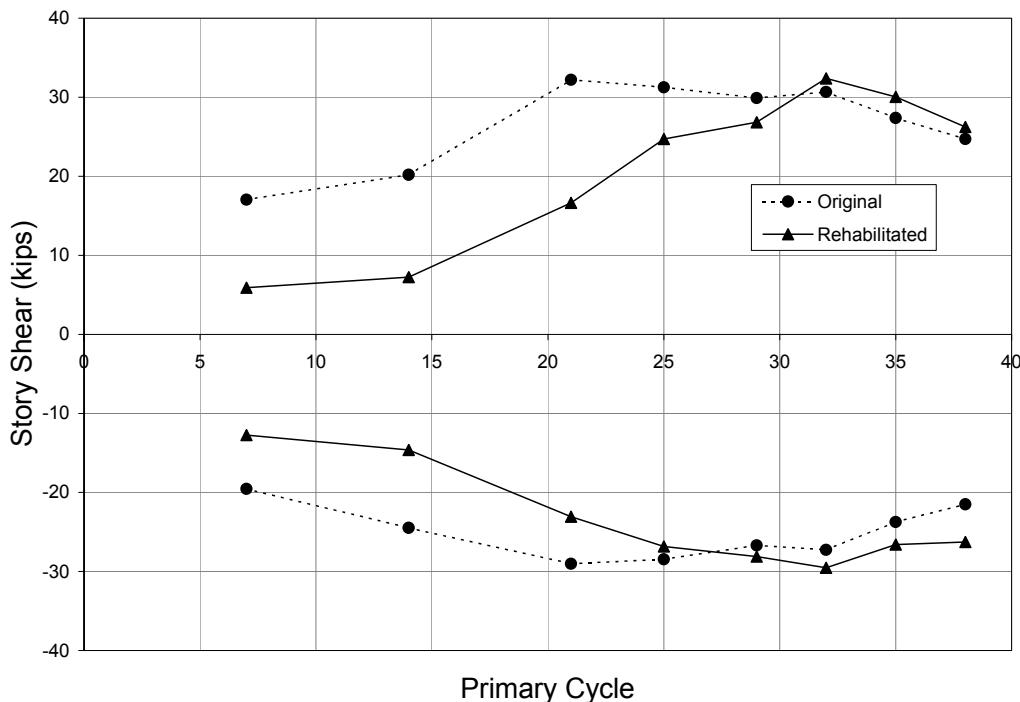
**Figure 6.** Base Shear During Each Primary Cycle for Both the Original and the Rehabilitated Test Structures.

The values of base shear during each primary cycle for both the original and the rehabilitated test structures are shown in Figure 6. This curve illustrates the fact that the original structure achieved peak load during the 21<sup>st</sup> cycle while the rehabilitated structure did not reach ultimate load until the 32<sup>nd</sup> cycle. Furthermore, the low initial stiffness is also evident by the fact that the values of base shear recorded for the primary cycles up to Cycle 29 for the rehabilitated model are lower than those values recorded for the original model. Another observation from Figure 6 is that during the last primary cycle (Cycle 38), the rehabilitated model has more residual strength left than the original model. This fact is directly related to the peak load occurring late in the loading history. Therefore, very few cycles were left to “erode” the value of peak load. Other than a loss of initial stiffness, the overall load-deflection behavior of both specimens was quite similar. For instance, the peak load in either direction was within 2% of the original value. Therefore, the FRP rehabilitation techniques were successful from a strength perspective.

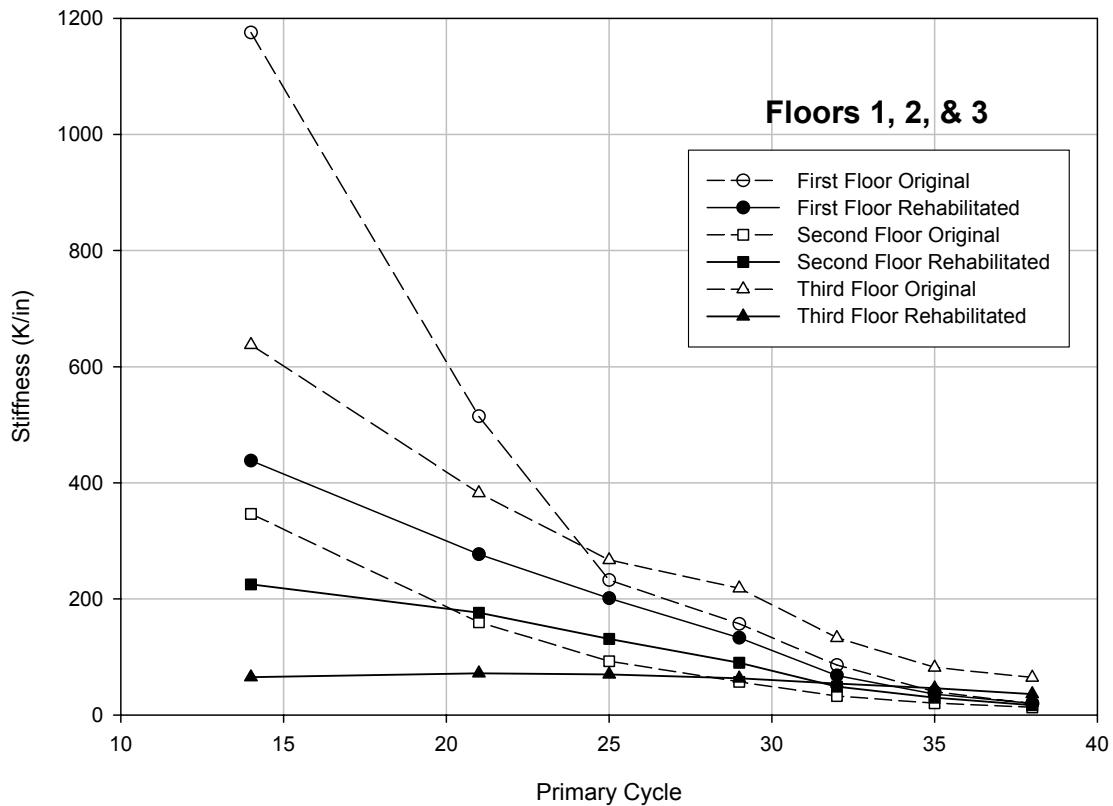
**Figure 7.** Stiffness of Each Floor During Primary Cycles for Both the Original and Rehabilitated Test Structures.

The small values of initial stiffness relative to the original test are illustrated by Figure 7 and provided in Table 3. In Figure 7, the stiffness of each story during primary cycles is shown for both the original and the rehabilitated structures. The first and second stories of the rehabilitated structure regained some of their initial stiffness, but not all of it. Recall that these two floors had concrete cracks sealed with epoxy, masonry infill replaced, exterior columns fully wrapped with CFRP, and the undersides of the beams wrapped with CFRP. Conversely, the third story regained almost none of its initial stiffness, which is consistent with the limited rehabilitative measures employed on that floor. (Remember that the only rehabilitation performed on the third floor was wrapping the exterior columns with CFRP on three sides.) The most important factor dictating the initial stiffness of the third story was the fact that the damaged CMU infill was left in place. The infill by far contributed the most to the in-plane stiffness of the frame. As the number of cycles increased and approached the final primary cycle, the

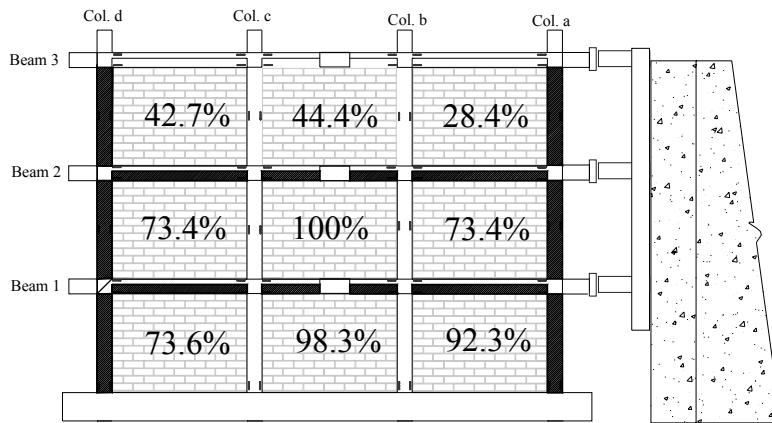
**Figure 8.** Panel Strain Distribution for the Rehabilitated Test Structures.

Panel strain distribution occurring during the positive stroke (i.e., toward the reaction structure) of Cycle 32 (peak load) is illustrated in Figure 8. Values of panel strain were normalized to the panel having the largest displacement during that cycle. The large strains in the first and second stories correspond to a significant increase in damage to the lower levels during this cycle. In addition, the strain in the first story, Bay A (see Figure 1), was much larger than the strain in Bay C. This difference can be attributed to the overturning moment from application of the loading protocol. The panel strain distribution was similar for both the original and rehabilitated structures.

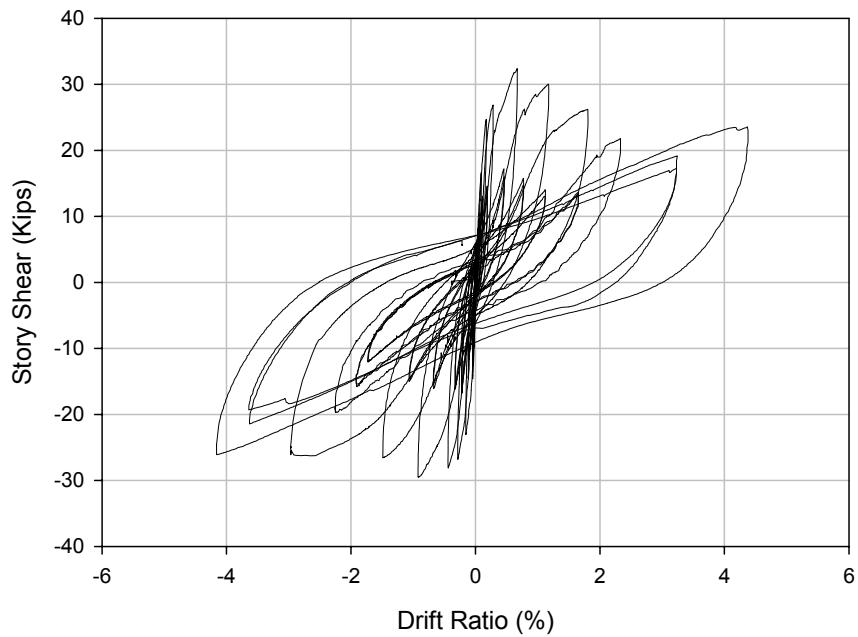
**Figure 9.** Cumulative Hysteretic Behavior of the First Floor.

A similar procedure was followed in order to maximize displacement demand on the first floor. During these cycles, a maximum drift ratio of approximately 4% was achieved along with a corresponding base shear of about 25 kips. A cumulative hysteresis curve containing all cycles is given for the first floor in Figure 9. Note the hysteresis loops were fairly open for the final three cycles indicating considerable inelastic behavior; significant damage to both the frame and the infill occurred during this time. After completing these three loading cycles, permanent inelastic deformation was evident in the first floor. Figure 10 shows the accumulated damage to the rehabilitated model after the completion of 32 loading cycles.

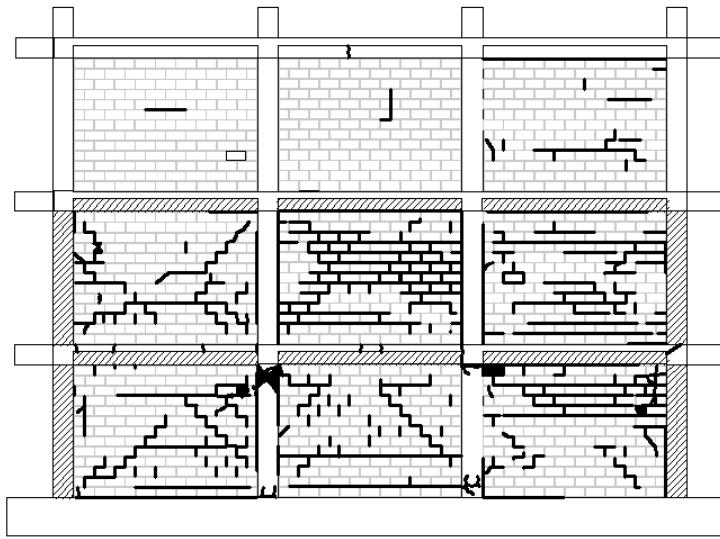
**Figure 10.** Damage Pattern Through 32 Loading Cycles on the Rehabilitated Model.
