REHABILITATION OF INFILLED NONDUCTILE CONCRETE FRAMES USING CARBON FIBER REINFORCED POLYMER

Abstract

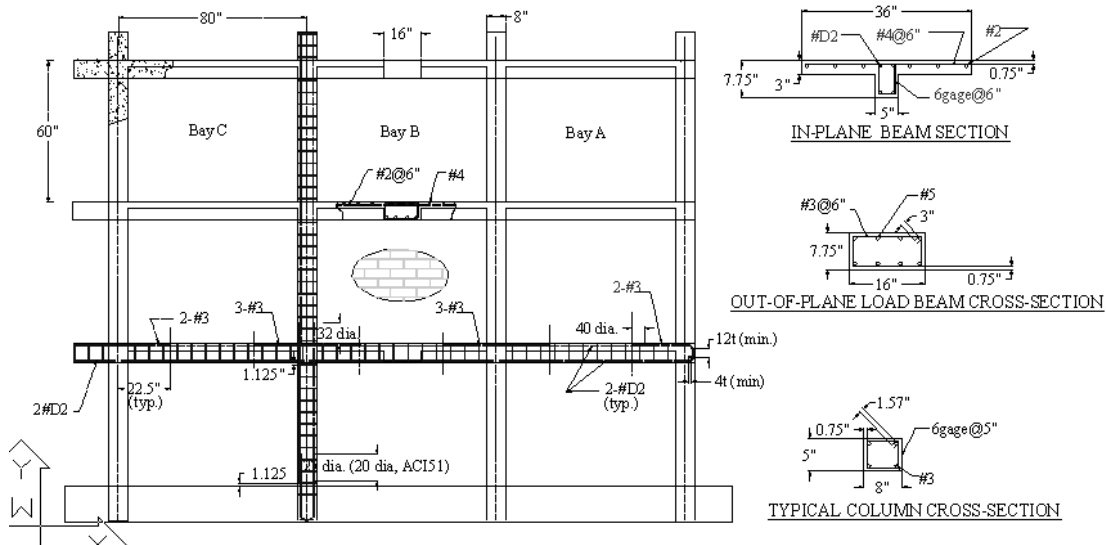
Figure 1. Half-Scale Experimental Model.

A half-scale three-story, three-bay reinforced concrete (R/C) frame infilled with concrete masonry units (CMU) was subjected to a cyclic loading protocol in order to better understand the structural behavior of this complex system (Al-Chaar 2001). The experimental model was constructed using design philosophies and corresponding code requirements of the 1950s. Therefore, the R/C frame lacked the seismic detailing required by modern building codes. Figure 1 illustrates the dimensions and reinforcement details used for the half-scale model in this experiment.

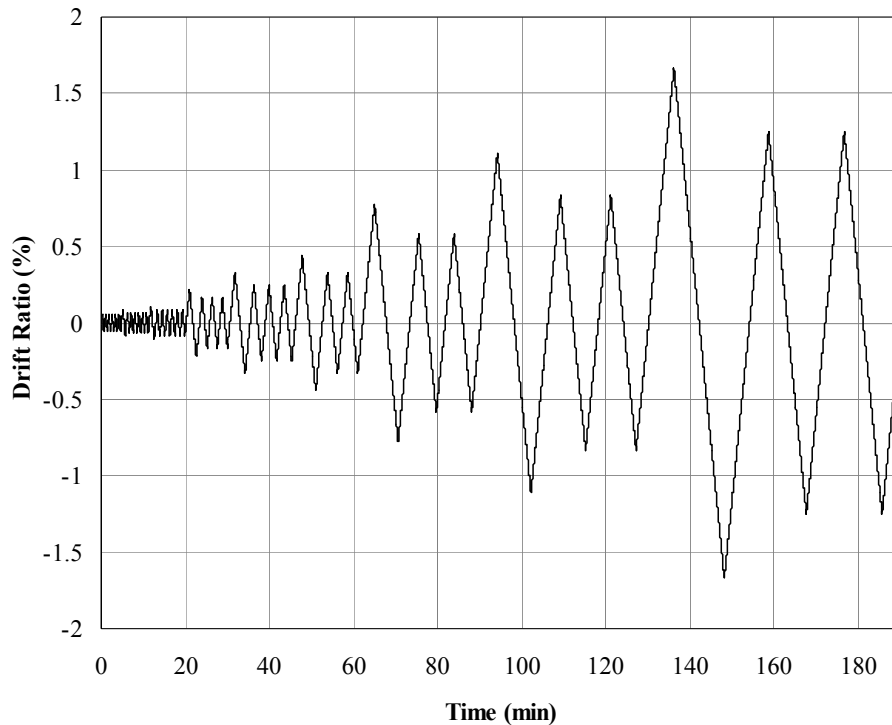
Figure 2. Cyclic Loading History.

Lateral loading on the third floor was based on a displacement-controlled cyclic loading protocol that represents demands from a hypothetical earthquake. The loading protocol is depicted in Figure 2. The lateral drift ratio refers to the third floor displacement over the entire height of the model. Lateral forces applied at the first and second floors were applied in force-control. These forces followed an inverted triangular distribution and were governed by the third floor lateral force.

After completing the loading protocol the test structure was repaired and rehabilitated to restore structural integrity, then subjected to another loading sequence according to the same pattern shown in Figure 2. The following discussion summarizes the rehabilitation methods applied and their success at restoring the structural properties of the system.

Once the test structure was rehabilitated, it was again subjected to the cyclic loading protocol shown in Figure 2. The load-deformation response of the rehabilitated structure was compared to the original structural response to determine the effectiveness of the rehabilitation. Story shear, drift ratio, and stiffness during relevant cycles were evaluated.

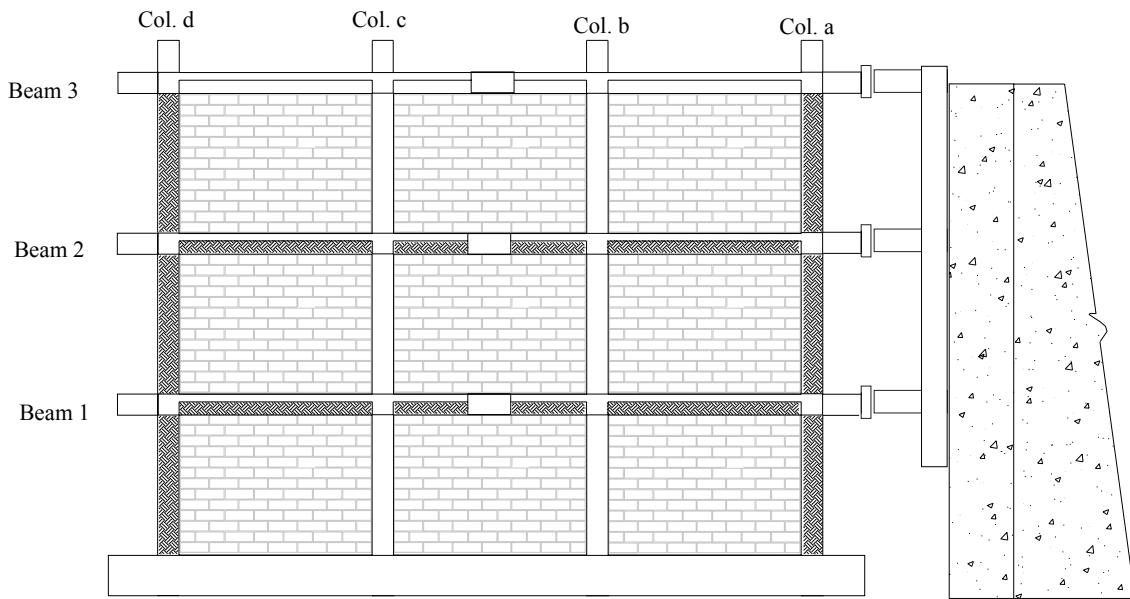
Figure 3. CFRP Placement.

CFRP composite with a fiber orientation of $+45^{\circ}/-45^{\circ}$ was used to strengthen the reinforced concrete frame according to the layout illustrated in Figure 3. The rehabilitation design was intended to completely wrap the exterior columns of the first and second stories, strengthening them without increasing the stiffness of the model. However, the third story columns were only three-quarters wrapped, which would prevent third-floor failure that might occur during testing due to strengthening of the lower stories by the CFRP overlays. The beams, on the other hand, were only wrapped at the stems of the T-beams, and only at the first and second stories. The third story of the model did not sustain enough damage to warrant removal of the infill or further rehabilitation with CFRP.

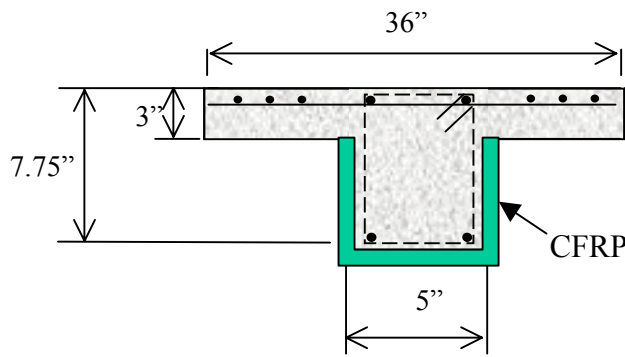
Figure 4. Dimensions and CFRP Placement of T-Beam Section

The goal of the CFRP rehabilitation was to regain the original moment capacities of the beams in the undamaged frame. A single ply of CFRP was applied to the stems of the damaged T-beams (see Figure 4). The CFRP was 0.0371 inches thick, with a tensile strength of 10.85 ksi and an initial modulus of elasticity of 1281 ksi. The moment capacities were calculated following ACI 440-00 Equation 9.2 except for including the contribution of the CFRP applied to the sides of the beam. The resulting moment capacities are tabulated in Table 1 for all three floors of the original and rehabilitated models.

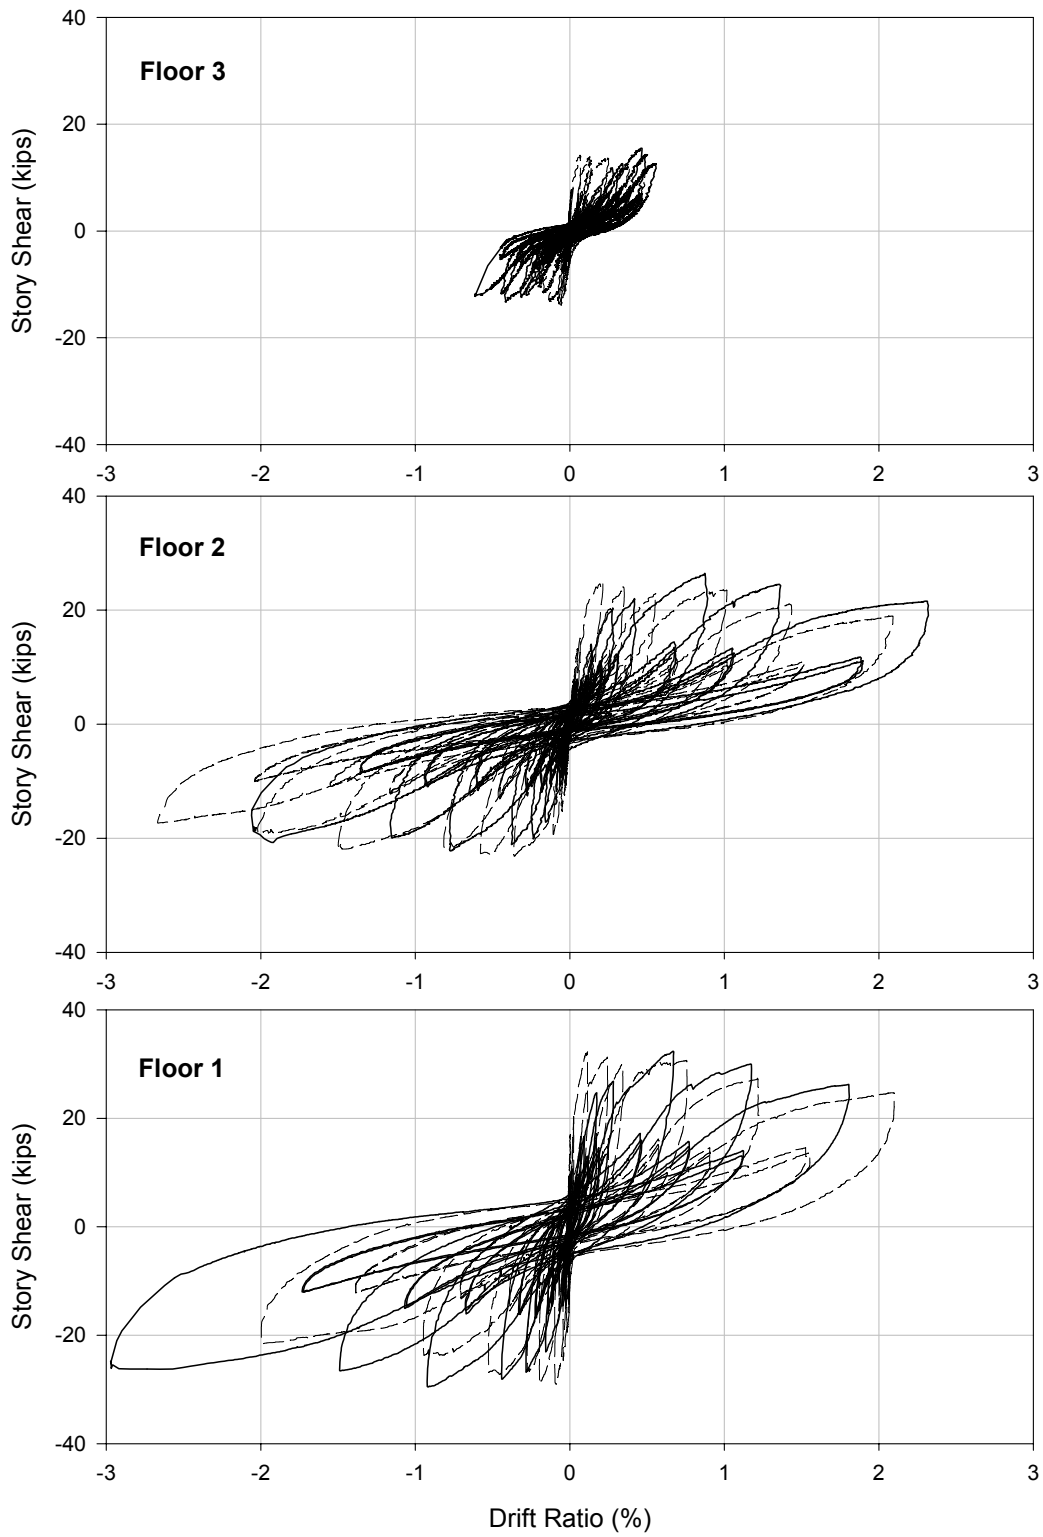
Figure 5. Load-Deformation Behavior for Each Story of the Original and Rehabilitated Test Structures.

The hysteretic behavior of the rehabilitated specimen is shown with the behavior of the original model in Figure 5. The solid black lines represent the load-deformation response of the rehabilitated model and the dashed gray lines illustrate the behavior of the original specimen. The peak lateral load for the rehabilitated model occurred during the 32nd cycle at a corresponding base shear of 32.39 kips in the positive stroke direction. In the negative stroke direction, a slightly smaller base shear of 29.53 kips was observed. These values were very slightly higher than the original test, where the peak values of base shear in each direction were 32.21 kips (positive) and

Also noticeable in Figure 5 is the relatively large first-story drift that occurred during the final negative, primary cycle of the rehabilitated model. This magnified first-story translation can be attributed to a sharp decline in lateral stiffness resulting from severe shear cracking near the top of Column 1c during the preceding positive stroke. Another observation from Figure 5 is that the drift ratio of the third story was much lower than the values observed in the first or second stories. This phenomenon occurred in both the original and rehabilitated models. The main cause of this behavior stemmed from the prescribed inverse triangular distribution of lateral forces and the resulting story shear distribution shown in Table 2. The shear on the first and second stories was roughly double the value applied to the third story. This story shear distribution caused the drift ratios for the first and second stories to be much greater than the third story. This behavior was amplified once the lower stories accumulated damage. The weakened first and second stories, therefore, captured most of the imposed displacement required of the third story.

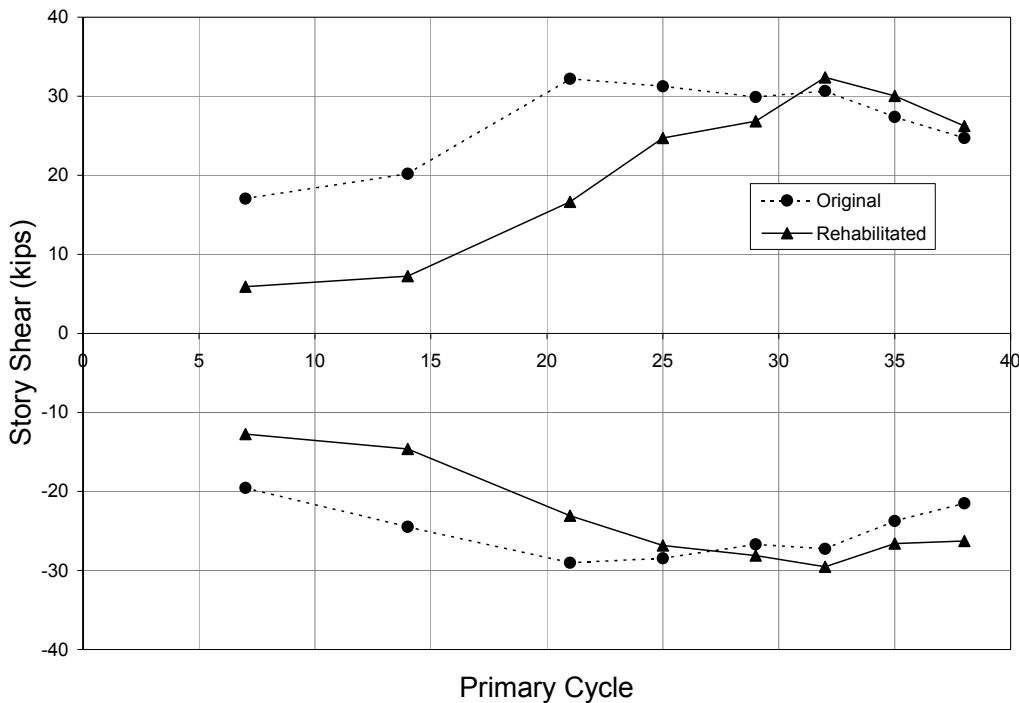
Figure 6. Base Shear During Each Primary Cycle for Both the Original and the Rehabilitated Test Structures.

The values of base shear during each primary cycle for both the original and the rehabilitated test structures are shown in Figure 6. This curve illustrates the fact that the original structure achieved peak load during the 21st cycle while the rehabilitated structure did not reach ultimate load until the 32nd cycle. Furthermore, the low initial stiffness is also evident by the fact that the values of base shear recorded for the primary cycles up to Cycle 29 for the rehabilitated model are lower than those values recorded for the original model. Another observation from Figure 6 is that during the last primary cycle (Cycle 38), the rehabilitated model has more residual strength left than the original model. This fact is directly related to the peak load occurring late in the loading history. Therefore, very few cycles were left to “erode” the value of peak load. Other than a loss of initial stiffness, the overall load-deflection behavior of both specimens was quite similar. For instance, the peak load in either direction was within 2% of the original value. Therefore, the FRP rehabilitation techniques were successful from a strength perspective.

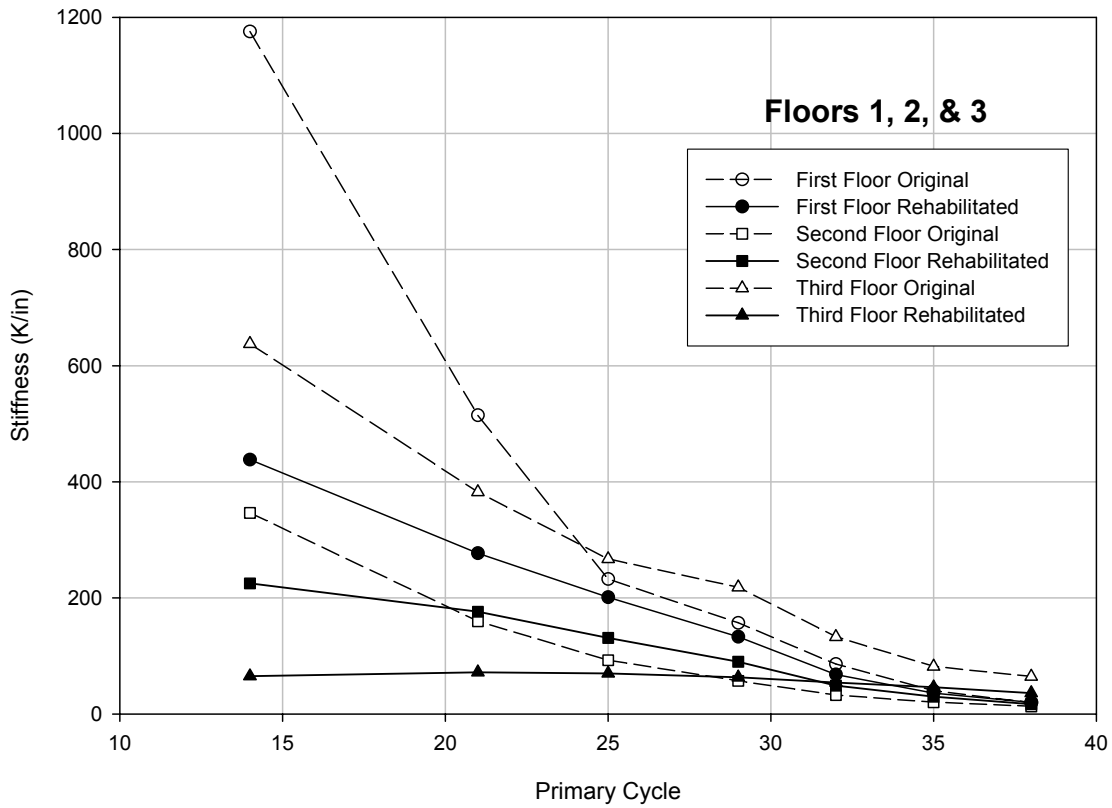
Figure 7. Stiffness of Each Floor During Primary Cycles for Both the Original and Rehabilitated Test Structures.

The small values of initial stiffness relative to the original test are illustrated by Figure 7 and provided in Table 3. In Figure 7, the stiffness of each story during primary cycles is shown for both the original and the rehabilitated structures. The first and second stories of the rehabilitated structure regained some of their initial stiffness, but not all of it. Recall that these two floors had concrete cracks sealed with epoxy, masonry infill replaced, exterior columns fully wrapped with CFRP, and the undersides of the beams wrapped with CFRP. Conversely, the third story regained almost none of its initial stiffness, which is consistent with the limited rehabilitative measures employed on that floor. (Remember that the only rehabilitation performed on the third floor was wrapping the exterior columns with CFRP on three sides.) The most important factor dictating the initial stiffness of the third story was the fact that the damaged CMU infill was left in place. The infill by far contributed the most to the in-plane stiffness of the frame. As the number of cycles increased and approached the final primary cycle, the

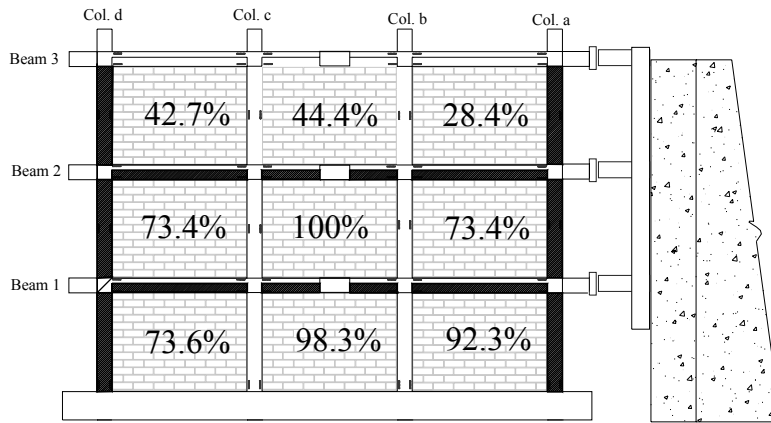
Figure 8. Panel Strain Distribution for the Rehabilitated Test Structures.

Panel strain distribution occurring during the positive stroke (i.e., toward the reaction structure) of Cycle 32 (peak load) is illustrated in Figure 8. Values of panel strain were normalized to the panel having the largest displacement during that cycle. The large strains in the first and second stories correspond to a significant increase in damage to the lower levels during this cycle. In addition, the strain in the first story, Bay A (see Figure 1), was much larger than the strain in Bay C. This difference can be attributed to the overturning moment from application of the loading protocol. The panel strain distribution was similar for both the original and rehabilitated structures.

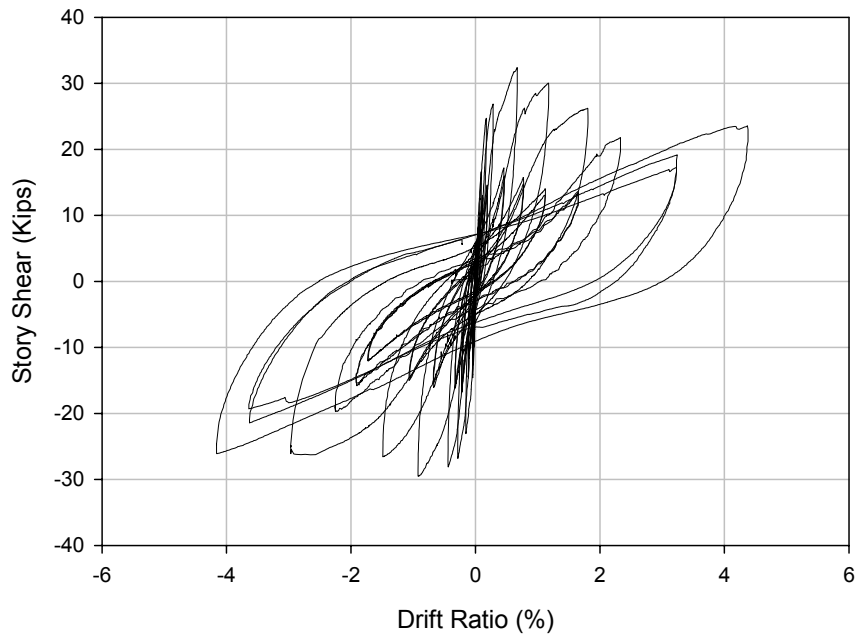
Figure 9. Cumulative Hysteretic Behavior of the First Floor.

A similar procedure was followed in order to maximize displacement demand on the first floor. During these cycles, a maximum drift ratio of approximately 4% was achieved along with a corresponding base shear of about 25 kips. A cumulative hysteresis curve containing all cycles is given for the first floor in Figure 9. Note the hysteresis loops were fairly open for the final three cycles indicating considerable inelastic behavior; significant damage to both the frame and the infill occurred during this time. After completing these three loading cycles, permanent inelastic deformation was evident in the first floor. Figure 10 shows the accumulated damage to the rehabilitated model after the completion of 32 loading cycles.

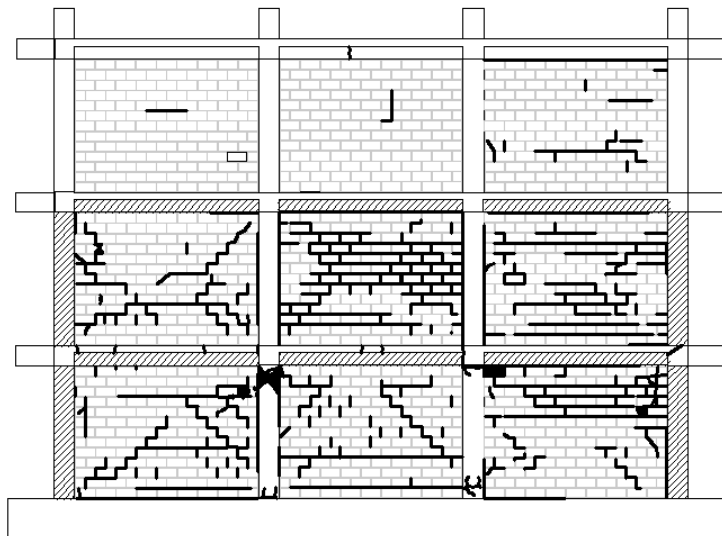
Figure 10. Damage Pattern Through 32 Loading Cycles on the Rehabilitated Model.
