## CORROSION REPAIR OF STEEL PIPE WITH CARBON FRP

Name: San Juan Generating Station, PNM  
Type: Industrial Facility  
Location: Farmington, NM  
Completed: October 2007

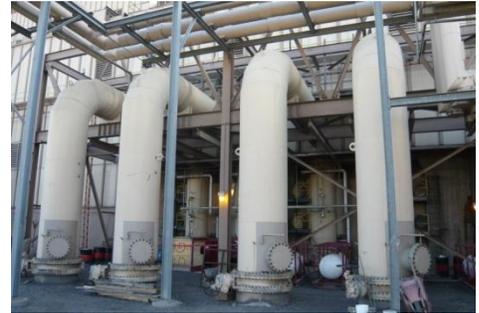
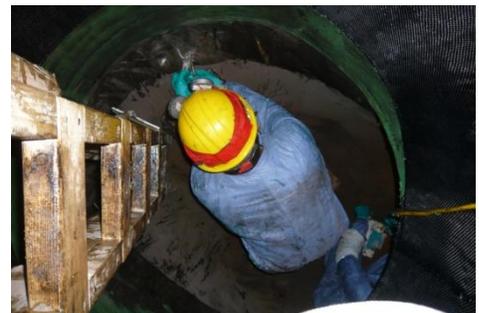
A special QuakeWrap® Carbon fabric was developed for this project to achieve the strengthening requirements with a **single layer** of carbon fabric – instead of **two layers** as the original design called for. Samples were constructed and tested to demonstrate the feasibility of the solution. 50-inch wide bands of carbon fabric were applied in the hoop direction, with a single overlapping joint along the bottom of the pipe. To avoid galvanic corrosion of the steel as a result of direct contact with the carbon fabric, a layer of glass fabric was applied first to the steel surface. The entire repaired section was coated with a layer of high chemical resistant coating.

- 10-ft and 4ft diameter steel pipe segments strengthened with Carbon FRP.
- Specially designed carbon fabric was used; this fabric allowed the pipe to be strengthened with only a single layer of fabric, compared to the previous phases at the same site that were done with two layers
- All equipment was re-designed and/or modified so that it could fit into the pipe through the 30-inch diameter manholes.
- 4 ft vertical raisers were repaired using under very tight spaces and using a special scaffolding system suspended on cables.
