REHABILITATION OF INFILLED NONDUCTILE CONCRETE FRAMES USING CARBON FIBER REINFORCED POLYMER

Abstract

A three-story, three-bay reinforced concrete frame with masonry infill panels was constructed and subjected to a series of damaging lateral forces for the purpose of assessing the effectiveness of CFRP overlays in increasing strength, stiffness, and deformation capacity. The test structure was a half-scale model designed to incorporate the essential structural characteristics of a general class of military buildings constructed in the 1950s. This specific building system lacked the seismic detailing incorporated into modern construction. A prescribed cyclic loading protocol put displacement demands on the test structure representative of those expected during light, moderate, and strong earthquake motions. The damaged test structure was then strengthened with CFRP wraps intended to restore its structural integrity to near-pretest condition. Prior to strengthening, damaged infill panels were replaced with new masonry and cracks in the concrete frame were injected with epoxy. Seismic performance of the rehabilitated structure was then re-evaluated using a series of reversed and repe

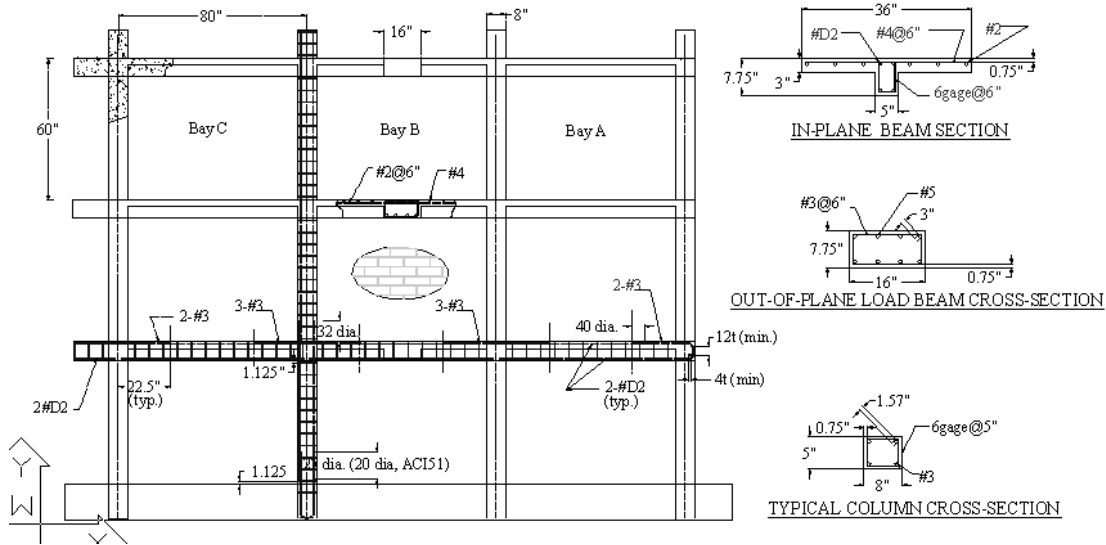
Figure 1. Half-Scale Experimental Model.

A half-scale three-story, three-bay reinforced concrete (R/C) frame infilled with concrete masonry units (CMU) was subjected to a cyclic loading protocol in order to better understand the structural behavior of this complex system (Al-Chaar 2001). The experimental model was constructed using design philosophies and corresponding code requirements of the 1950s. Therefore, the R/C frame lacked the seismic detailing required by modern building codes. Figure 1 illustrates the dimensions and reinforcement details used for the half-scale model in this experiment.

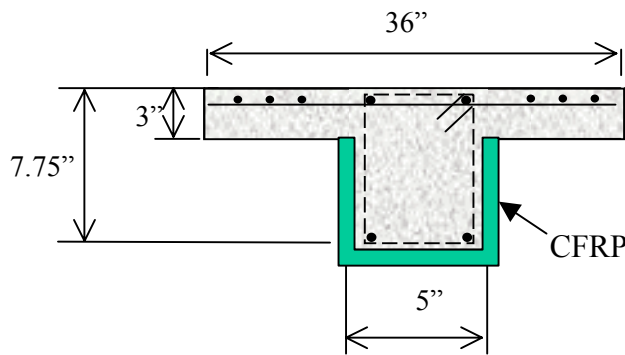
Figure 4. Dimensions and CFRP Placement of T-Beam Section

The goal of the CFRP rehabilitation was to regain the original moment capacities of the beams in the undamaged frame. A single ply of CFRP was applied to the stems of the damaged T-beams (see Figure 4). The CFRP was 0.0371 inches thick, with a tensile strength of 10.85 ksi and an initial modulus of elasticity of 1281 ksi. The moment capacities were calculated following ACI 440-00 Equation 9.2 except for including the contribution of the CFRP applied to the sides of the beam. The resulting moment capacities are tabulated in Table 1 for all three floors of the original and rehabilitated models.

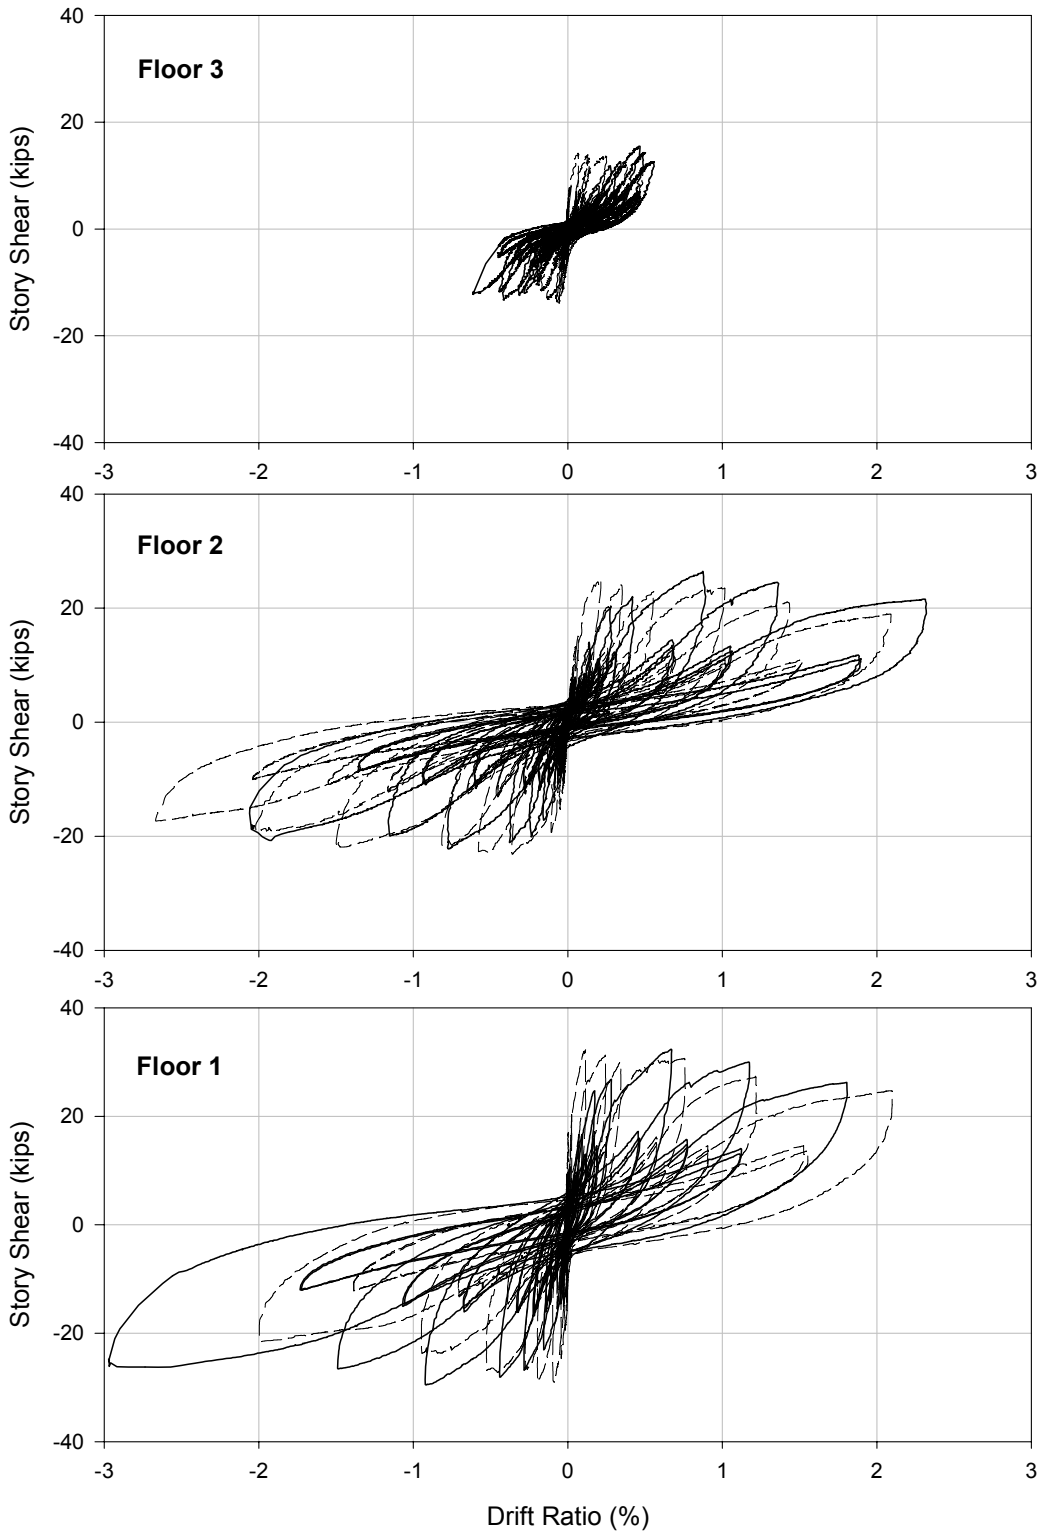
Figure 5. Load-Deformation Behavior for Each Story of the Original and Rehabilitated Test Structures.

The hysteretic behavior of the rehabilitated specimen is shown with the behavior of the original model in Figure 5. The solid black lines represent the load-deformation response of the rehabilitated model and the dashed gray lines illustrate the behavior of the original specimen. The peak lateral load for the rehabilitated model occurred during the 32nd cycle at a corresponding base shear of 32.39 kips in the positive stroke direction. In the negative stroke direction, a slightly smaller base shear of 29.53 kips was observed. These values were very slightly higher than the original test, where the peak values of base shear in each direction were 32.21 kips (positive) and

Also noticeable in Figure 5 is the relatively large first-story drift that occurred during the final negative, primary cycle of the rehabilitated model. This magnified first-story translation can be attributed to a sharp decline in lateral stiffness resulting from severe shear cracking near the top of Column 1c during the preceding positive stroke. Another observation from Figure 5 is that the drift ratio of the third story was much lower than the values observed in the first or second stories. This phenomenon occurred in both the original and rehabilitated models. The main cause of this behavior stemmed from the prescribed inverse triangular distribution of lateral forces and the resulting story shear distribution shown in Table 2. The shear on the first and second stories was roughly double the value applied to the third story. This story shear distribution caused the drift ratios for the first and second stories to be much greater than the third story. This behavior was amplified once the lower stories accumulated damage. The weakened first and second stories, therefore, captured most of the imposed displacement required of the third story.

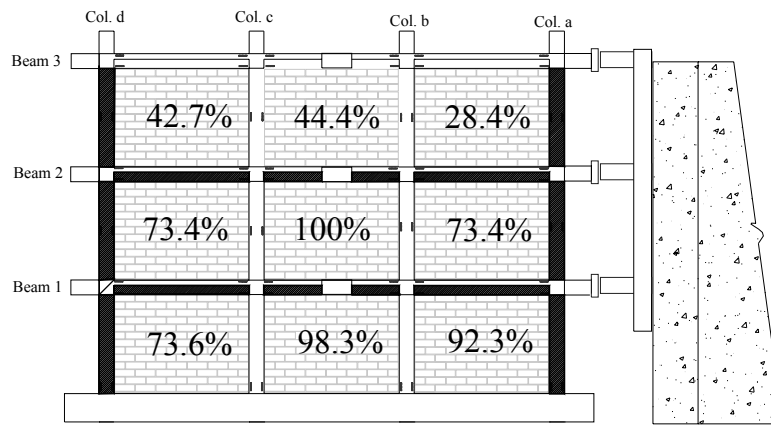
Figure 8. Panel Strain Distribution for the Rehabilitated Test Structures.

Panel strain distribution occurring during the positive stroke (i.e., toward the reaction structure) of Cycle 32 (peak load) is illustrated in Figure 8. Values of panel strain were normalized to the panel having the largest displacement during that cycle. The large strains in the first and second stories correspond to a significant increase in damage to the lower levels during this cycle. In addition, the strain in the first story, Bay A (see Figure 1), was much larger than the strain in Bay C. This difference can be attributed to the overturning moment from application of the loading protocol. The panel strain distribution was similar for both the original and rehabilitated structures.
