# Seismic Retrofit of URM Walls with Fiber Composites

by M. Ehsani<sup>1</sup>, Ph.D., P.E. and H. Saadatmanesh<sup>2</sup>, Ph.D., P.E.

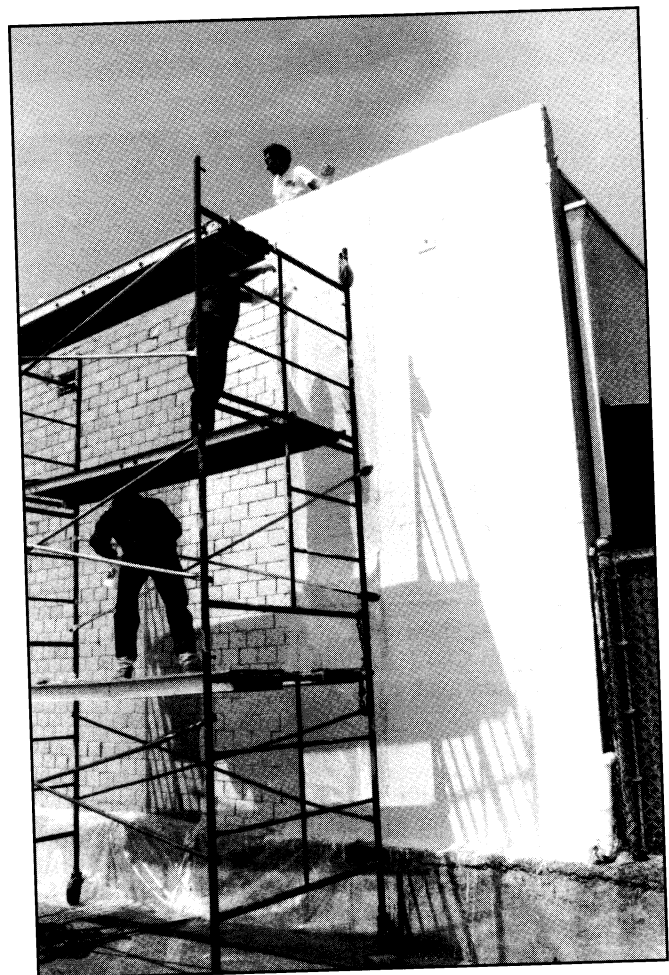
Fig. 12—Application of *QuakeWrap*™ to the wall (Photo courtesy of External Reinforcement, Inc.)

loose and were reset, and the shear cracks in the wall were filled with mortar. The two-part epoxy was mixed in the field and applied in thin layers to the wall. The 3-ft. (915-mm) wide fabrics were then placed on the wall in vertical strips and pressed against the uncured epoxy. In a similar fashion, the next strips of fabric were added with sufficient overlap with the adjacent strips to form a continuous fabric on the wall (Fig. 12). The nuts and washer plates associated with seismic anchors from the earlier retrofit were temporarily removed and were replaced after the composite fabric was installed. The bottom edge of the fabric was anchored to the existing footing with a steel anchor plate and bolts. On the exterior surface, the top edge of the fabric was anchored to the existing wall parapet. On the interior, the top of the fabric was wrapped around blockings which were fastened to the floor joists. Fig. 13 shows the interior wall surface at the completion of the project; the conveyor belt system and the bolts and straps which were used in the earlier retrofit to tie the roof to the wall can also be seen.

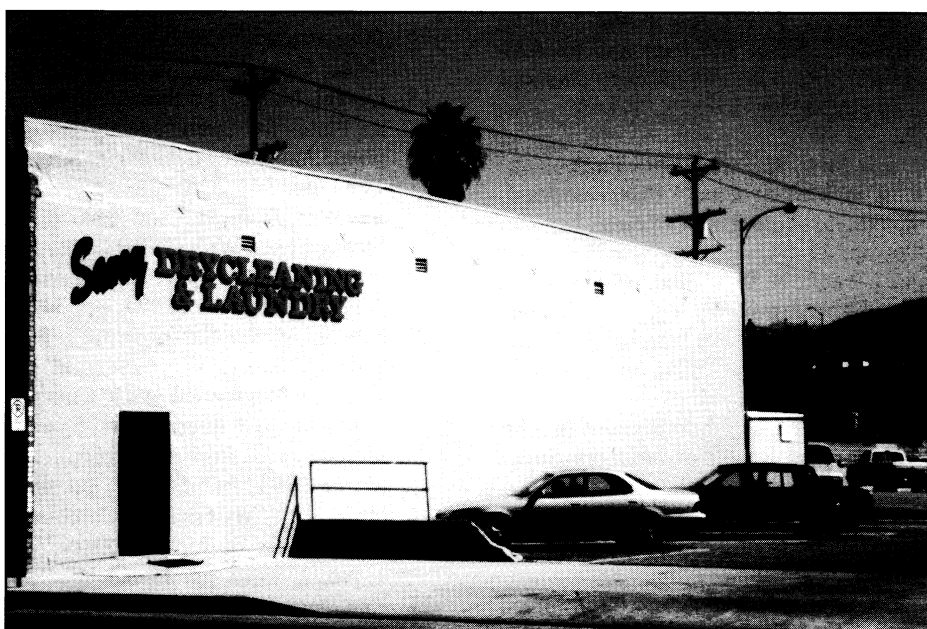
Fig. 14—Exterior of wall at completion of project (*Photo courtesy of External Reinforcement, Inc.*)

Once the fabrics were attached to the wall, a second coating of epoxy was applied to the exterior surface so that the fabric was totally impregnated with the epoxy. Finally, the exterior surface of the wall was covered with a special ultraviolet-protective coating; the coating color was selected to match the original color of the building. Fig. 14 shows the wall upon complete installation of *QuakeWrap*™ after the application of the ultraviolet-protecting paint.
