FRP REPAIR OF BEAMS IN PARKING STRUCTURE

Name: Martini Park Parking Garage
Type: Parking Structure
Location: Scottsdale, AZ
Completed: August 2008

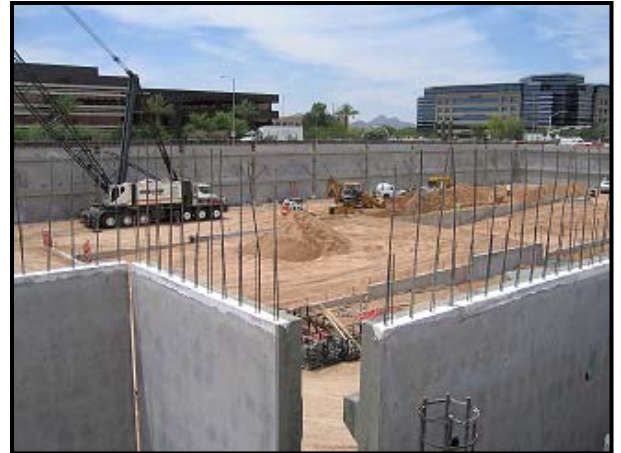
A new parking structure was built in Scottsdale, Arizona. 17 prestressed double T beams were designed to span over the width of 60 ft. Before the construction of the building the original design loads changed. In the retail section on top of the parking structures a stage was planned to be built. The new loads exceeded the design loads for the DT beams, which had been originally design without those loads.

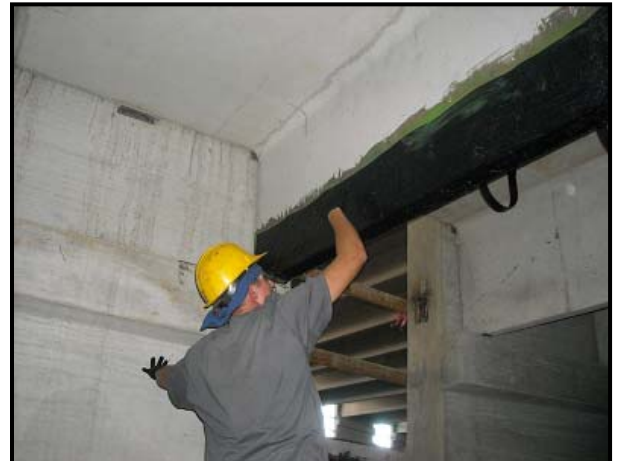
17 DT beams, i.e. 34 stems needed additional strengthening. QuakeWrap® FRP Strengthening System was selected. One 2 ft wide layer of unidirectional QuakeWrap® carbon FRP was applied as a flexural reinforcement. As shear reinforcement the same material was applied in the perpendicular direction. The two feet wide strips were spaced 4 ft on center. The beams could be accessed with scaffolding, no scissors lift or man lift was needed. The 34 stems were wrapped by a crew of 5 workers in 11 days.
