## CARBON FRP REPAIR OF UNDERWATER BRIDGE PIERS

**Name:** Bay View Bridge  
**Type:** Bridge Structure  
**Location:** Ft. Lauderdale, FL  
**Completed:** June, 2007

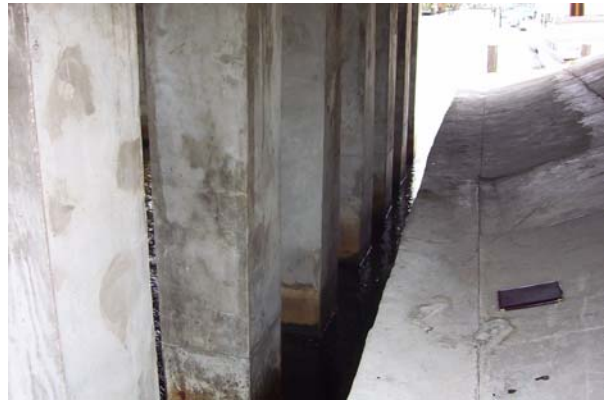
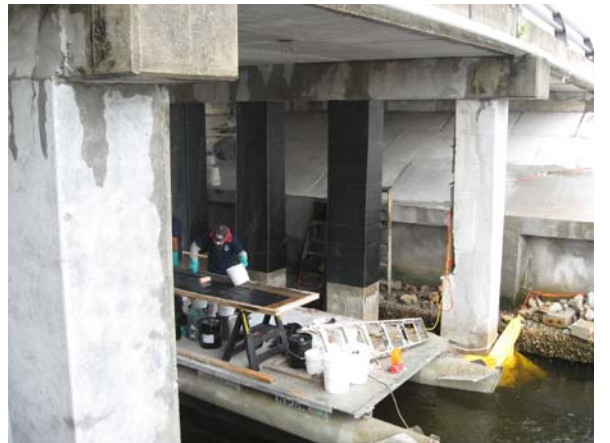
Partially submerged bridge piers have a tendency to present severe corrosion problems at the splash zone, where several wet/dry cycles occur daily due to natural ocean tides.

Patching the concrete at this elevation only provided a temporary fix, since concrete and steel deterioration reappeared in the short term. A long term and maintenance free solution was desired.

QuakeWrap™ FRP Repair System was selected to provide the desired solution. QuakeWrap FRP carbon fabric was applied from the pier cap elevation to a couple of feet below the low tide water elevation on all the bridge piers.

Special epoxy resins AquaWrap™ was developed that allowed the FRP fabric to completely cure underwater and remain in full contact with the concrete pier surface even when subjected to strong underwater currents.

After retrofit work was completed, the piers were painted to obtain the final architectural finish.
