FRP REPAIR OF BRIDGE PIER SUBJECTED TO IMPACT DAMAGE

Name: I-70 Overpass
Type: Bridge Structure
Location: Kansas City, Missouri
Completed: November 2005

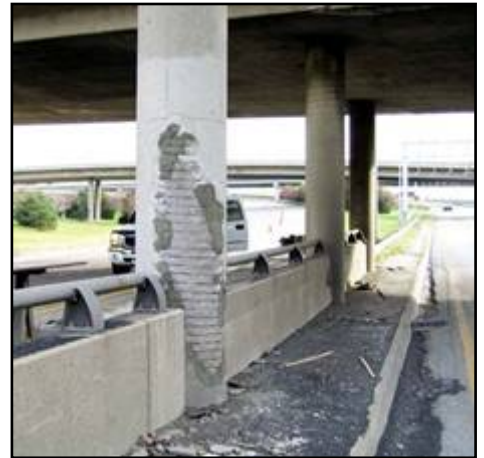
A truck had run into this bridge pier located near downtown Kansas City, MO. The impact of a truck had caused damage to the concrete pier and had resulted in loss of cover concrete, exposing the steel reinforcement. In addition to loss of strength, the exposed reinforcing bars were subjected to corrosion.
