## FRP REPAIR OF REINFORCED CONCRETE BEAMS IN PARKING STRUCTURE

**Name:** City Court Garage  
**Type:** Parking Structure  
**Location:** Tucson, Arizona  
**Completed:** June 2005

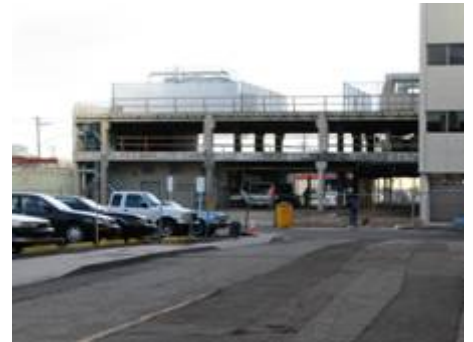
The City Court Parking Garage on Alameda Street was damaged by corrosion due to water running down the roof. Twelve inverted T-beams had deteriorated to the point of requiring shoring steel beams to share the loads transmitted by the double-T prestressed concrete beams framing into them.

The original retrofit called for new secondary steel frame to support the double-T beams. This option was expensive and very time-consuming; the city required a speedy solution.

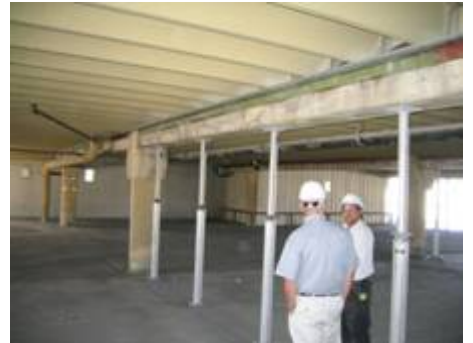
The City chose to go with a Design-Build concept and QuakeWrap® Repair System was selected as the most cost effective option. All inverted T-beams were wrapped with a single layer of QuakeWrap® composite glass fabric to provide for the missing (corroded) steel and reestablish the original design capacity.

The FRP retrofit job was finished ahead of schedule in 3 weeks.

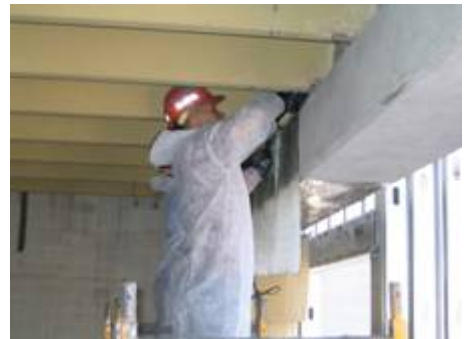
- Inverted T-Beam reinforcement was damaged by corrosion
- Original retrofit design using a new steel framing system was too expensive and required too much time to construct.
- QuakeWrap, Inc. was awarded a Design-Build contract by the City.
- Corrosion damage in twelve beams was repaired
- These beams were wrapped in composite glass fabric and painted.
