FRP RETROFIT OF REINFORCED CONCRETE COLUMNS IN HIGH RISE CONDOMINIUM TOWER

Name: Plaza in Clayton
Type: Condominium Tower
Location: St. Louis, Missouri
Completed: September 2003

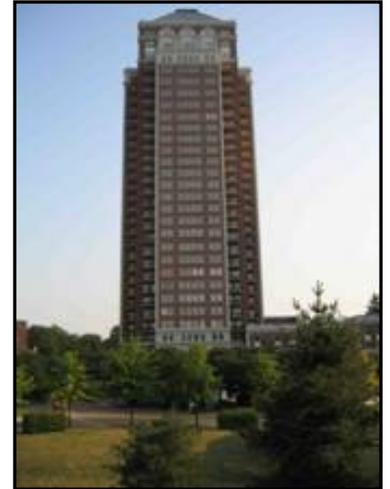
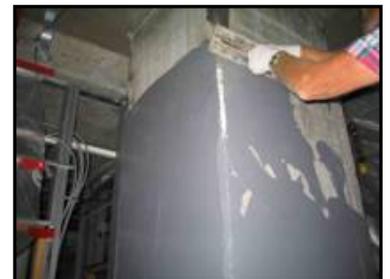
FRP composite carbon fabric was saturated in the garage (using QuakeWrap® Saturating Machine) and it was sent up to the floors using passenger elevators. Columns were wrapped in two layers of fabric. The complete confinement of the columns increased the compressive strength of the concrete, increasing its load sharing participation and a result, the existing longitudinal steel was deemed adequate. The lacking additional hoop reinforcement was accounted for by orienting the carbon fibers in the transverse direction. The FRP retrofit also upgraded the seismic capabilities of the columns by increasing their ductility.

The small thickness of the fabrics allowed the wooden panels to be re-installed around the columns after FRP retrofit was completed.
