REPAIR OF TILTUP CONCRETE WALL PANELS WITH GLASS FRP

Name: Courtaulds Aerospace
Type: Tilt-up Walls
Location: Glendale, California
Completed: October 1994

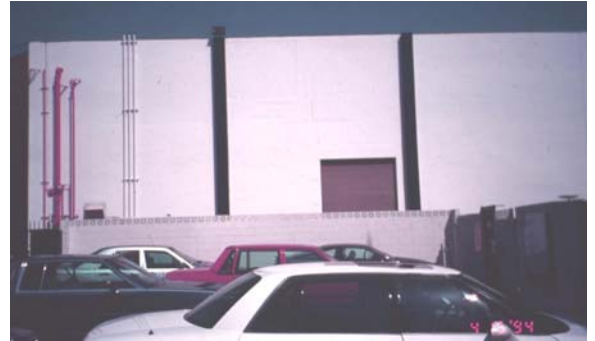
The chemical facility building was damaged by the 6.7 magnitude Northridge Earthquake of January 1994. Courtaulds Aerospace needed the building to remain functional during the strengthening process. A large number of pipes passing through the facility could not be dismantled and had to be worked around during the retrofit process.
