CENTER FOR INFRASTRUCTURE ENGINEERING STUDIES

Laboratory and Field Testing of FRP Composite Bridge Decks and FRP-Reinforced Concrete Bridge for the City of St. James, Phelps County, MO

**CIES
02-26**

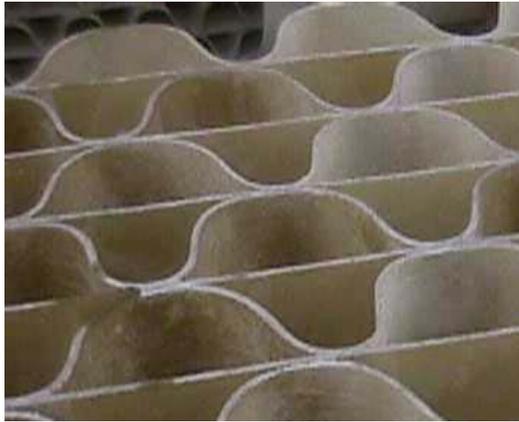
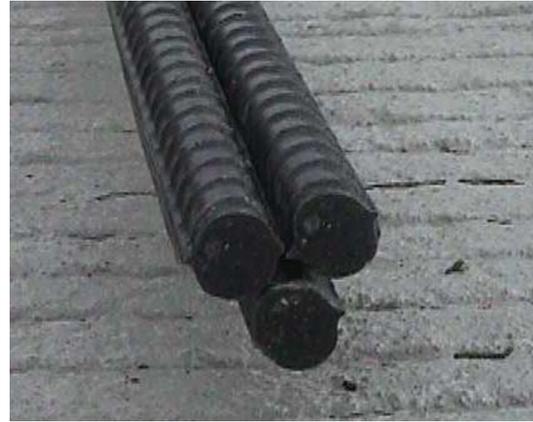
Figure 1.1 FRP Materials Utilized

(a) Corrugated GFRP core

(b) Bundled CFRP Bars

installed by Oden Enterprises, Inc. located in Wahoo, Nebraska. Figure 1.1 illustrates the FRP materials utilized for this project.

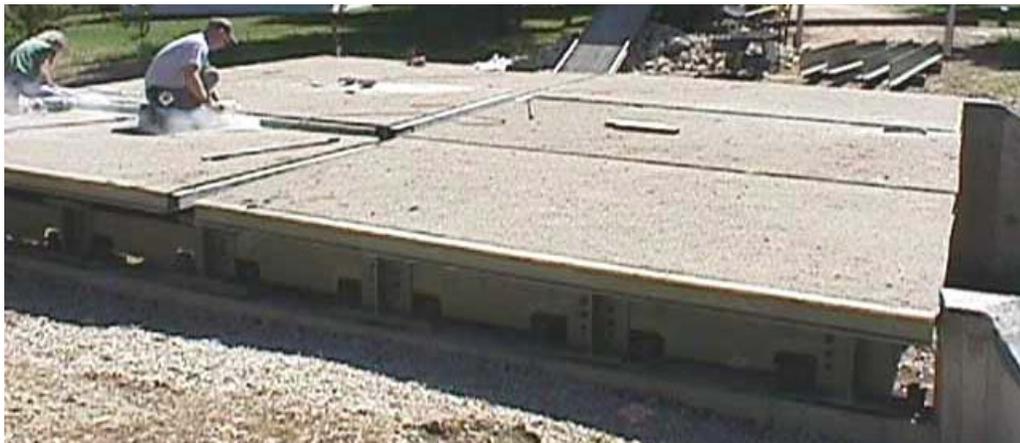
Figure 3.3 St. Johns Street Bridge Structure

corrugations of the core of the FRP panels run perpendicular to the direction of traffic, spanning from girder to girder, the moment of inertia based on these measurements is 48.932 in^4 (2036.7 cm^4) per 1-ft (0.3-m) wide section. It should be noted that for all of the FRP sandwich panels, the calculation of the moment of inertia is conducted assuming the section to be representative of an I-beam, whereby the hollow spaces in the core are ignored and only the FRP materials are considered. Figure 3.3 illustrates the overall structure of the St. Johns Street Bridge, exhibiting the seven steel girders and six FRP panels.

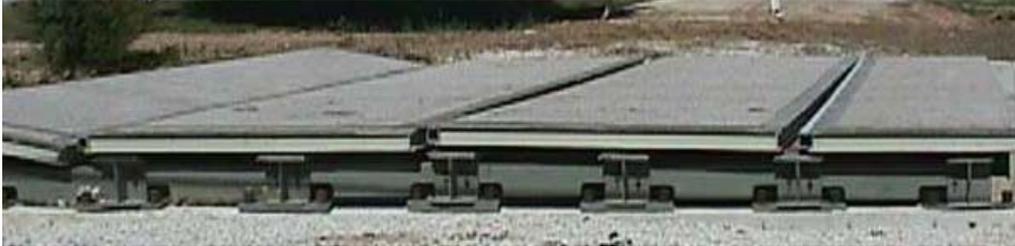
Figure 3.4 Jay Street Bridge Structure

section. The overall structure of the Jay Street Bridge, including the steel girders and FRP panels, is illustrated in Figure 3.4.

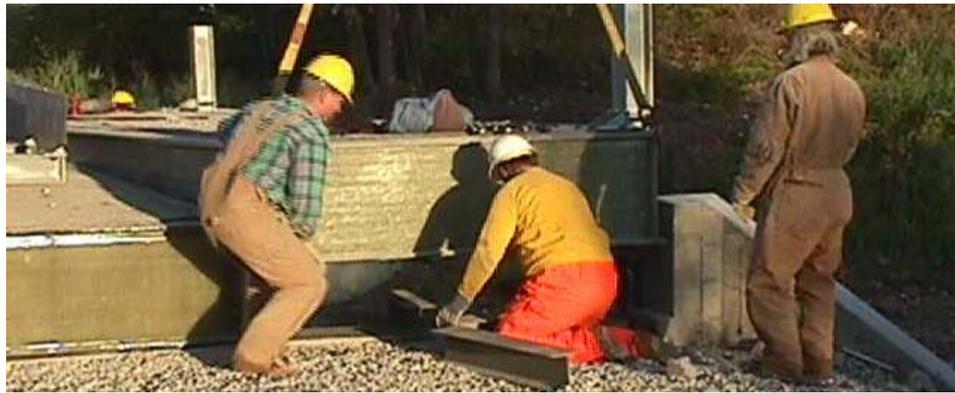
Figure 3.5 St. Francis Street Bridge Structure

ft (8.0 m) in length and 6.83 ft (2.08 m) in width. The thickness of the individual layers in the core is 0.09 in (2.3 mm), resulting in a total thickness of 1.08 in (27.4 mm) for the 12 layers of core material in a representative 1-ft (0.30 m) section. In this case, the corrugations of the core of the FRP panels run parallel to the direction of traffic, spanning from abutment to abutment. The moment of inertia based on these measurements is 3320.0 in^4 (138188.8 cm^4) per 1-ft (0.3-m) wide section. Figure 3.5 illustrates the structure of the St. Francis Street Bridge.

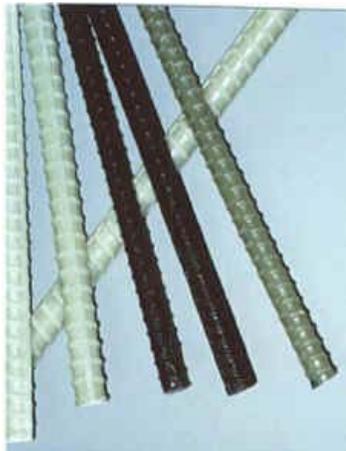
Figure 3.6 FRP Bars Produced by Marshall Industries Composites, Inc.

For the CFRP bars, a guaranteed design tensile strength of 270 ksi (1862 MPa) and a tensile elastic modulus of 15.2 Msi (104.8 GPa) were given by the manufacturer. For the GFRP bars these values were 105 ksi (724 MPa) and 6 Msi (41.4 GPa), respectively. A design compressive strength of 4000 psi (27.6 MPa) was used for the concrete in the FRP-RC bridge panels. Verification of the FRP and concrete material properties was conducted and is outlined in Section 6.

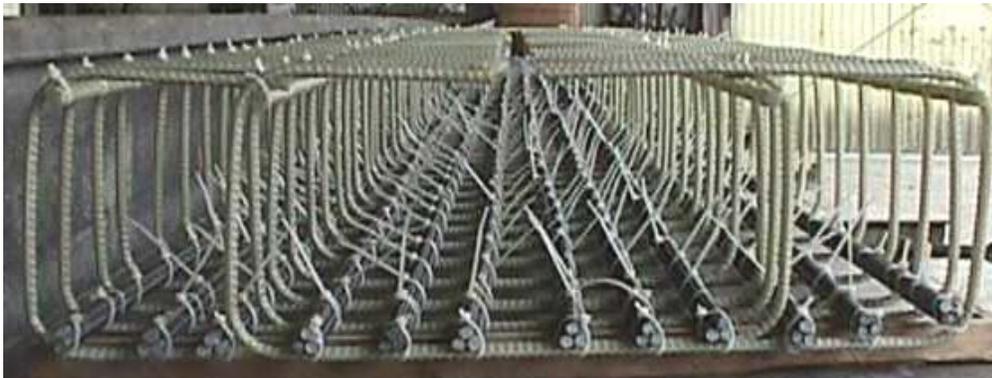
Figure 3.7 FRP Reinforcement Layout

Based on the material properties and design parameters, the longitudinal reinforcement consists of 12 bundles of three 3/8-in (9.5-mm) CFRP bars, while for the shear stirrups 3/8-in (9.5-mm) GFRP bars are utilized. Although their contribution to the flexural capacity of the member is not considered, 1/2-in (12.7-mm) GFRP bars are

the reinforcing bars in the desired reinforcement configuration. Note the plastic ties in Figure 3.7.

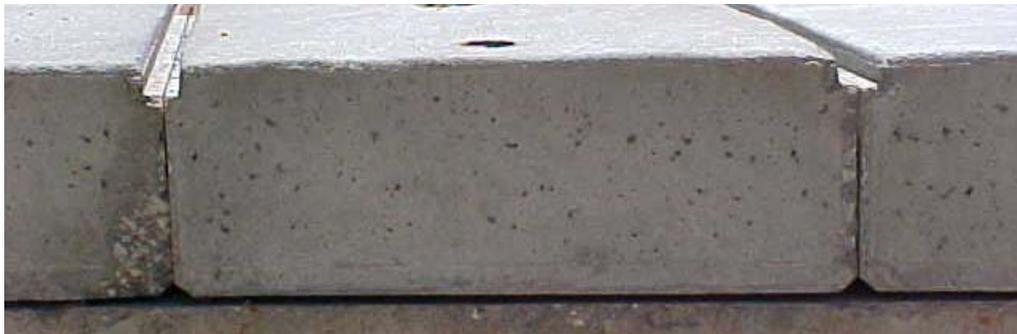
Figure 3.8 Walters Street Bridge Structure

utilized in the top side of the cage. Top transverse reinforcement consisting of 1/2-in (12.7-mm) GFRP bars at 4 ft (1.2 m) is also provided in the panels. Due to the fact that thermoset resins are used in the manufacturing of the FRP bars, the FRP manufacturer conducted all necessary bending of the reinforcing bars prior to their shipment to the concrete precaster. Figure 3.7 illustrates the layout of the FRP reinforcement in each panel. Each of the nine bridge panels measure 2.83 ft (0.9 m) in width, 24 ft in (7.3 m) length, and 1 ft (0.3 m) in depth. The overall structure of the bridge is illustrated in Figure 3.8.

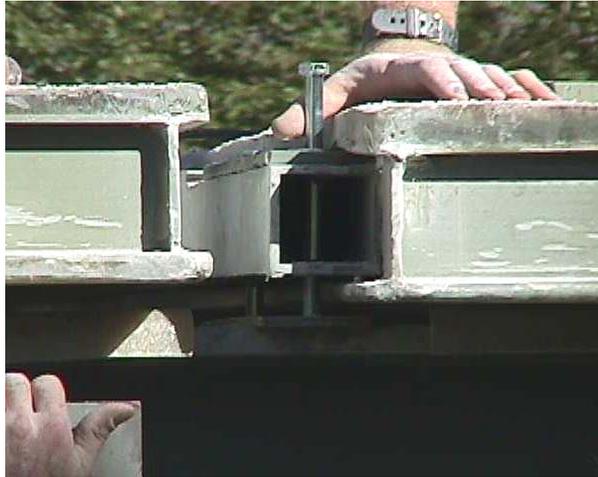
Figure 4.1 Cross Section of Panel Joint and Clamp Assembly – St. Johns Street

Tasks unique to the use of steel-supported FRP panels that warrant further attention are the connection of the panels to one another and to the girders and the connection of the panels/girders to the abutments. The connection of the panels together and to the girders was achieved through the use of a GFRP tube inserted between adjacent panels. The panels are mechanically clamped to the girders at the intersection of the panels and girders in eight locations and nine locations for the St. Johns Street and Jay Street Bridge, respectively. A detail of the panel joint and girder clamp connection for the St. Johns Street Bridge is illustrated in Figure 4.1. A similar configuration was

The clamping assembly used on the St. Johns Street Bridge consists of two bolts extended down through the tube, one of either side of the girder flange, two steel plates one on the top and one on the bottom of the FRP tube, and small steel angles, which

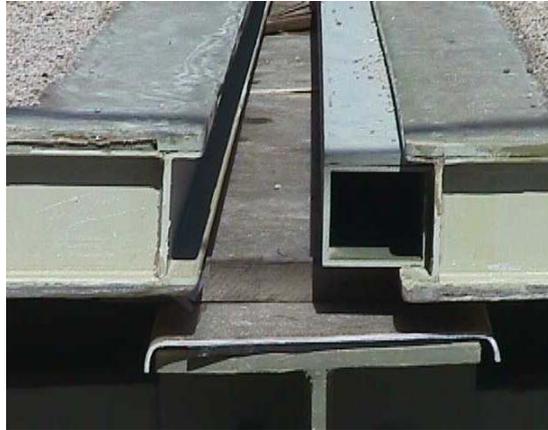
Figure 4.2 Cross Section of Panel Joint– Jay Street

used for the Jay Street Bridge, with slight modification due to the alignment of the girders and panels; see Figure 4.2.

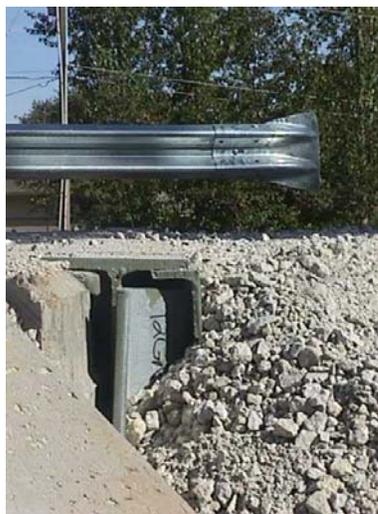
Figure 4.3 Cross Section of Abutment Detail

Once the panels are clamped down to the girders, the connection of the panels/girders to the abutments is made. This connection consists of a steel T-beam installed over the edge of the panel, which is welded to the girder and also to the corrugated sheet piling, which is installed roughly 1.5 ft (0.45 m) below the top of the abutment perpendicular to the direction of traffic along the abutment. Figure 4.3 illustrates this detail, which serves to restrain the ends of the panels against vertical movements.

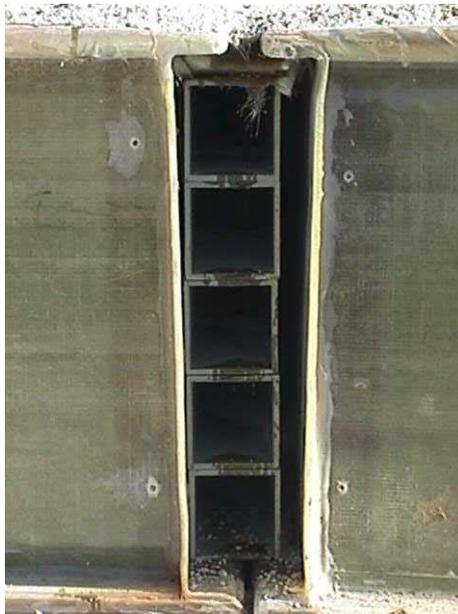
Figure 4.4 Cross Section of the Panel Joint – St. Francis

The connection of the panels together and to the abutments was achieved through the use of GFRP tubes connected together and inserted between adjacent panels. A bolt inserted through the tubes in the joint was secured at the top of the tubes by a steel plate and at the bottom of the panel to a steel angle bolted to the abutment. Additionally, the panels are supported by the abutment itself. A detail of the panel joint and abutment connection are illustrated in Figure 4.4 and Figure 4.5, respectively.

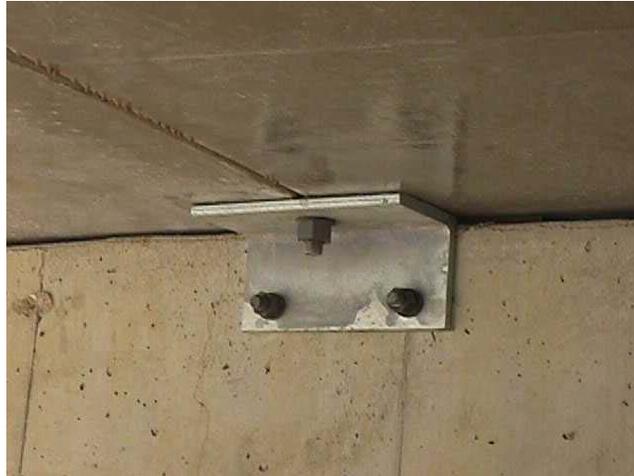
Figure 4.5 Abutment Connection Detail

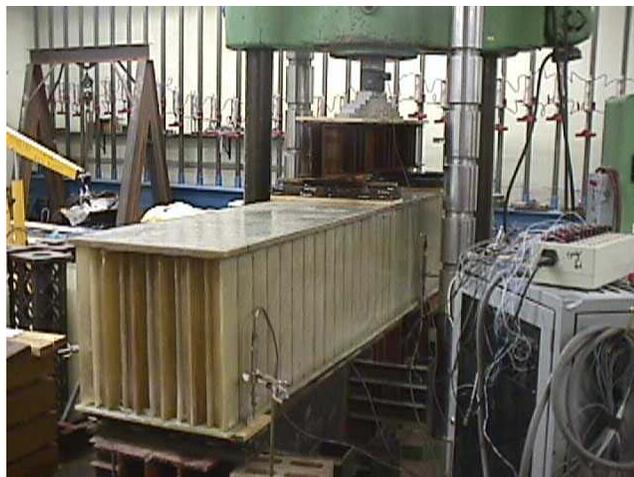
Figure 5.3 Flexural Test Setup – SF-2-1 and SF-2-2

through the use of 8 in (203.2 mm) by $\frac{3}{4}$ in (19.0 mm) plywood boards and 6 in (152.4 mm) by 1 in (25.4 mm) steel plates. In each case the plywood was directly against the specimen and the steel plate was between the plywood and the steel roller. Figure 5.2 illustrates one of the support points of the specimens. Instrumentation of the beams consisted of eight linear variable differential transformer (LVDT) transducers placed one on either side of the section at each support point, at the mid-point, and at one quarter-point of the beam. Figure 5.3 illustrates the test setup for the SF-2-1 and SF-2-2 specimens.

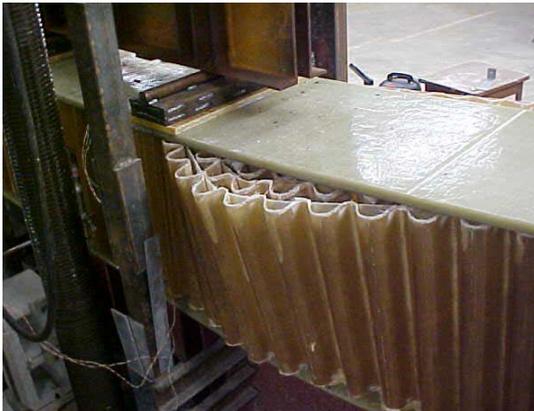
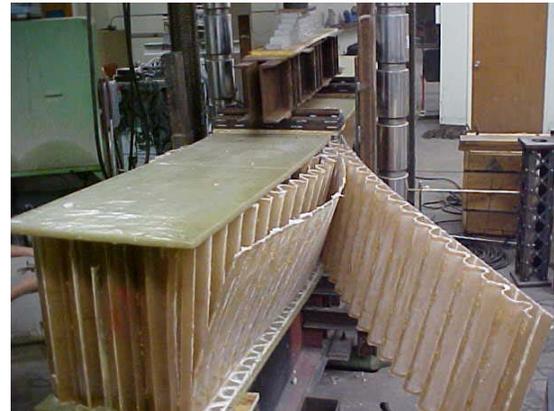
Figure 5.7 Failure Mode of Specimen SF-2-2

(a) Lateral Expansion

(b) Complete Detachment

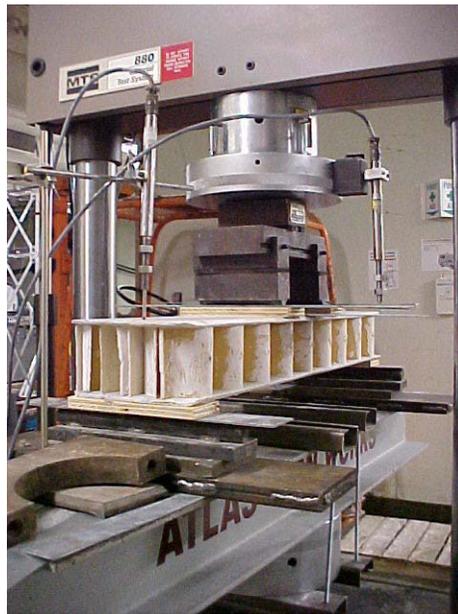
Figure 5.9 Test Setup for the Small-Scale Beam GFRP Sandwich Panel Specimens

for the specimens was approximately 2.6. A picture of the test setup is illustrated in Figure 5.9. Loading of the specimens was performed by an MTS880 universal testing machine; loading was conducted using a constant displacement rate until failure of the specimen occurred. It should be noted that similar measures to those noted for the SF-2 specimens to distribute the load were taken for these specimens as well.

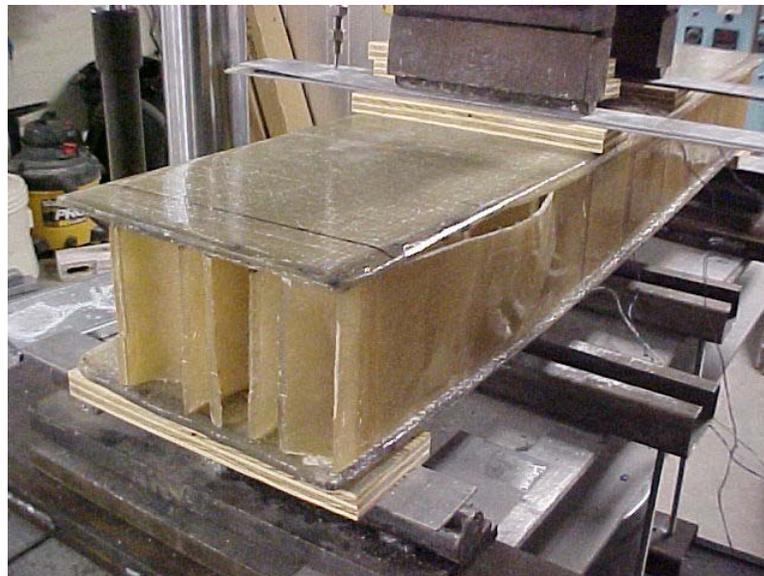
Figure 5.11 Failure Mode of the Small-Scale GFRP Sandwich Panel Specimens

Failure of all three panels occurred by delamination of the core from the top and bottom faces of the panel on only one end of the panel. In the case of the control and environmental cycle exposed specimens, lateral expansion of the core material occurred whereby one side of the core material bulged out approximately 0.5 in (12.7 mm) at approximately one-quarter of the span. Figure 5.11 illustrates the failure mode exhibited by the control and environmental cycle exposed specimens. It should be noted that the variability in the manufacturing process could have influenced both the failure load and the failure mode of the specimens tested.

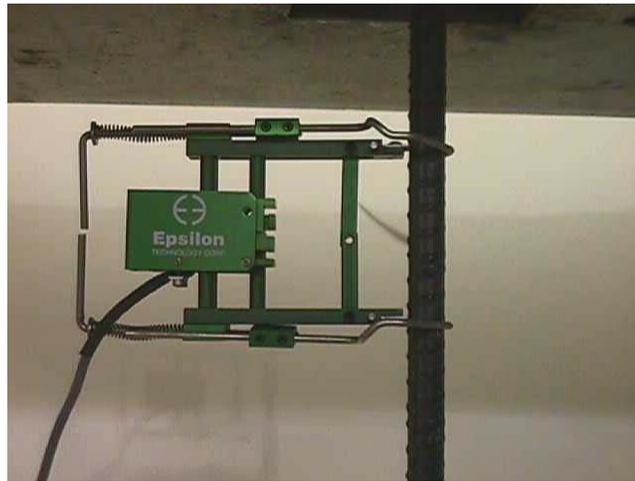
Figure 6.1 Extensometer Utilized During Tensile Testing

conducted by Micelli et al. (2001). Furthermore, an overall specimen length of $40d_b$ plus two times the gripping length, where d_b is the diameter of the bar, was used based on provisional specifications for FRP bars testing that are under review by ACI Committee 440K (2002 Draft). For the first portion of each test, an extensometer was attached to the bar to monitor the deformation under load, thus allowing for determination of the tensile elastic modulus of the bar. See Figure 6.1 for a picture of the extensometer as it was attached during testing.

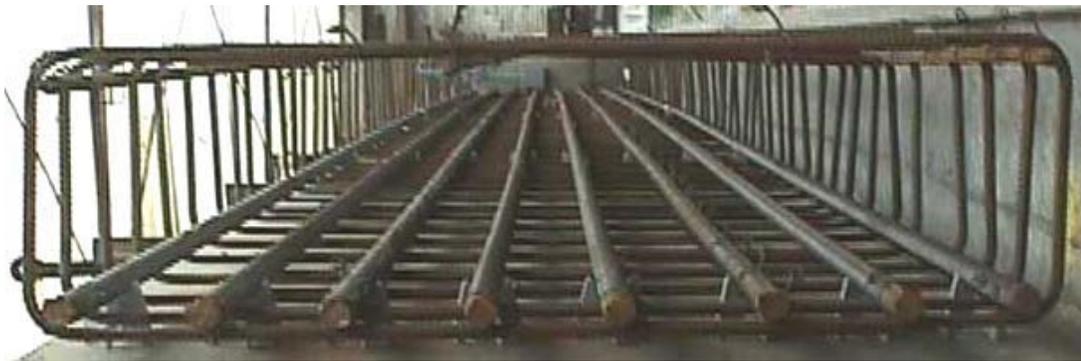
Figure 6.4 Steel Reinforcement Layout

reinforced panel consisted of eight 7/8-in (22.2-mm) bars for the tensile longitudinal reinforcement, three 1/2-in (12.7-mm) bars for the compressive longitudinal reinforcement and two 3/8-in (9.5-mm) bars for the shear reinforcement. Figure 6.4 illustrates the layout of the steel reinforcement in the panel. The design compressive strength of the concrete for the steel-RC panel was 4000 psi (27.6 MPa) and steel reinforcement with a yield strength of 60 ksi (413.7 MPa) was utilized; it should be underlined that a bi-linear constitutive model was assumed for the steel, neglecting any strain hardening that may occur.

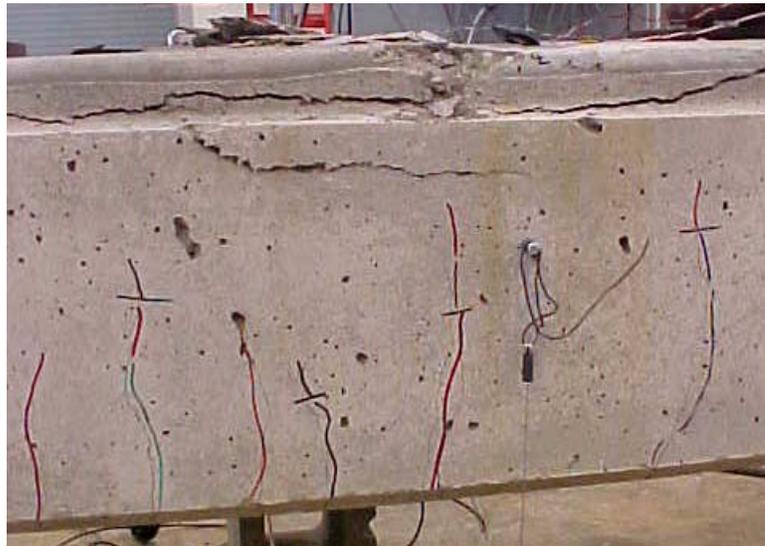
Figure 6.9 Failure of the Steel-RC Panel During the Flexural Testing

capacity tests is illustrated in Figure 6.9 and Figure 6.10, respectively. The shear cracking of the FRP-RC panel in Figure 6.10 is highlighted with lines to make it more visible.

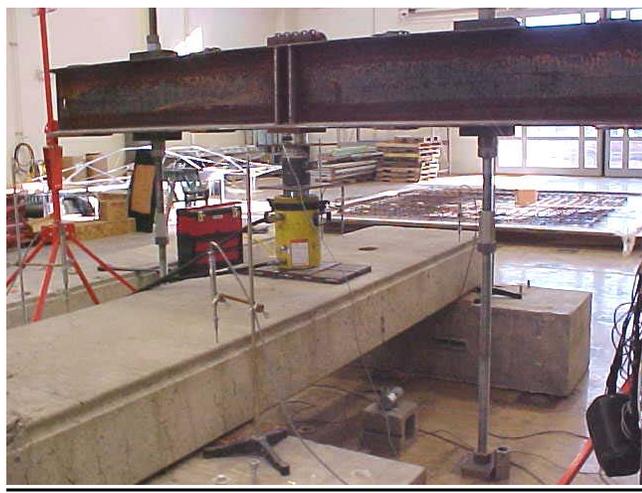
Figure 6.14 Test Setup for Shear Testing

Utilizing the material properties obtained from the laboratory characterization and the ACI guidelines for FRP- and steel-RC, the ultimate shear capacity of the steel-RC and FRP-RC panels was predicted at approximately 70.7 kips (314.5 kN) and 30.8 kips (137 kN), respectively. The concrete contribution to the shear capacity is approximated for the steel-RC by

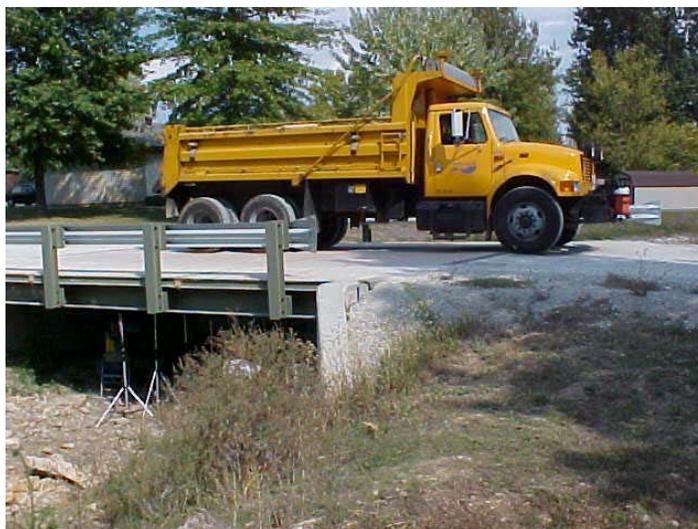
Figure 7.3 In-situ Bridge Load Test – St. Johns Street

Stop	Truck Position
1	Middle and rear axles of the truck centered longitudinally on the northern two panels, approximately 4.42 ft (1.35 m) onto the bridge from the north end
2	Middle and rear axles of the truck centered longitudinally on the joint between the northern two panels and the center two panels, approximately 8.83 ft (2.69 m) onto the bridge from the north end
3	Middle and rear axles of the truck centered longitudinally on the center two panels, approximately 13.25 ft (4.04 m) onto the bridge from the north end (i.e., at mid-span)
4	Middle and rear axles of the truck centered longitudinally on the joint between the center two panels and the southern two panels, approximately 17.67 ft (5.38 m) onto the bridge from the north end
5	Middle and rear axles of the truck centered longitudinally on the southern two panels, approximately 22.08 ft (6.73 m) onto the bridge from the north end

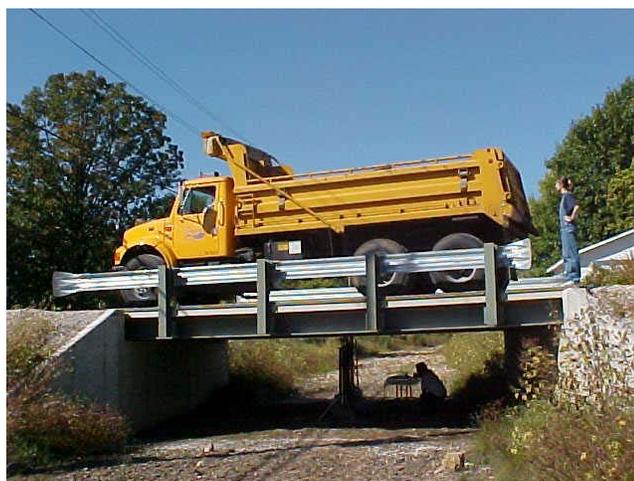
Figure 7.15 In-situ Bridge Load Test – Jay Street

Figure 7.14 illustrates the lateral location of the first four truck passes. Three additional passes were conducted symmetrically to Passes 1 through 3 as was a pass at 20 mph (32 kph) at the same location as Pass 4. Assuming that the bridge behaved symmetrically, the measurements from the symmetric load passes were used to complete the deflected shapes for Passes 1 through 3. During each pass the truck was stopped at five longitudinal locations. Table 7.3 details the location of the truck stops. Due to the axle loads and axle spacing of the loading truck, truck location 3 corresponds to the worst-case loading condition. A picture of the bridge during the load test is shown in Figure 7.15.

Stop	Truck Position
1	Middle and rear axles of the truck centered approximately 2.5 ft (0.76 m) onto the bridge from the north end
2	Middle and rear axles of the truck centered approximately 7.5 ft (2.29 m) onto the bridge from the north end
3	Middle and rear axles of the truck centered approximately 12.5 ft (3.81 m) onto the bridge from the north end (i.e., at mid-span)
4	Middle and rear axles of the truck centered approximately 17.5 ft (5.33 m) onto the bridge from the north end
5	Middle and rear axles of the truck centered approximately 22.5 ft (6.86 m) onto the bridge from the north end

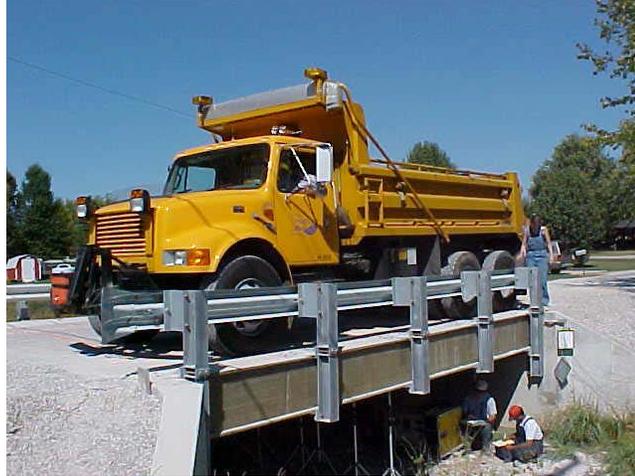
Figure 7.27 In-situ Bridge Load Test – St. Francis Street

five longitudinal locations. Table 7.4 details the location of the truck stops. Due to the axle loads and axle spacing of the loading truck, truck location 3 corresponds to the worst-case loading condition. A picture of the bridge during the load test is shown in Figure 7.27.

Stop	Truck Position
1	Middle and rear axles of the truck centered approximately 2 ft (0.61 m) onto the bridge from the east end
2	Middle and rear axles of the truck centered approximately 7 ft (2.13 m) onto the bridge from the east end
3	Middle and rear axles of the truck centered approximately 12 ft (3.66 m) onto the bridge from the east end (i.e., at mid-span)
4	Middle and rear axles of the truck centered approximately 17 ft (5.18 m) onto the bridge from the east end
5	Middle and rear axles of the truck centered approximately 22 ft (6.71 m) onto the bridge from the east end

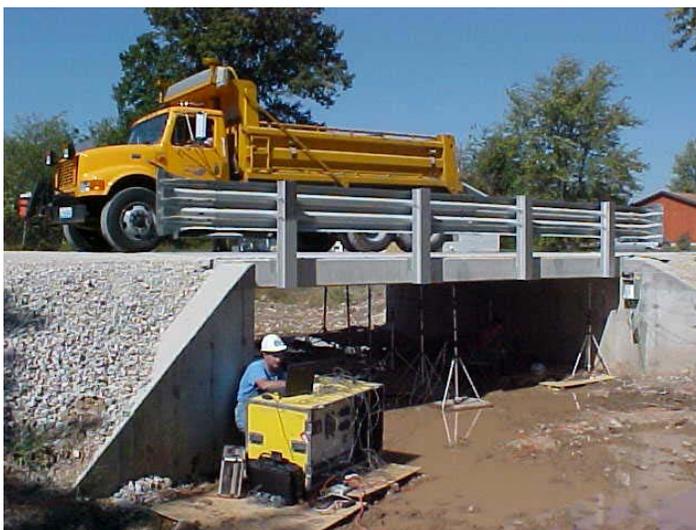
**Figure 7.37 In-situ Bridge Load Test – Walters Street**

Stop	Truck Position
1	Middle and rear axles of the truck centered approximately 1 ft (0.30 m) onto the bridge from the north end
2	Middle and rear axles of the truck centered approximately 6 ft (1.83m) onto the bridge from the north end
3	Middle and rear axles of the truck centered approximately 11 ft (3.35 m) onto the bridge from the north end (i.e., at mid-span)
4	Middle and rear axles of the truck centered approximately 16 ft (4.88 m) onto the abutment from the north end
5	Middle and rear axles of the truck centered approximately 21 ft (6.40 m) onto the abutment from the north end

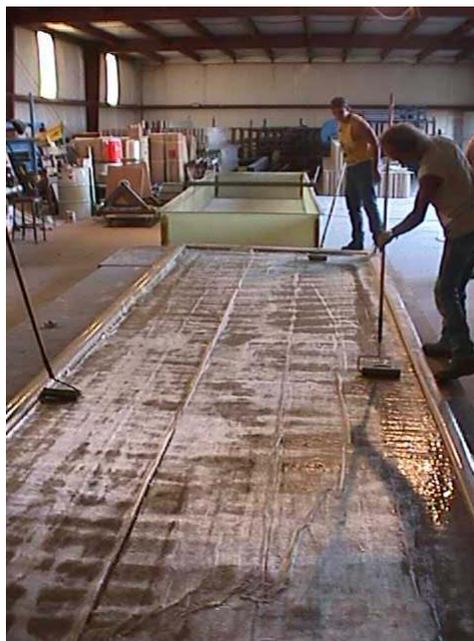
2. The layers of the FRP material are laid-up on a frame to form the bottom face of the panel. This process took approximately 4 hours.

Figure A.2 Manual Lay-up of the Bottom Face

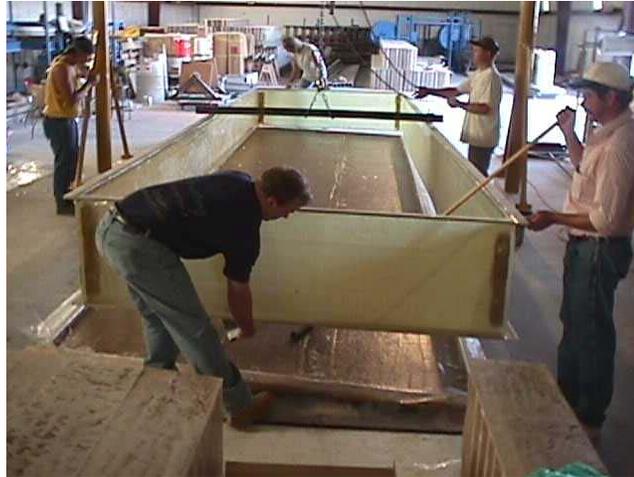
3. Pultruded FRP channels are utilized to close the sides of the panels. This process took approximately 1 hour.

Figure A.3 Installation of the Panel Edges

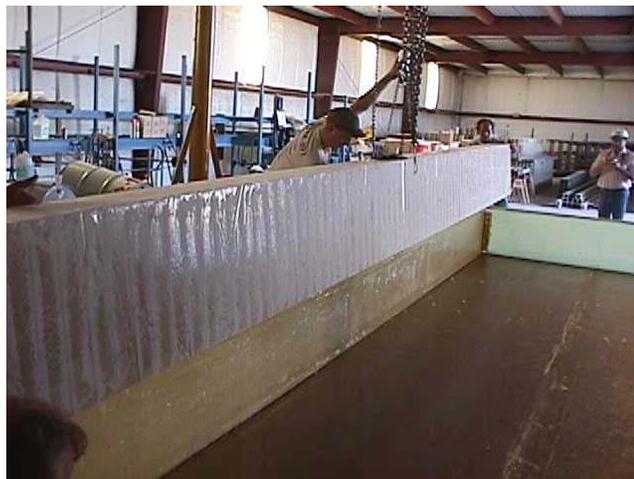
4. The sections of core are placed into position on the bottom face of the panel while it is still wet. This process took approximately 2 hours.

Figure A.4 Installation of the Core Sections

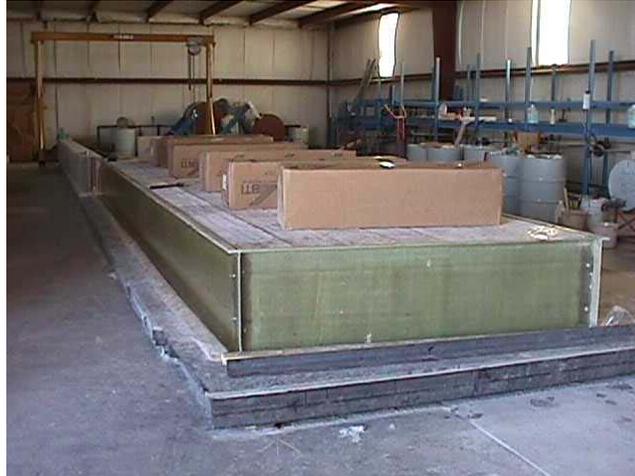
5. The core sections are weighted to press them into the bottom face for bonding purposes. The core and bottom face were allowed to cure with the weights on top over night (approximately 8 to 10 hours).

Figure A.5 Weighting of the Core Sections

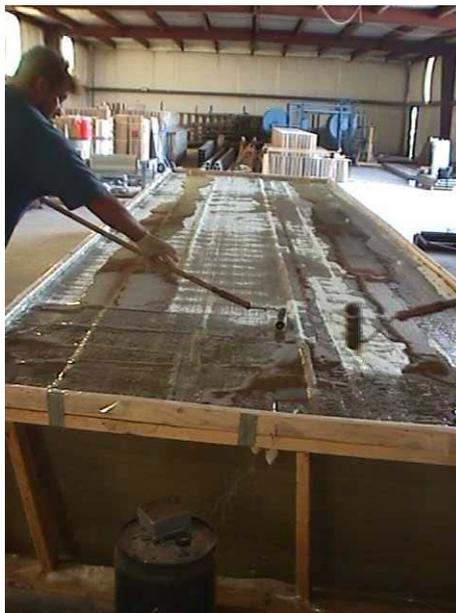
6. The layers of FRP are laid-up on the top of the core sections in order to form the top face. This process took approximately 4 hours.

Figure A.6 Manual Lay-up of the Top Face

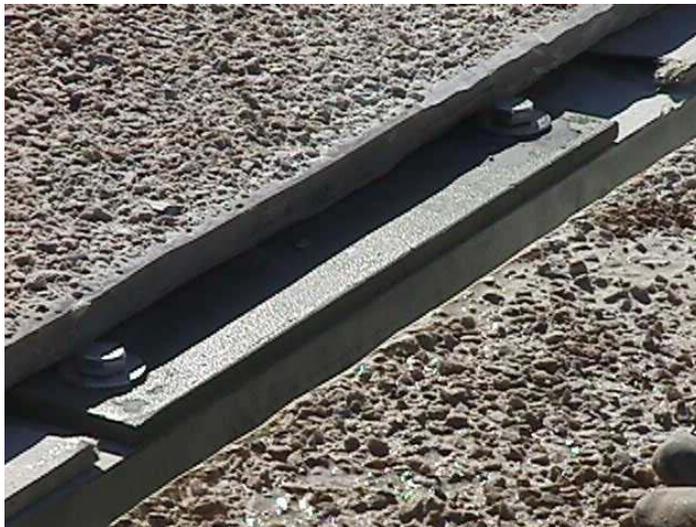
Figure D.8 Top View of Clamping Assembly – St. Johns Street

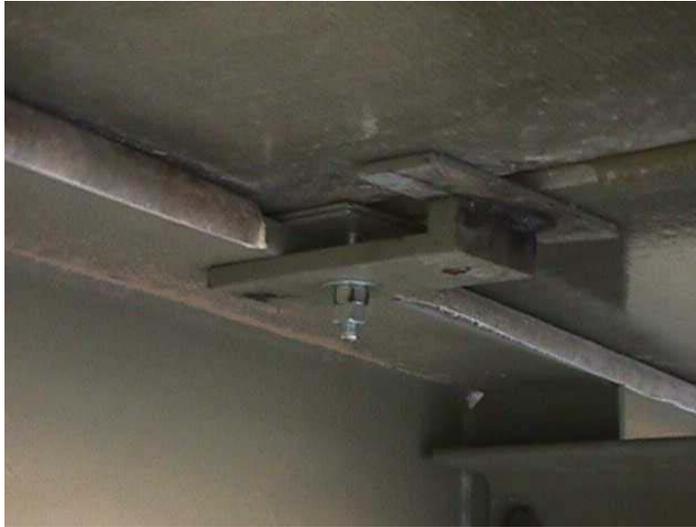
Figure D.9 Underside view of Clamping Assembly– St. Johns Street

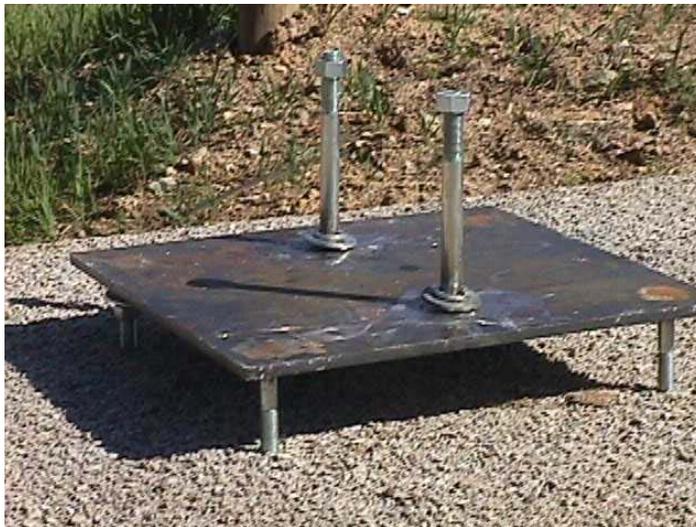
Figure D.10 Clamping Assembly– Jay Street

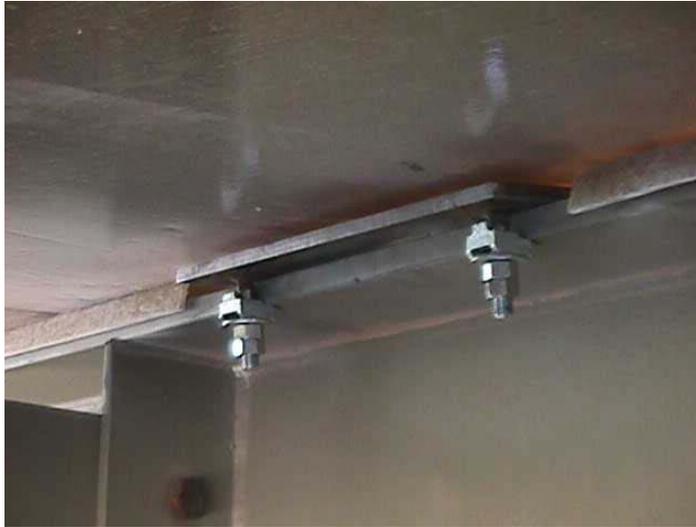
Figure D.11 Underside View of Clamping Assembly– Jay Street

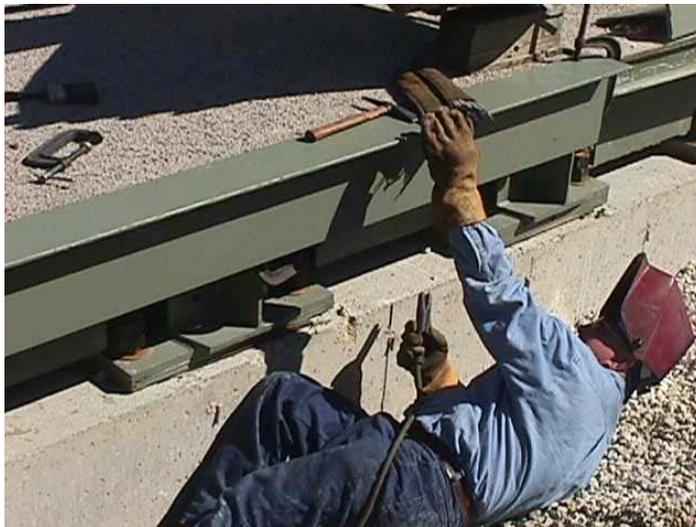
Figure D.12 Connection of the T-beam to the Girders– St. Johns and Jay Street

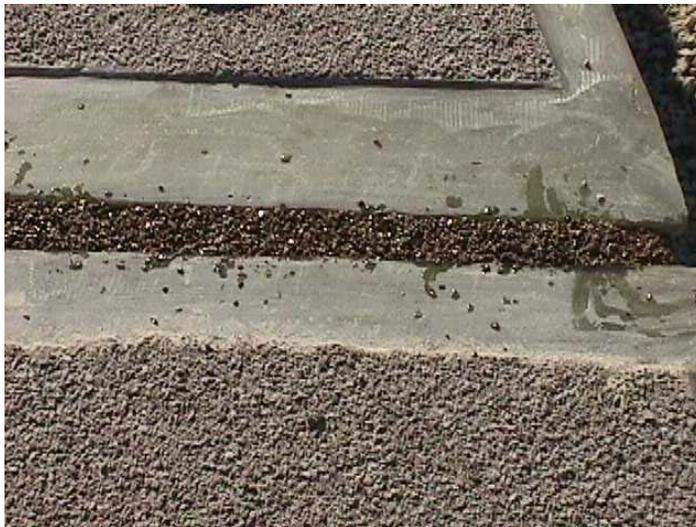
Figure D.14 Filling of Joint Space with Polymer Concrete – St. Johns and Jay Street

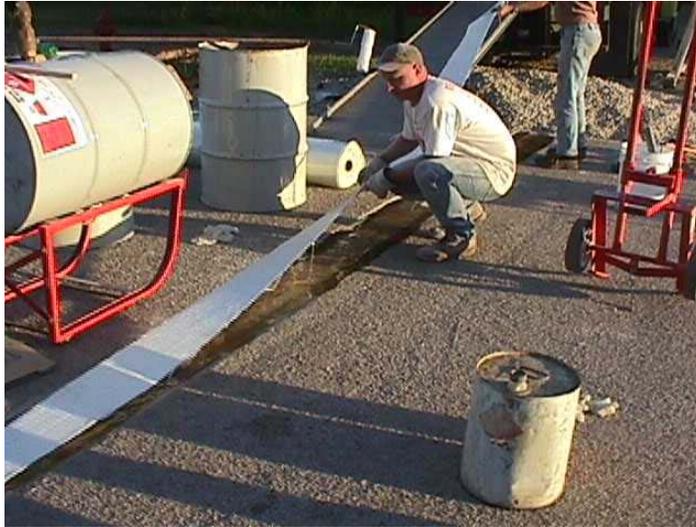
Figure D.15 Lay-up of FRP Layers over the Joint Space – Jay Street

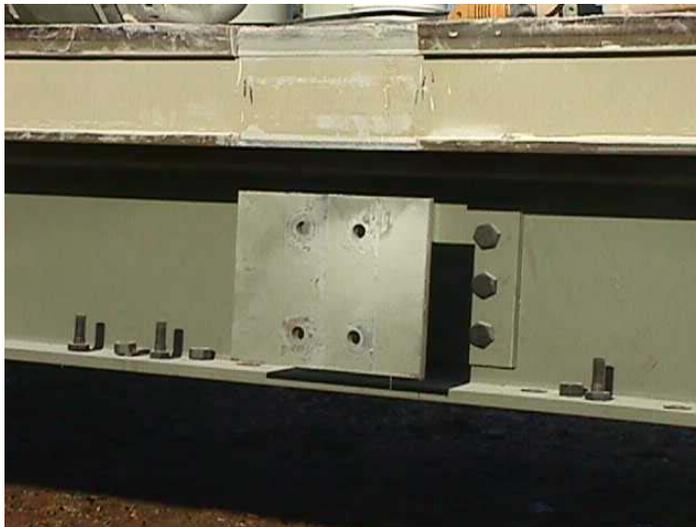
Figure D.16 Spacer Block Between the Girders and the Guardrail Posts – St. Johns and Jay Street

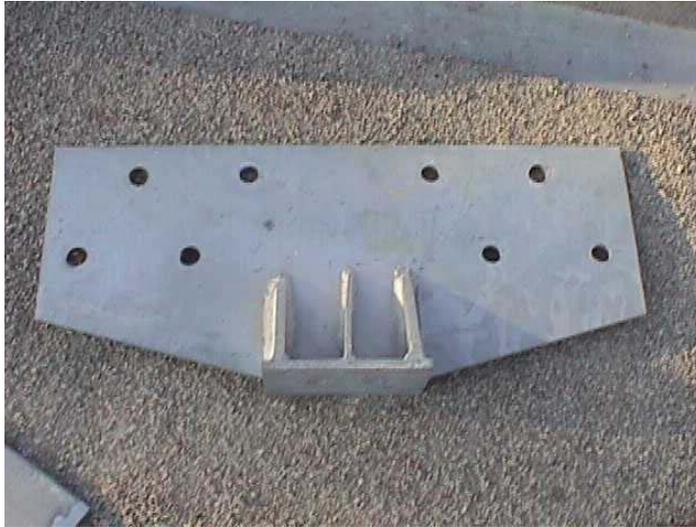
Figure D.19 Steel Plate Utilized to Attach Guardrail Posts to the Panels – St. Francis Street

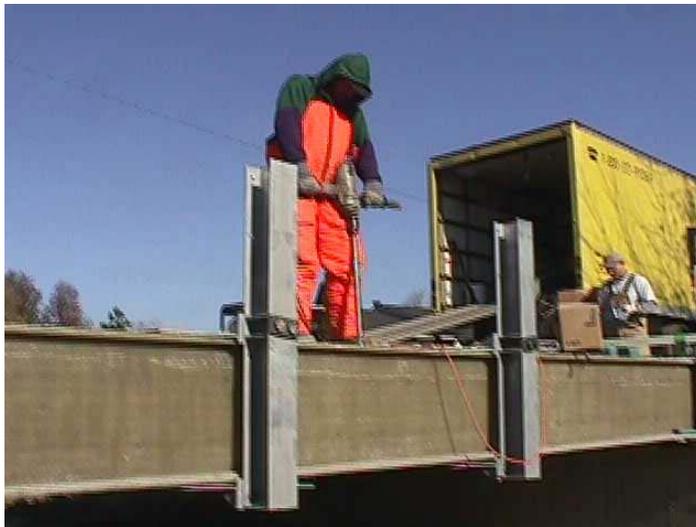
Figure D.20 Drilling Holes through the Deck to Attach the Guardrails to the Panels – St. Francis Street

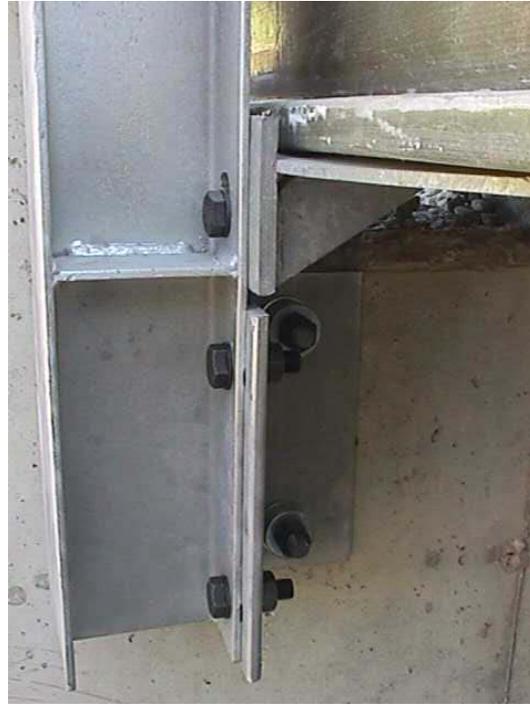
Figure D.21 End Guardrail Post with Additional Connection to the Abutment – St. Francis Street

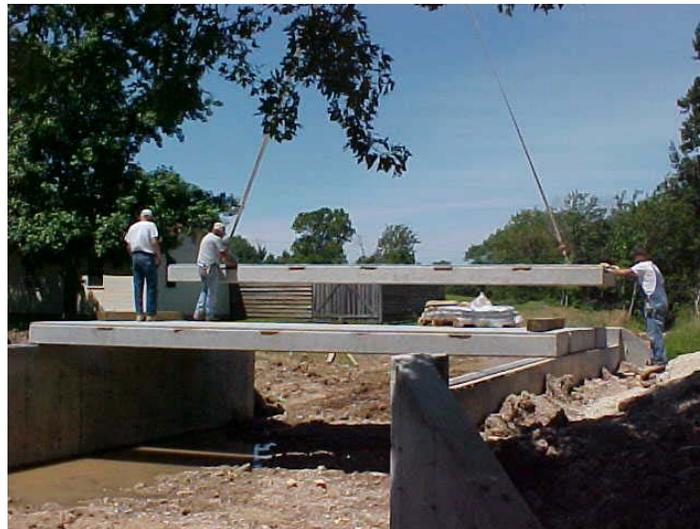
Figure D.22 Setting of the Bridge Panels – Walters Street

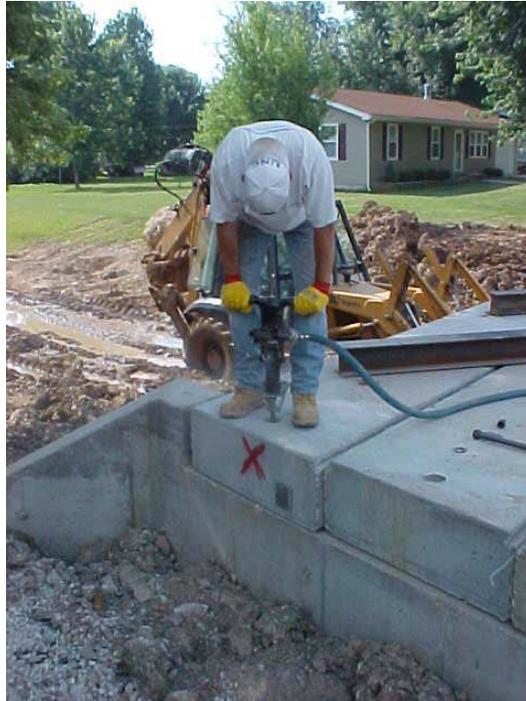
Figure D.23 Drilling Holes to Anchor the Panels to the Abutments – Walters Street

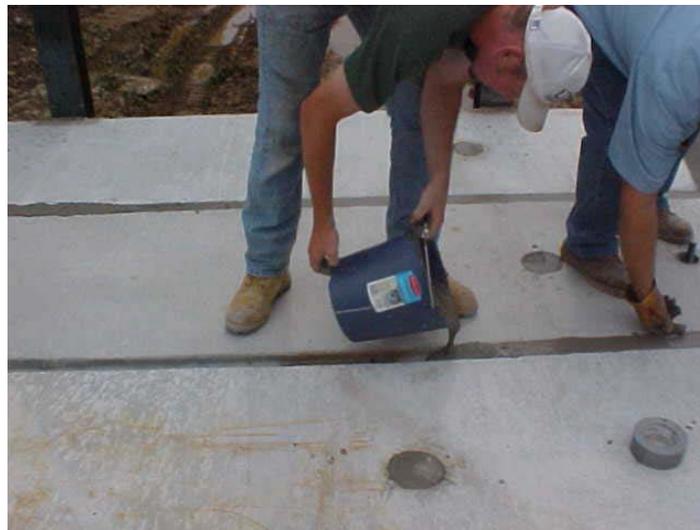
Figure D.24 Filling Panel Joints and Abutment Anchor Holes with Grout – Walters Street

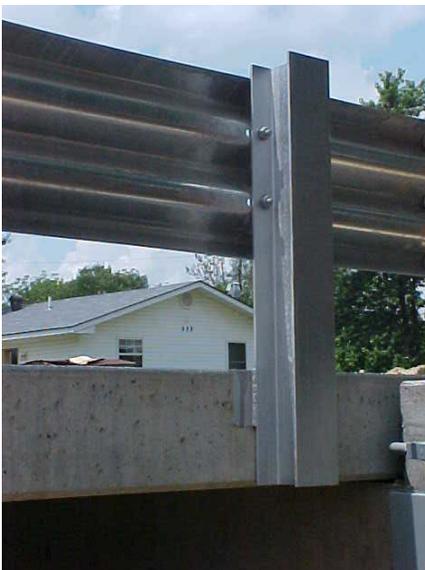
Figure D.25 Installed Guardrail – Walters Street
