## FRP RETROFIT OF MASONRY WALL IN HEALTH CARE FACILITY

**Name:** Veterans Affairs Medical Center  
**Type:** Health Care Facility  
**Location:** Tucson, AZ  
**Completed:** January 2005

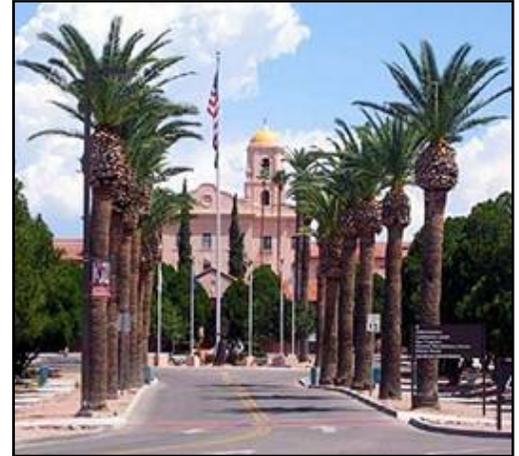
The demolition of an adjacent storage room gave concern to the stability of a tall unreinforced masonry wall in the boiler room of the hospital.

The wall required strengthening for stability and to resist lateral shear loads. Access to the wall from inside the boiler room was very limited and there were many pipes attached to the wall that could not be removed or relocated.

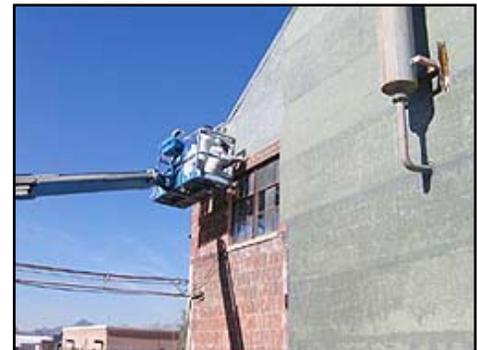
- URM wall required strengthening
- Very limited work space from inside the room
- Access was limited by the many appurtenances attached to the wall
- 2,500 ft<sup>2</sup> of QuakeWrap® glass fabric used
- The pipes attached to the wall remained intact
- Walls painted at completion
