FRP REPAIR OF UOFA MIRROR LAB THIMBLE

Name: University of Arizona Mirror Lab Thimble
Type: Tower
Location: Tucson, Arizona
Completed: May 2008

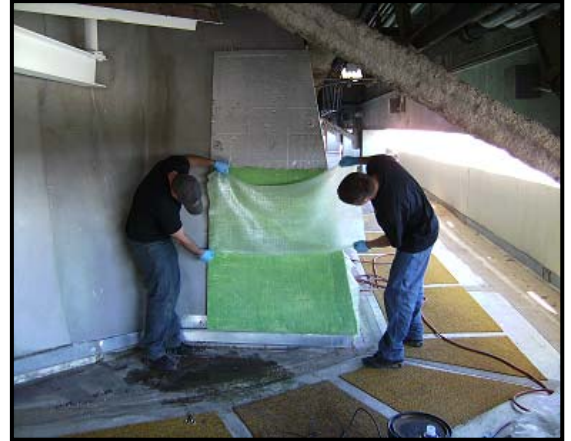
This unique thimble structure atop the University of Arizona Football stadium sits directly above the university's world-renown mirror lab where multi-million dollar mirrors are manufactured for observatories worldwide. The exterior insulation and finish system (EIFS) sheets were damaged during a storm, causing leakage of rain water on the mirror laboratory below. This was clearly unacceptable and prior repairs had also failed.

QuakeWrap® FRP Repair System was selected since it would create a "one piece" structure that would be extremely strong, waterproof and resistant to wind loads.

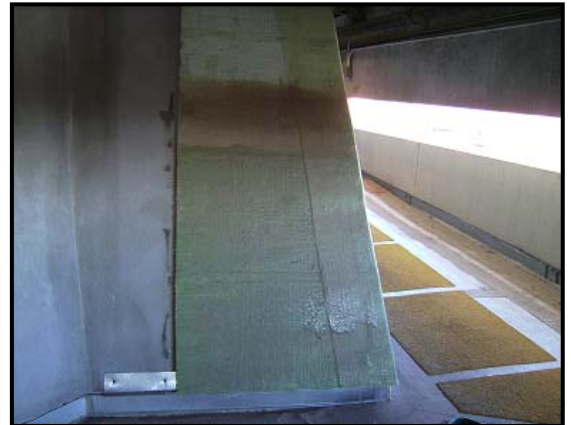
Once scaffolding was set up, one inch thick EIFS boards were installed to cover the whole structure. QuakeWrap® VB26G fabric was then installed in one layer to provide strength, resistance to wind and waterproof membrane. A final textured coating was applied over the repaired structure to hide the texture of the fabric and the overlapping joints (see photo below).

This installation was completed in 5 days using a 4 man crew.

- FRP repair provided to waterproofing and resistance to wind loads.
- Wrapped in one layer of QuakeWrap® VB26G fabric.
- Coated and painted to resemble original structure.
